# Gully Stabilization

Last Resort Farm, Monkton, VT

## Pond Brook Tributary

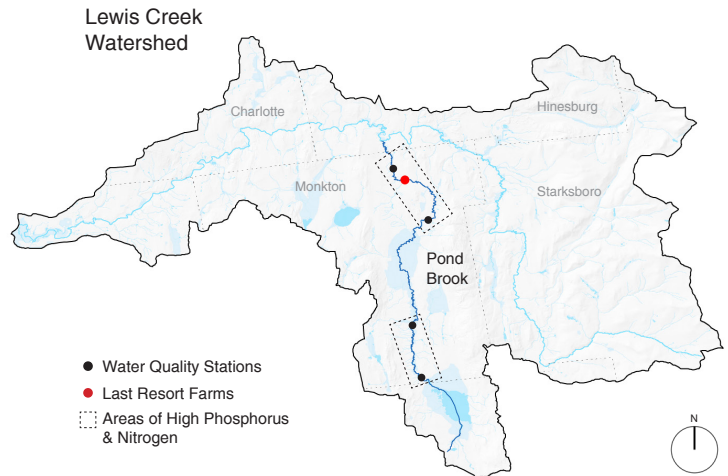
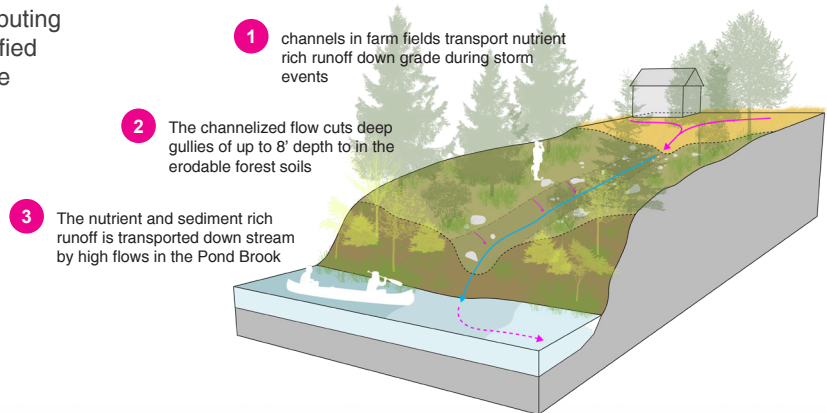
Gully erosion was revealed along this reach - a likely contributing source of sediment and nutrients. Five gullies were identified that are fed by swales that developed in hay fields on the Last Resort Farm, and cut down through steep, forested slopes with erodable soils that formed the valley walls along Pond Brook. Where gullies met the Pond Brook, there were large deposits of sediment, which would be periodically flushed and transported downstream by high flows in the Pond Brook.
