**Stream Corridor Plan
LaPlatte River and Tributaries
Town of Hinesburg, Vermont**

Prepared by the LaPlatte Watershed Partnership
June 2007

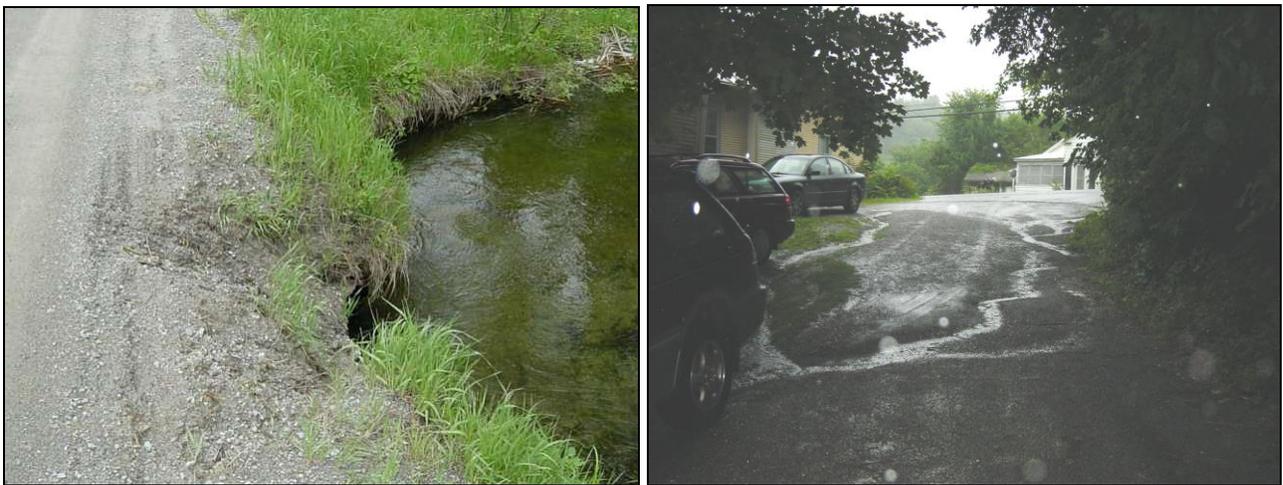
Runoff from roads, driveways, and road washouts during storms also appeared to be a source of increased sediment and increased runoff in the streams. Driveways and roads had essentially dammed floodplains and channeled runoff directly to streams, which was especially evident in hill reaches. Exposed soil from incremental development in the watershed was another source of sediment to stream channels.

Sand and gravel from roads and driveways washing into the channel.

Sediment from roads and driveways can be addressed with improved ditches, limiting future driveway lengths in sensitive areas, and other methods. The Better Back Roads program would be helpful.

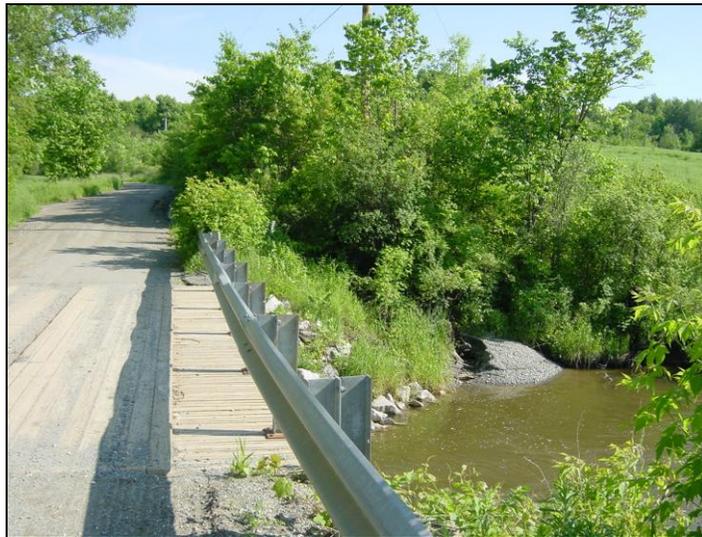
Leavensworth Road and bridge at M12 with large sediment deposit on the right where the road ditch meets the channel.

An undersized bridge is in the reach at Leavensworth Rd. Flooding problems have been identified here by the landowner, who has noticed increased flooding of fields. The bridge and road were apparently designed to have flood flows run over the road, so even though the bridge constricts the bankfull width, pressure is low because of the opportunity for flood flows to access the floodplain and flow over the road. Development past the river on Leavensworth Road now makes road closure due to flooding inconvenient. A series of culverts under the road and adjacent to the bridge to pass flood flows has been proposed. If the culverts are put in and the road therefore raised, more pressure would likely be placed on the bridge (which brings problems there) because the floodplain would be constricted as well.

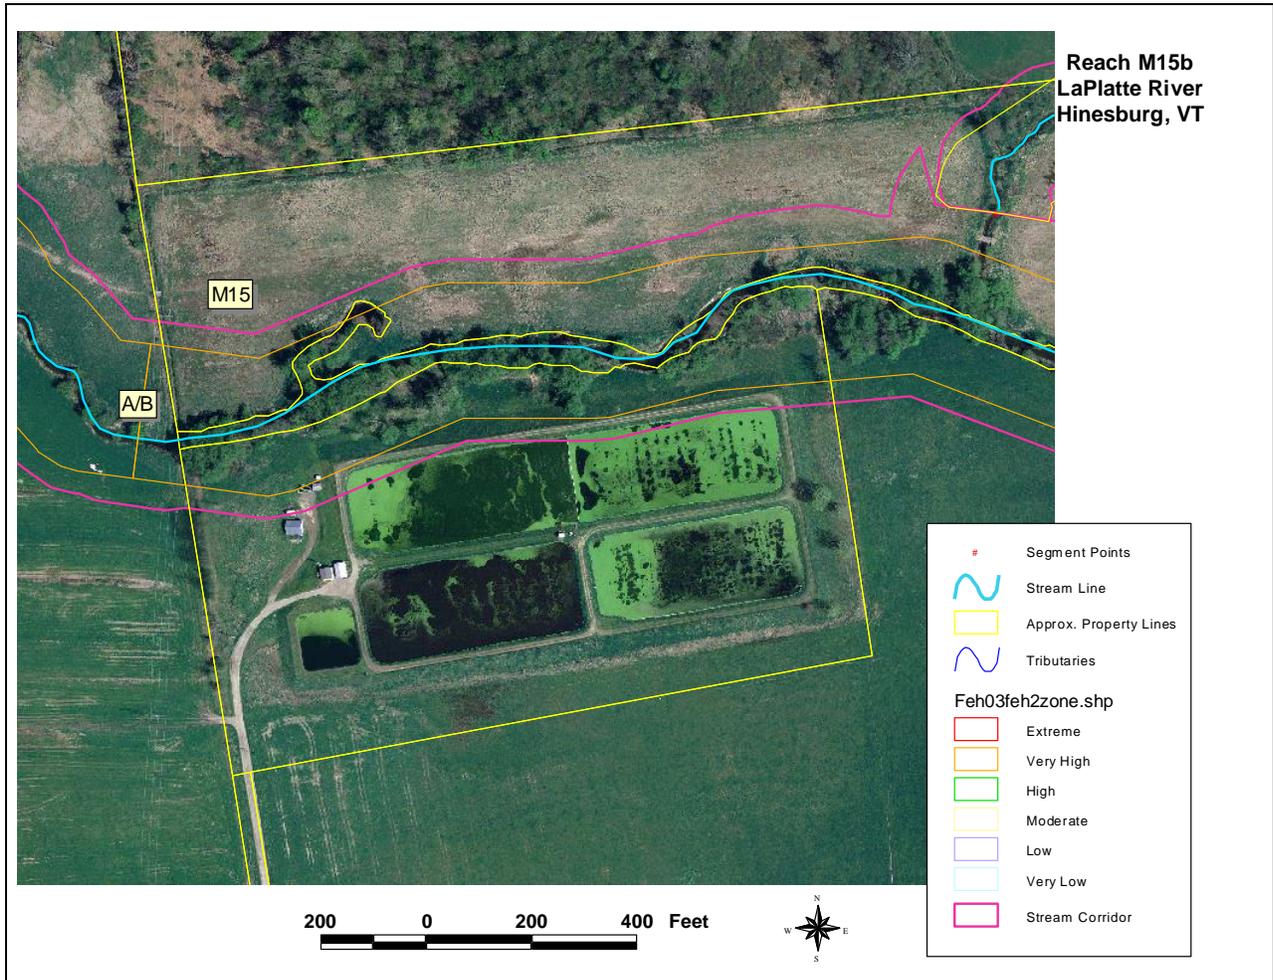
The channel was straightened and incised, resulting in greater stream power and increased sediment transport capacity. No recently abandoned channels were observed to capture as a restoration tool. The Hinesburg Sewage Treatment Plant is a permanent constraint within the corridor on the left bank. The LWP has been working with the Town of Hinesburg to plan future Plant expansions out of the stream corridor. Other than that, adjacent land use appeared to be fallow field and flow and sediment load alterations do not appear to be significant enough to inhibit the active geomorphic restoration of floodplain and meanders.

Downstream area of M15B with the STP on the left bank. The STP encroaches into both the FEH corridor and the Stream Corridor. The stream has begun to meander here and is migrating toward the berm of the lagoon.

Active restoration such as lowering of the floodplain may be preferable to a passive approach here due to the proximity of the Sewage Treatment Plant. The channel appeared to be adjusting and protection of the corridor could allow for passive geomorphic restoration, although an active approach near the STP might be preferable to provide protection and relief to that investment. Restoring the segment through a combination passive/active approach is a possibility as well.

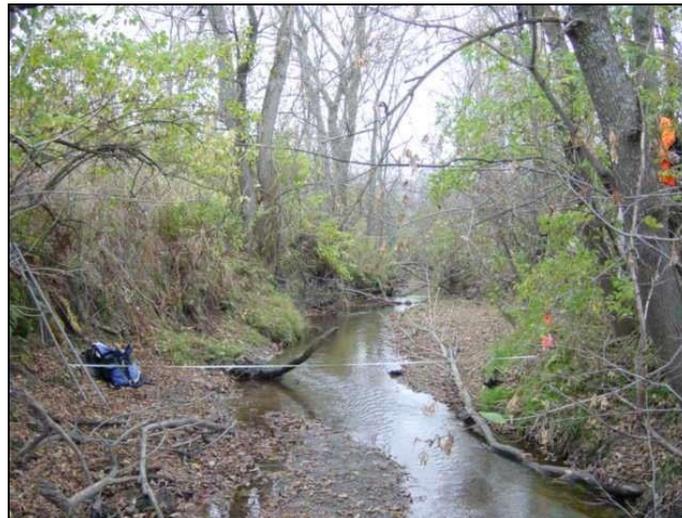
Reach M17 experienced a stream type departure (C to B) and currently appeared to be widening and aggrading, attempting to gain some floodplain and sinuosity in its incised and entrenched position.

Reach M17, entrenched and now widening and aggrading.

The river corridor is undeveloped but the channel has been straightened and likely dredged deeper. If the channel were not actively managed, it may adjust to equilibrium conditions, although the 20-30 year “near-term” time line may not be realistic due to the clay present in the bed and banks, which has limited movement. However sediment supply is high, so protecting the river corridor and pursuing a passive restoration approach here could allow for floodplain and meander redevelopment over the long-term, without the cost of active restoration. Berms present in the reach are not the main reason the channel is incised.

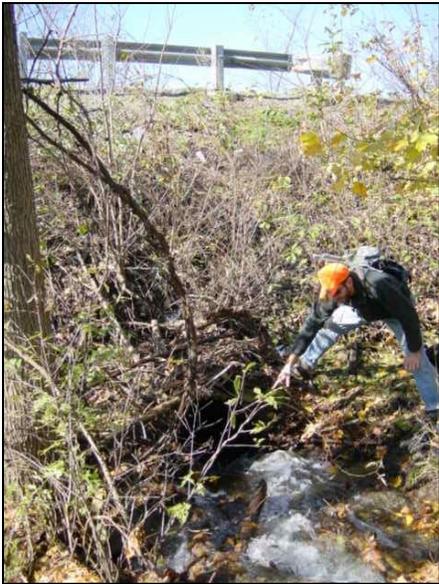
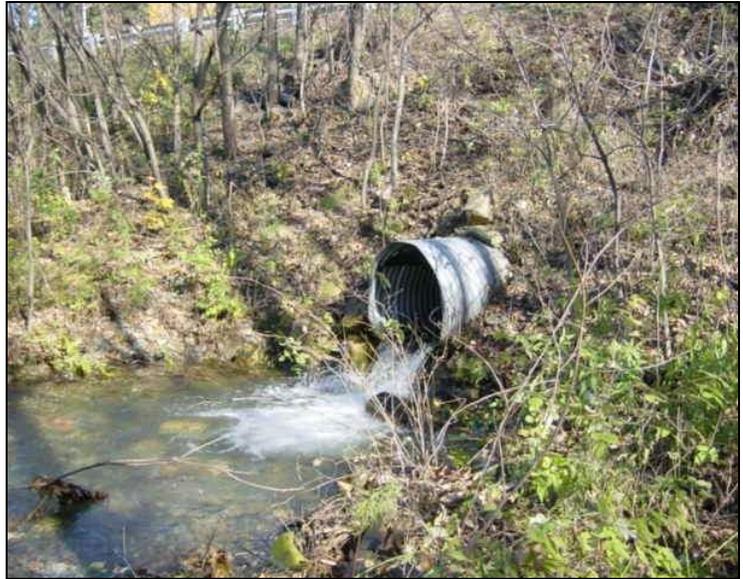
Culvert on segment M18B. The upstream end of the culvert was blocked by sediment and debris and was hardly visible (left). Extreme scour was apparent at the downstream end and beyond (right).

The river corridor is largely undeveloped except for one house on the left bank, but the channel is not likely to adjust to equilibrium due to the undersized culvert at Route 116. The streambed was actively eroding with active head cuts observed. The stream was deeply incised (1.9). The culvert should be replaced with protection provided to the house on the left bank if necessary. Sediment from upstream of the culvert would erode and enter the system, however that could aid adjustments underway downstream by slightly raising bed elevation and/or inducing meanders (such as in reach M17). If sediment introduction is undesirable from a water quality standpoint, structures could be placed to partially retain the sediment and encourage floodplain restoration or the sediment could be removed.

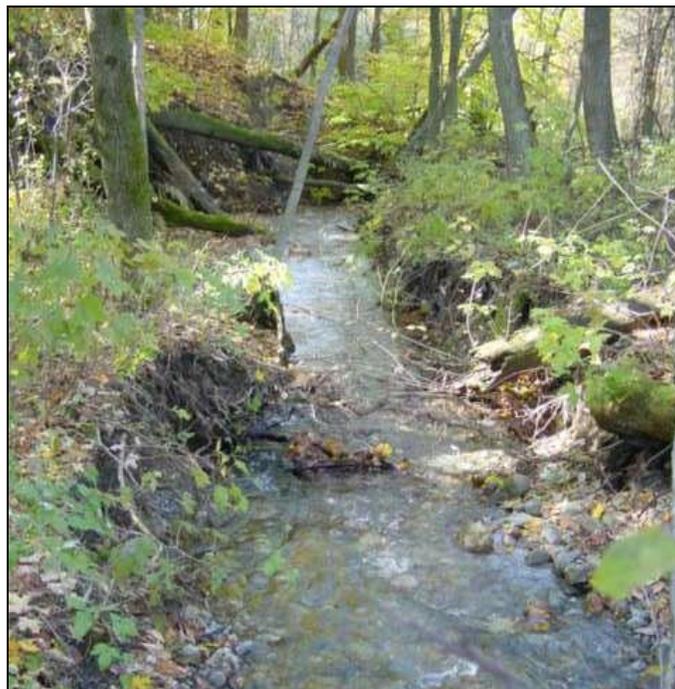
Extreme effects of constricting the channel and blocking flow of sediment has led to property damage with aggradation upstream and erosion downstream.

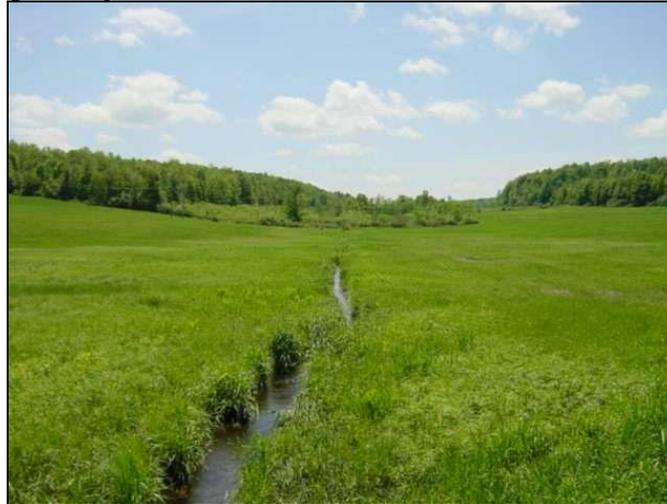
Channel and valley view. Note straightening and lack of woody riparian vegetation.

The river corridor is undeveloped and likely to adjust to equilibrium, although due to clay soils, may be in the long-term rather than the near-term. Protect the stream corridor to allow for adjustment to equilibrium. The landowner was working to fence the pasture and plant a 35-foot buffer (spring of 2007 planting).

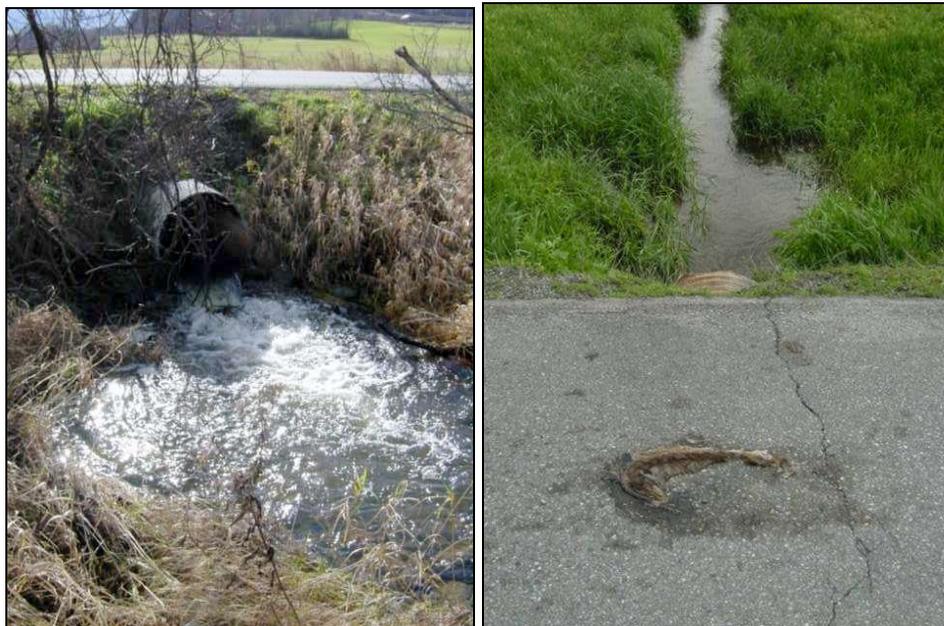
A culvert at Charlotte Road constricts the channel with sediment deposition upstream and scour downstream and a high incidence of road-killed wildlife. Sediment deposition is not likely to create a significant channel adjustment if it moves downstream, so replacing the structure with one of appropriate size is recommended.

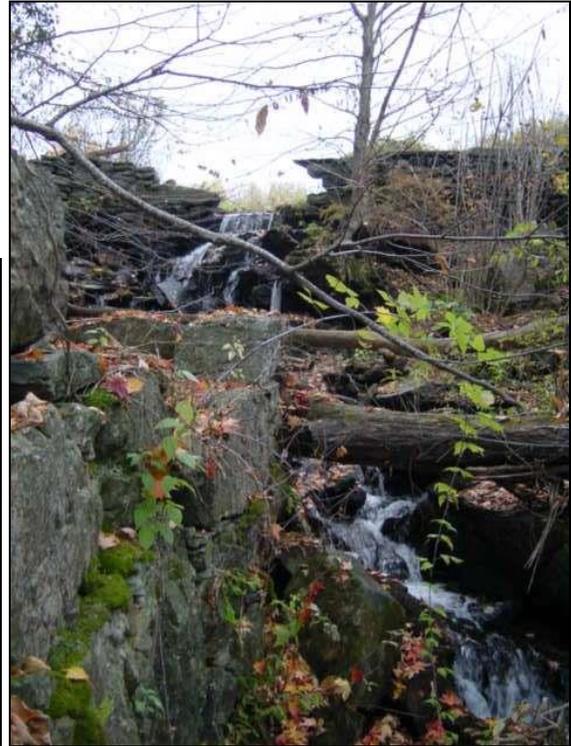
Old Mill dam near town cemetery.

River corridor is undeveloped and stream impacted by historical mill operations and dams as well as deforestation. This reach is under adjustment and may regain equilibrium in the near term if watershed stressors are not increased, such as further development with driveways and road ditches. So protecting the corridor is recommended, although a low priority as this area is wooded and difficult for development within the corridor. Minimal bank erosion was observed.

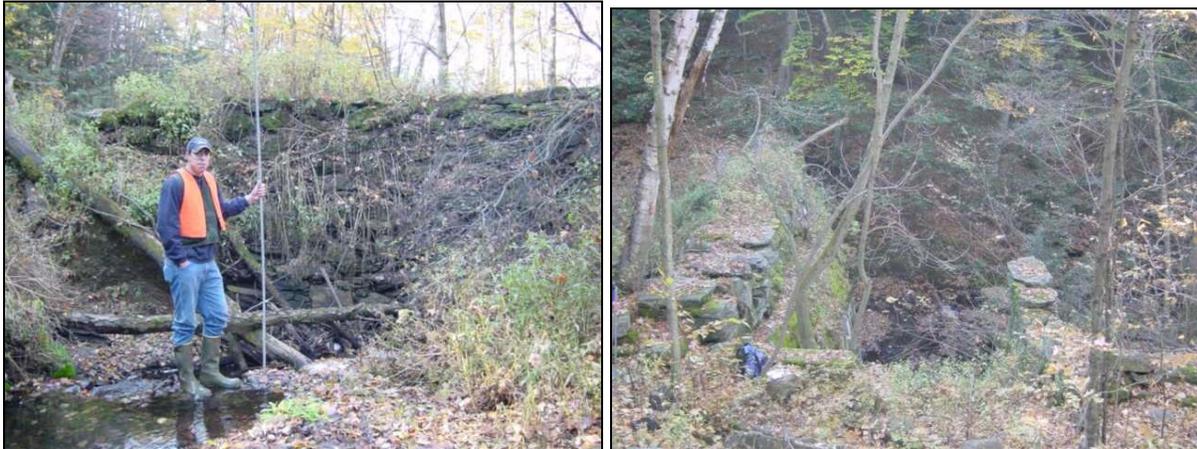
Old mill dam upstream and downstream photos.

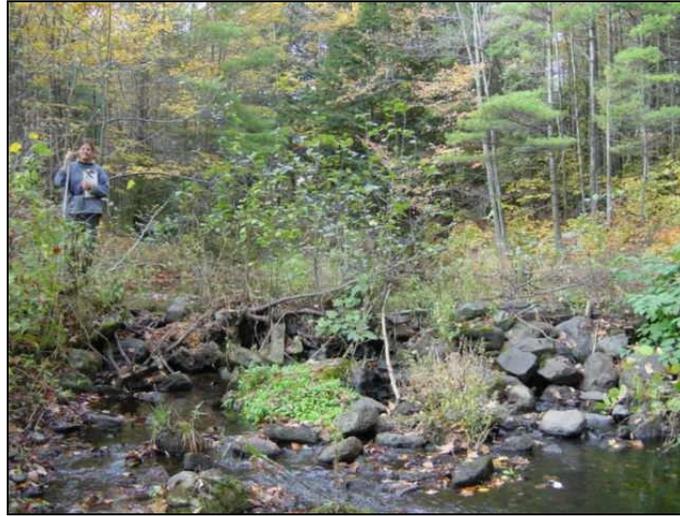
A dam was located in the reach and appeared to be non-functioning. Removal of this dam is recommended. A grade control structure may be necessary to prevent the channel from head cutting. Riprap and rock walls confine the channel toward the upstream end. Analysis of whether any of this could be removed without endangering infrastructure and homes is recommended.

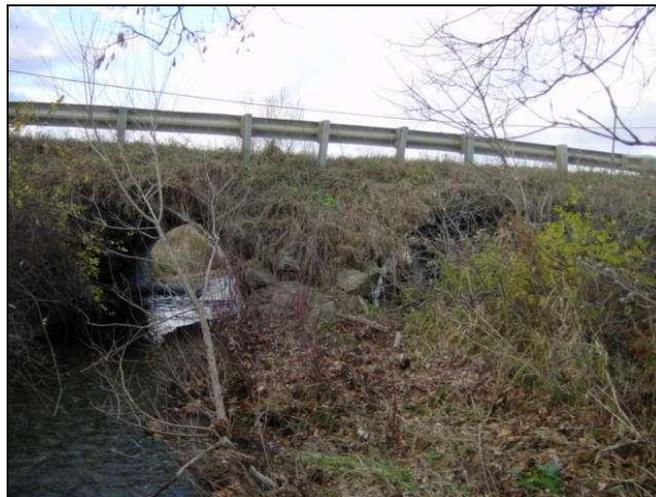
The double culvert at Route 116 constricts the channel and should be replaced with one of appropriate size. Route 116 also acts as a dam here. Sediment deposition has been a problem upstream of this culvert and has been cleaned out with riprap placed on the right bank.

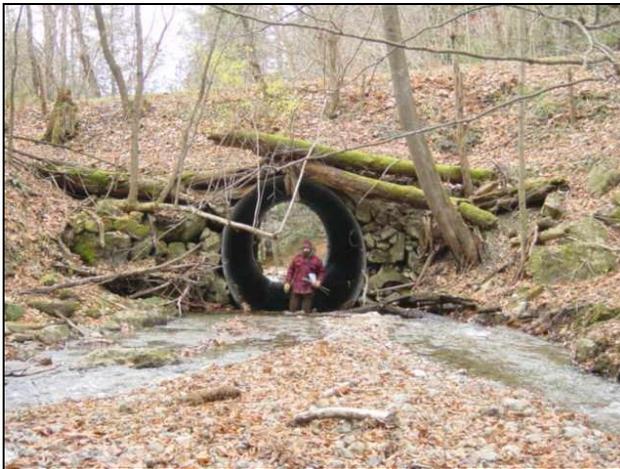
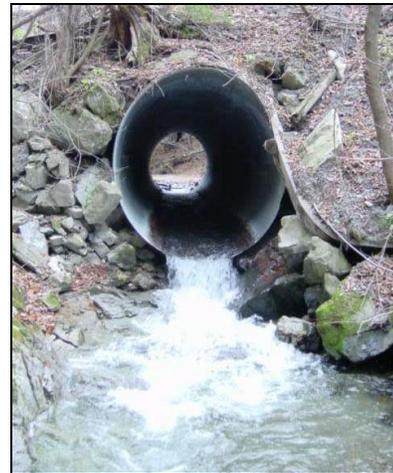
Beecher Hill Brook (T5.01B) culvert. Note aggradation forming bars and splitting flow upstream. Some erosion was noted downstream, although the downstream end falls onto ledge and boulders.

A culvert constricts the channel in this segment at Beecher Hill Road. Sediment upstream could deposit downstream near the left bank barns and house. Further analysis is needed to ensure that these investments are not impacted by replacement of this structure with one of appropriate size.

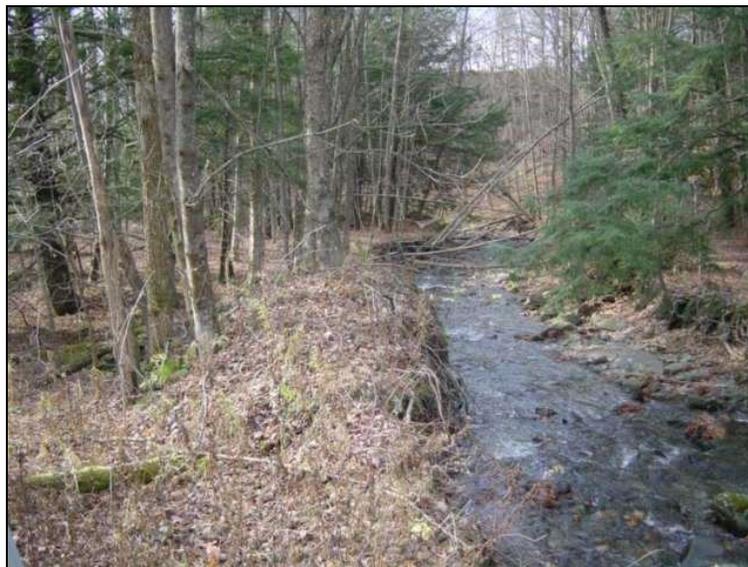
Segment T5.01D had been straightened, moved, and bermed historically, likely in conjunction with construction of North Road. Following the channel alteration, the stream had no access to floodplain and appears to have severely widened and incised. Continued incision and widening (channel enlargement) were evident in headcuts and scoured banks, leaving property at risk. This segment had ledge grade controls at both the upstream and downstream ends, helping confine these adjustments to this area.

Signs of an old channel were evident to the left of the photo. The channel appeared to have been moved to its current location and held in place by a berm, seen in the center of the photo.

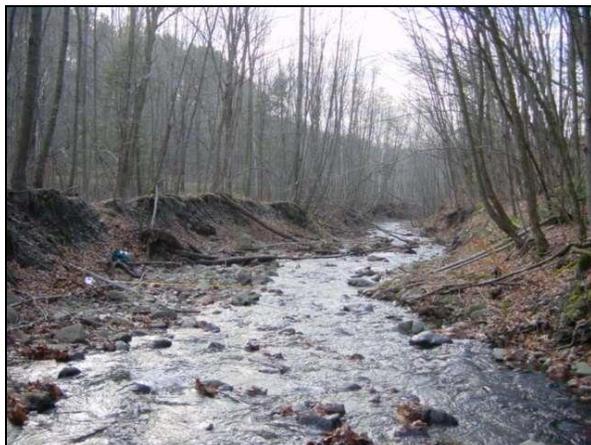
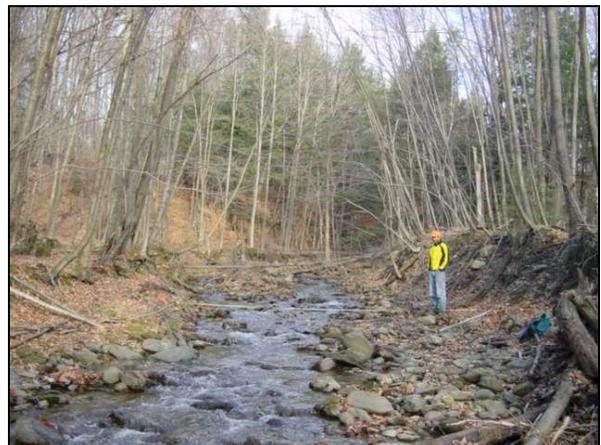
Significant channel enlargement following straightening and berming.

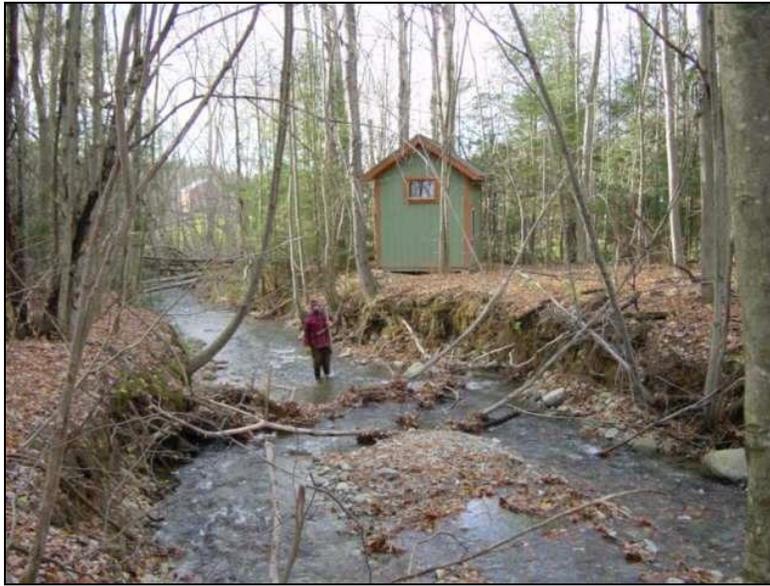
Channel enlargement further downstream leaving investments in danger.

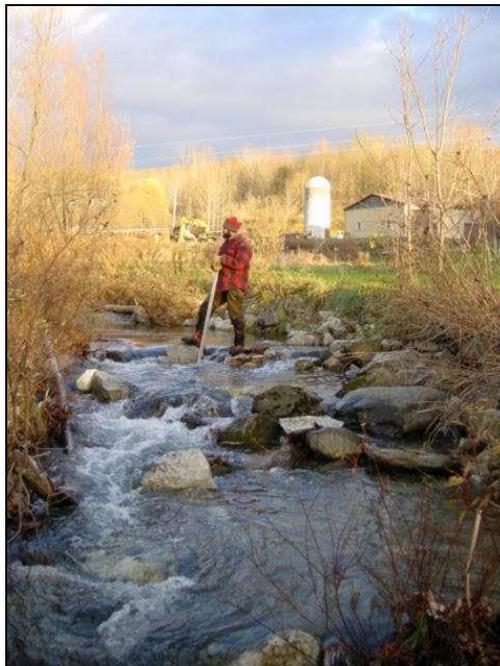
A head cut was identified downstream of the Beecher Hill Road bridge near North Road. This area has some floodplain access, so constructing a weir to arrest the head cut is recommended.

Headcut downstream of Beecher Hill Rd.

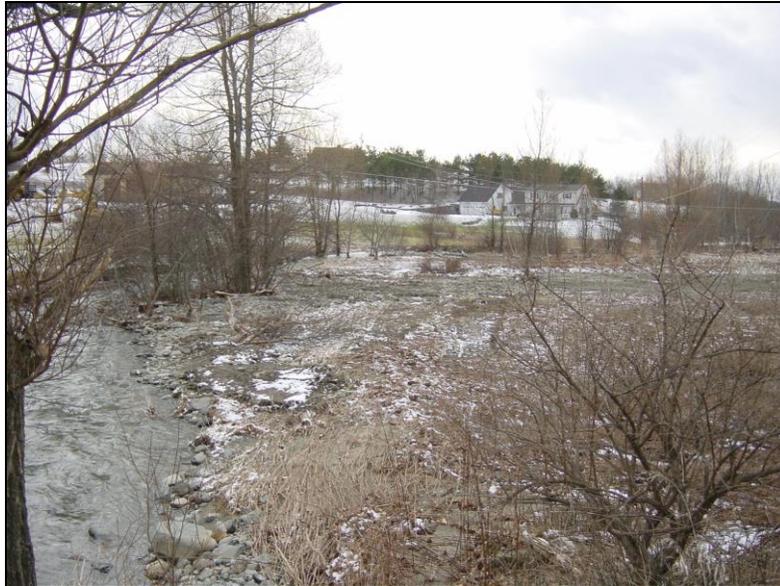
Floodplain fill replaced after January 18, 2006 storm flows, reducing sediment and flow attenuation in this area, which was between 2 degrading areas.

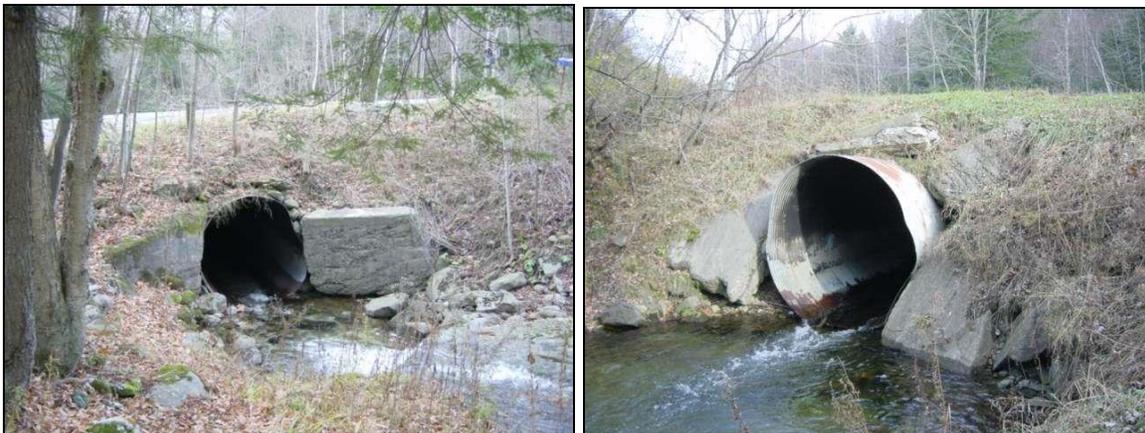
A bridge constricts the channel at Beecher Hill Road. Replacement with one of appropriate size is recommended. A culvert constricts the channel and has a significant downstream drop at the North Road. Grade controls upstream provide stability to this area. Replacement with one of appropriate size and orientation is recommended as a high priority to reduce erosion at the site. The segment is incised due to the berms. Parts of an abandoned channel exist that could be used for restoration. This should be examined in planning for restoration of the incised segment. The restoration may need to include bed forms and floodplain features in equilibrium with the higher stream power due to the North Road occupying some floodplain area.

Culvert at North Rd views: upstream end and downstream end.

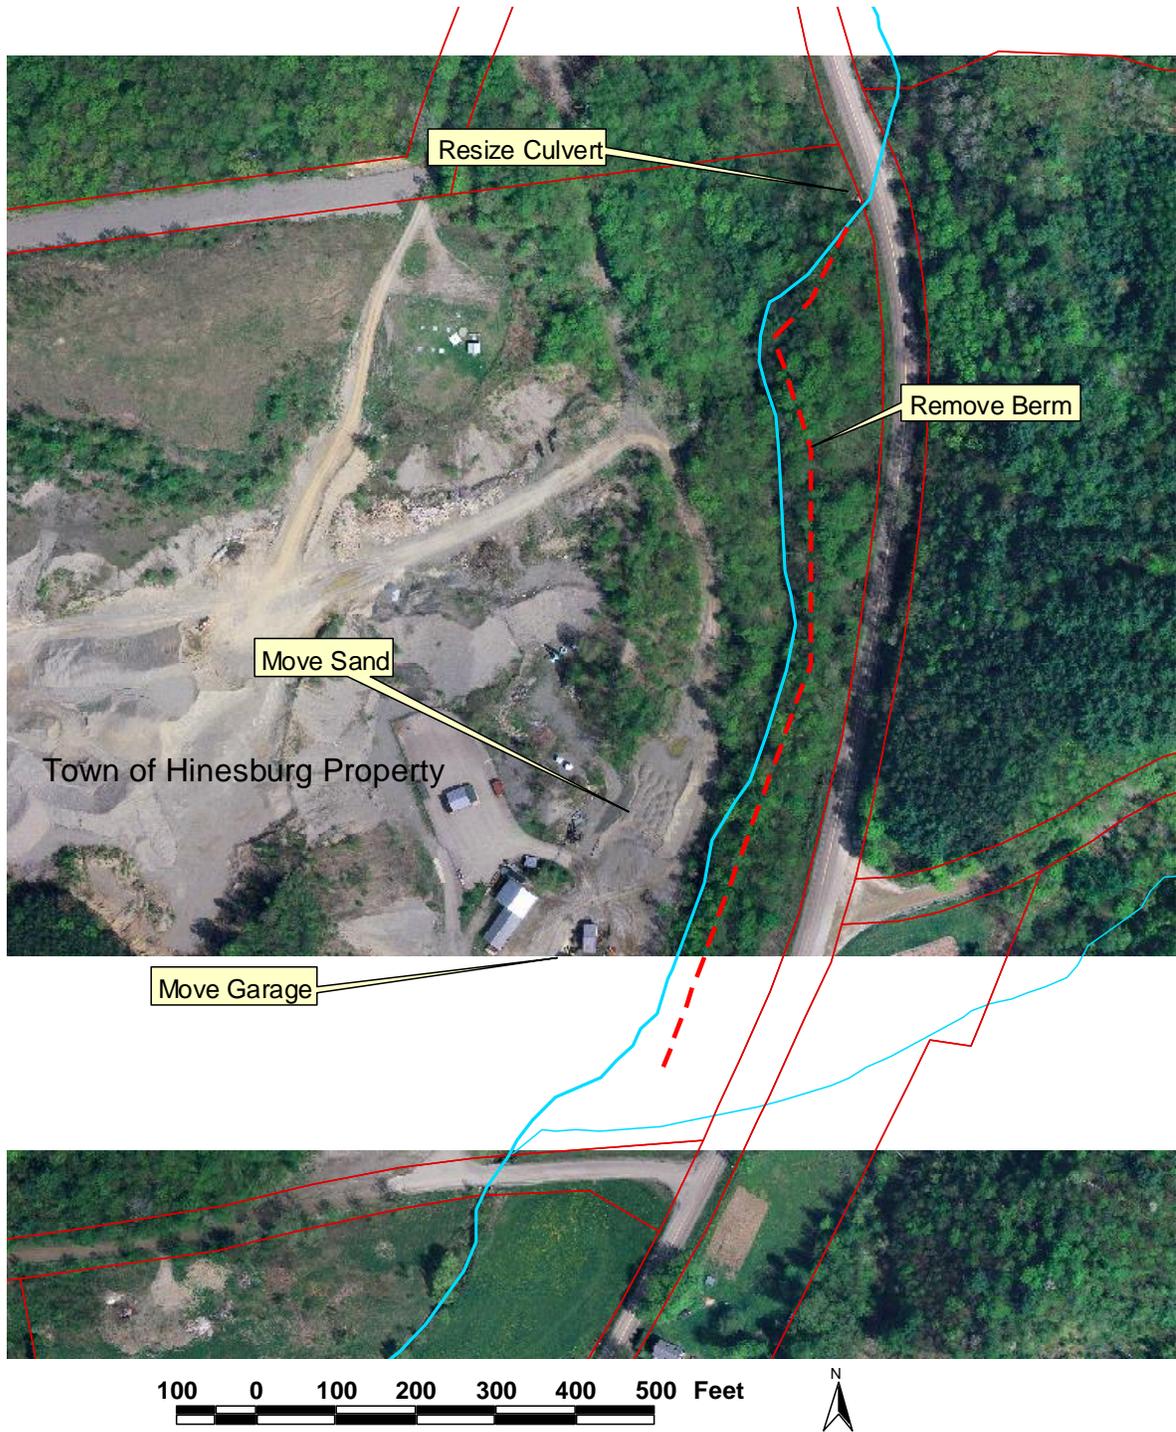
Town Garage Site T5.01D

Town Garage site map showing berm highlighted in red, North Rd to the east, Beecher Hill Rd to the south, the town garage and sand pile, and the location of the undersized culvert.

- Concept project components include:
- Conserve corridor
 - Move Town Garage and sand pile
 - Remove berm
 - Resize culvert upstream
 - Stabilize North Rd if and where necessary
 - Recapture old channels
