APPENDIX K – Outreach / Project Development

Lewis Creek Watershed

Chittenden & Addison Counties, Vermont

April 2010

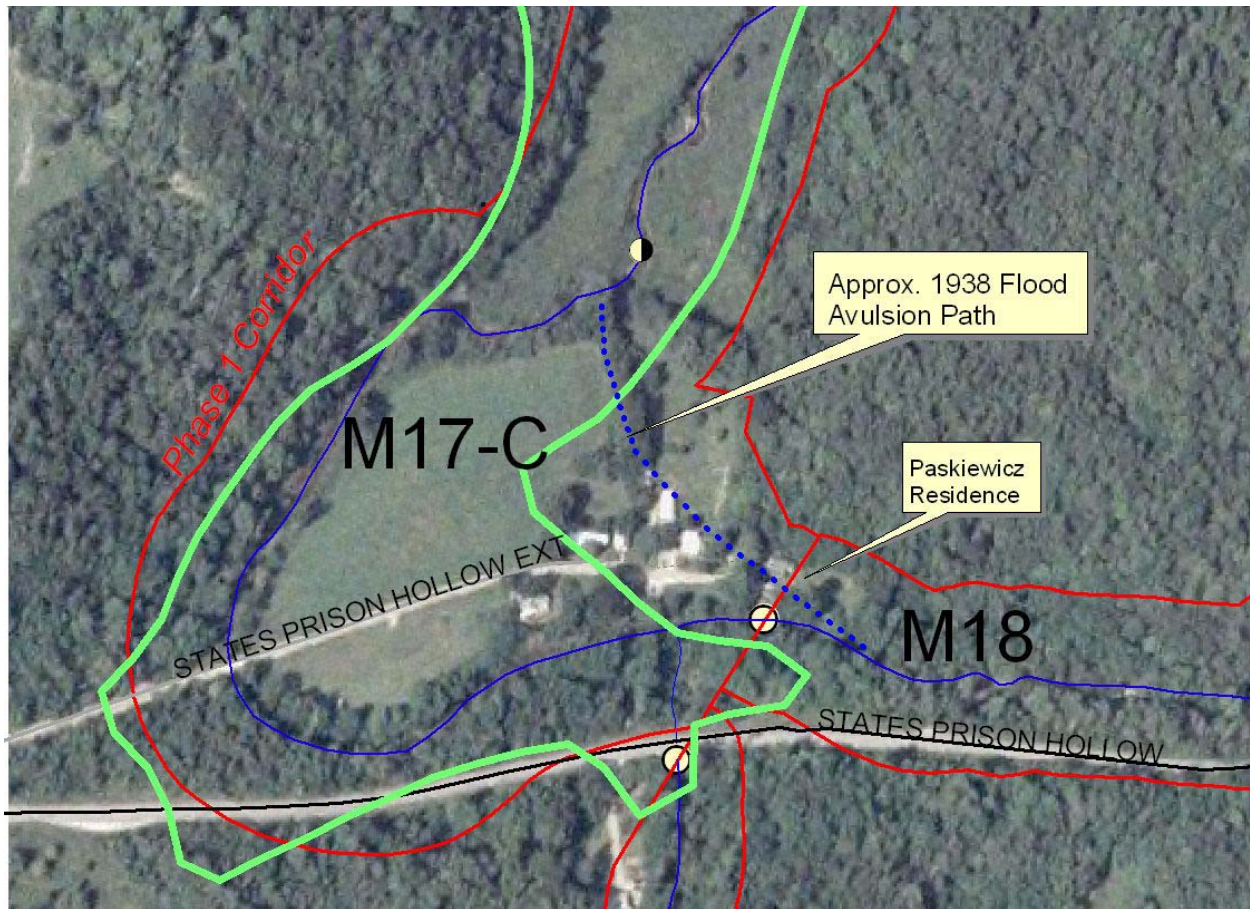
Figure 1. Location of Paskiewicz residence. River corridor (Phase 1) outlined in red. 2003 base photograph. Blue line represents surface waters digitized from 1995 orthophotographs. Green line indicates area of 100-year flood digitized by ACRPC from Town of Starksboro, VT Flood Insurance Rate Map Panel 05, effective date: December 4, 1985.

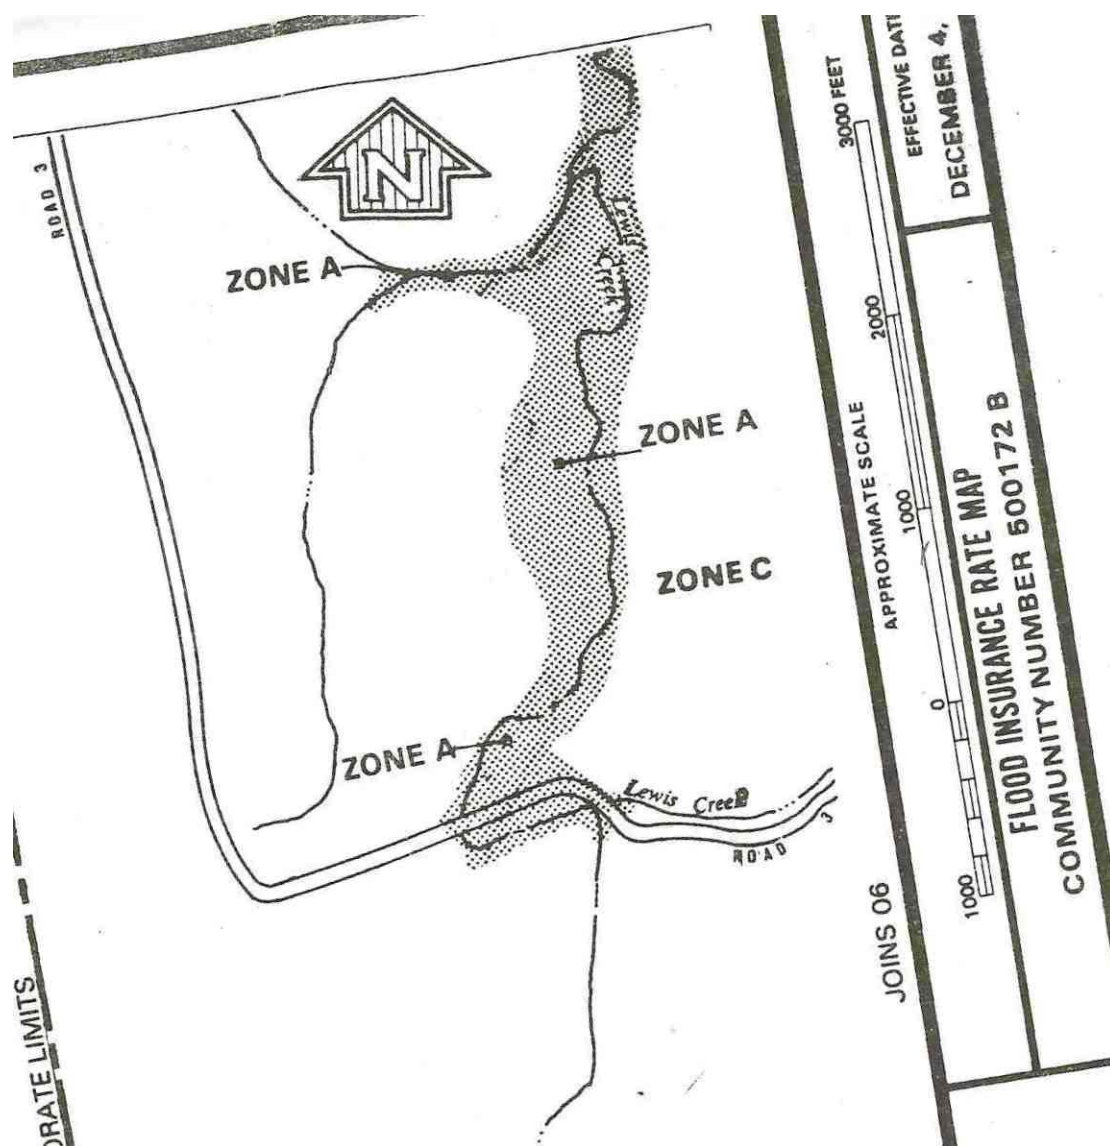
Figure 2. Reprint of Town of Starksboro, VT Flood Insurance Rating Map, panel 05 for vicinity of Paskiewicz residence. Former alignment of States Prison Hollow Road depicted. Zone A indicates Areas of 100-year flood: base flood elevations and flood hazard factors not determined. Town of Starksboro, VT Flood insurance Rate Map Panel 05, effective date: December 4, 1985.

During the September 2007 meeting, Kristen Underwood brought up the topic of the FEMA-FIRM maps (see Figure 2) – their degree of accuracy in locating areas at risk of inundation flooding at the base of the gorge, and also the fact that erosion hazards are not well captured by the FEMA-FIRM maps. Historic accounts of the 1938 flood and the placement of the berms along Lewis Creek (see Figure 3) appear to suggest the high risk of erosion and inundation flooding damage to the Paskiewicz property. Ms. Paskiewicz indicated that she would like to learn more about the potential flood risks at her location.

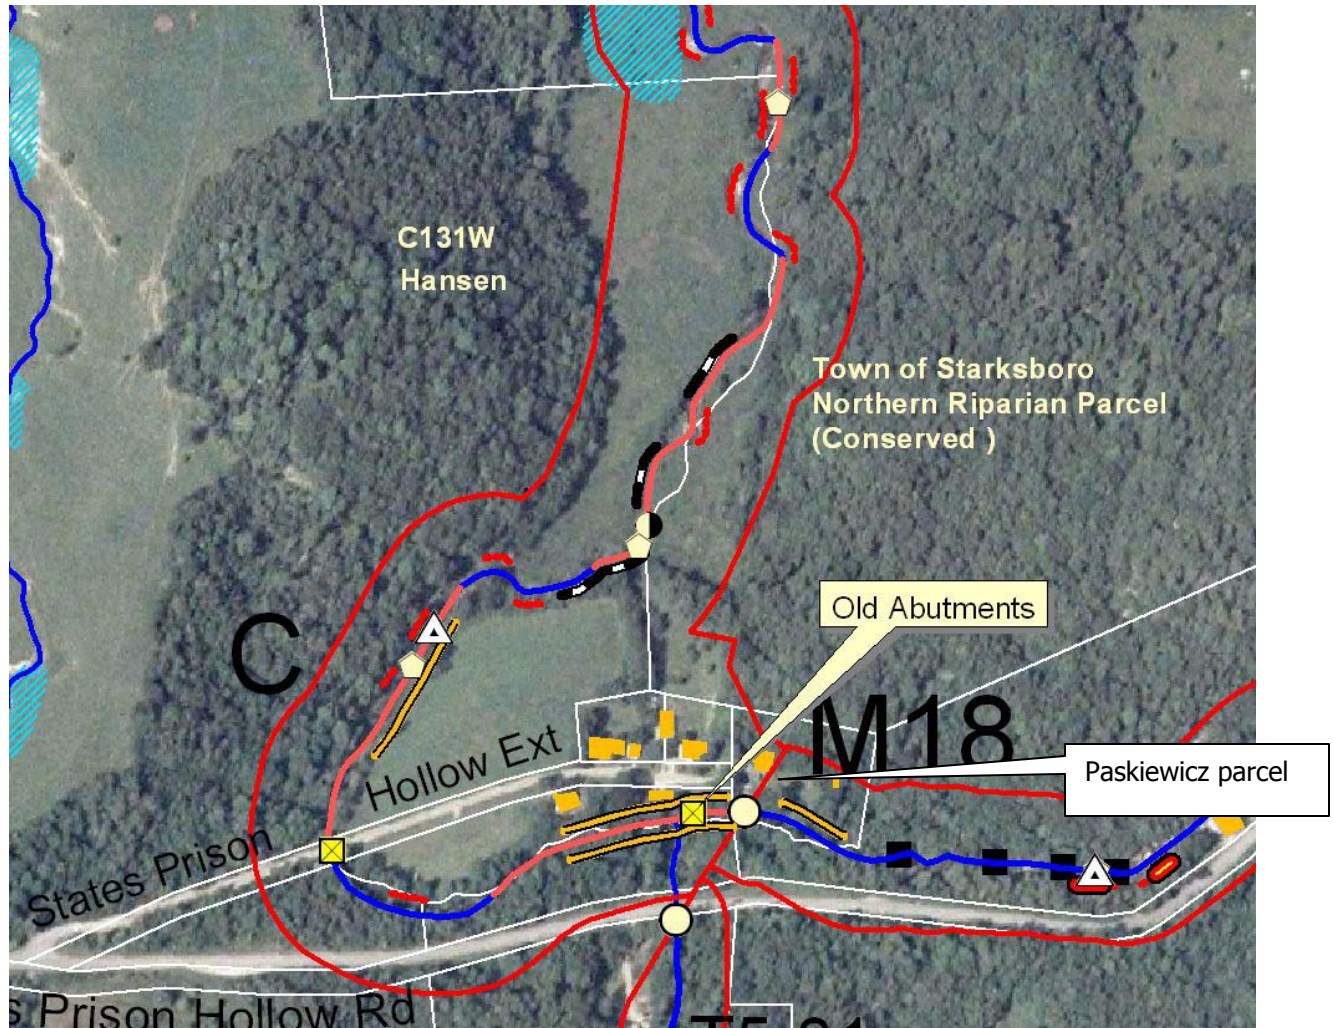
Figure 3. Phase 2 stream geomorphic assessment data for Segment C of reach M17 in vicinity of Paskiewicz residence. *Old abutments are present, just downstream of Paskiewicz residence at the location of the former crossing of States Prison Hollow Road, a portion of which now remains as States Prison Hollow Extension. White lines indicate parcel boundaries. Base photograph, dated 2003.*

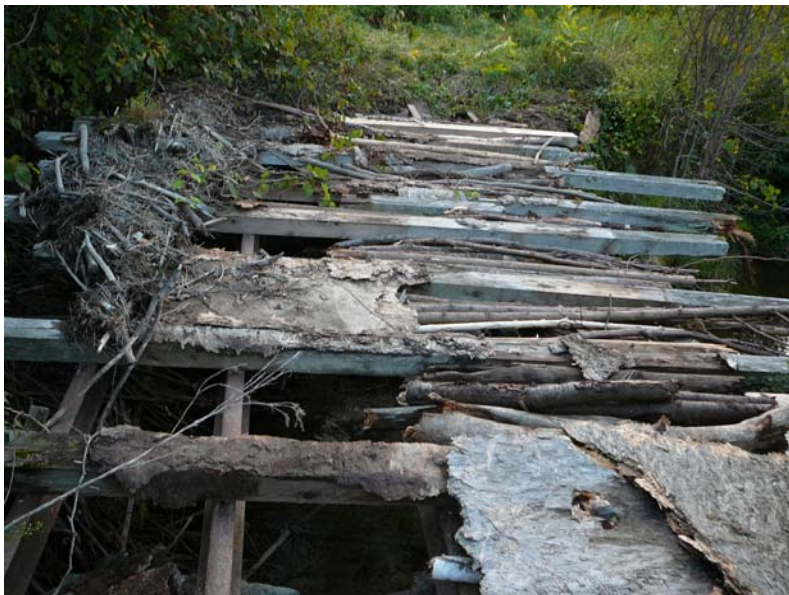
Figure 3. LaRue private bridge,
Reach M17, Segment B
10 September 2007

The bridge is constructed of wooden planking over steel I-beams supported on a laid-up stone abutment (right bank) and a concrete abutment (left bank). The approximate bridge span is 18 feet, and clearance to the stream bed is approximately 6.3 feet (measured September 2002). This crossing is significantly undersized with respect to the reference bankfull width (52.2 feet) and the measured bankfull width (33.7 feet). A downstream scour pool was observed in Sept 2002. On 10 September 2007, a beaver dam was present within 3 feet upstream of the bridge. Debris from spring runoff (according to Robbin) was observed on the deck of the bridge. The bridge is in considerable disrepair. Several small sticks have been placed between remaining wooden planks. Robbin suspects this has been done by area residents who use the bridge (against her and Chris' wishes) to access the property with ATVs. Robbin expressed concern for riders' safety and will be talking with their neighbors – there is also concern for liability.

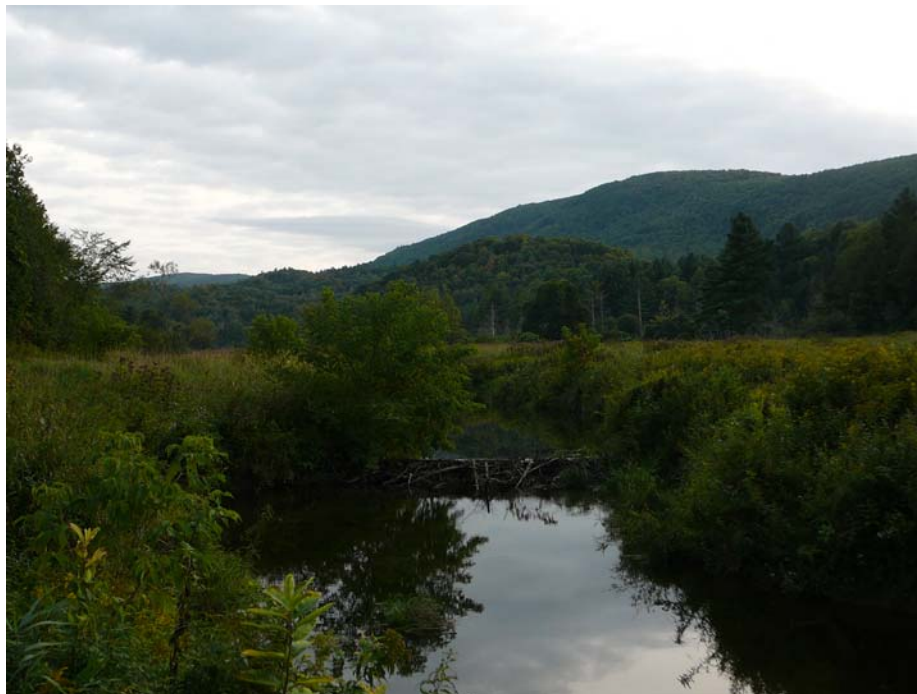
Figure 4. View upstream (south) from center of LaRue property; beaver dam in foreground; Hogback Mountain in background.

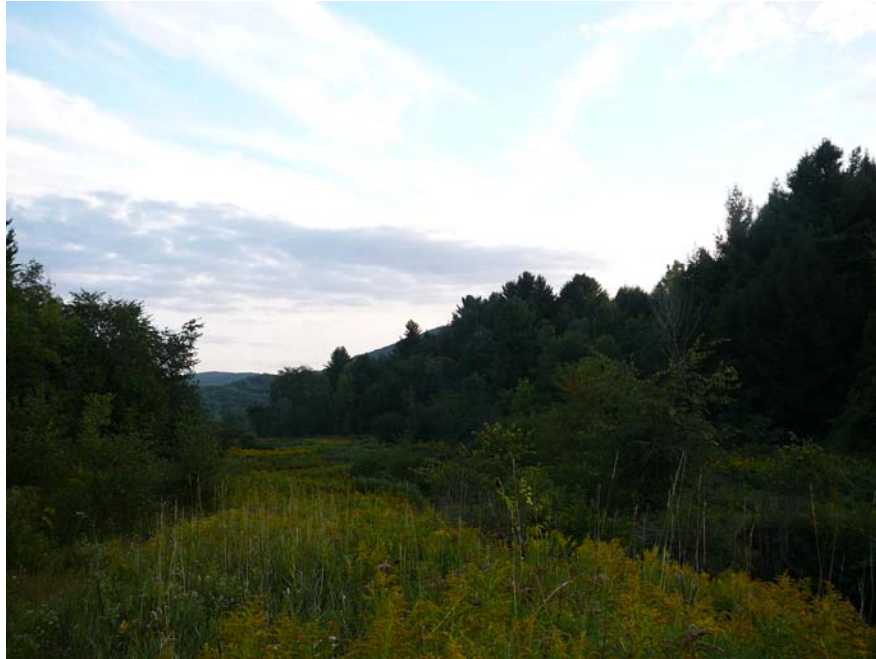
Figure 5. View upstream (south) from vicinity LaRue private bridge.

There is a private bridge crossing near the middle of the property which permits access to fields and forest along the western half of the property from the eastern half which has frontage along Route 116. While secondary access is possible to the western half of the property across private lands from States Prison Hollow Road, there is no deeded right-of-way or other legal access through these private lands from States Prison Hollow Road. At present, the bridge is used primarily for private recreation, but Robbin and Chris would like to restore the bridge to a condition which could support farm vehicles.

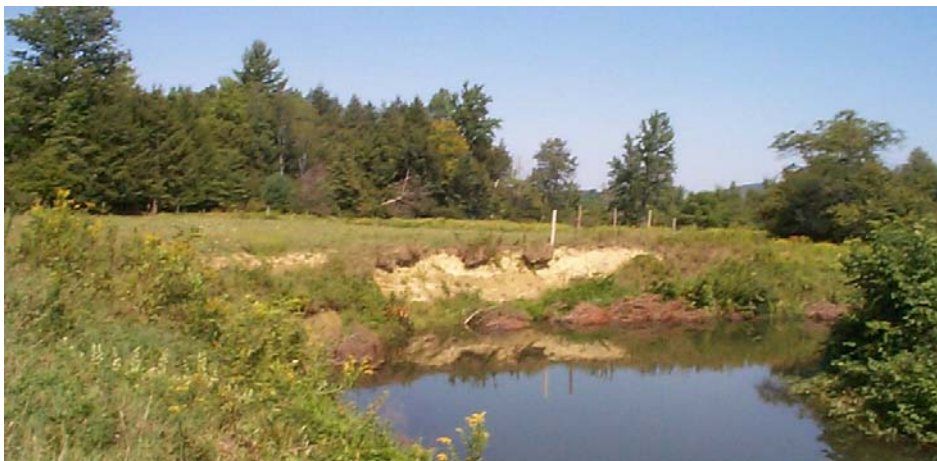
Figure 2. Meander Bend A at Clifford site (reference Map 1). (Above) - meander in August 2001 exhibiting active slumping and erosion; note cedar revetments along water line. (Right) - meander in May 2005, erosion mostly healed.

By 2005, erosion along the prominent meander bends treated in 2001 was mostly healed and these banks were no longer actively slumping (see Figure 2). Conversely, erosion along other segments of restored streambank was active, and seedlings planted in 2003 were being carried on slump blocks into the channel (see Figure 3). Based on the width of these slump blocks, lateral migration was estimated at 2 to 3 feet in two years. It should be noted that some of these slumping banks (but not all) were associated with the location of a breached beaver dam, and beaver impoundments and activities may have compromised the effectiveness of the revetments in some areas.

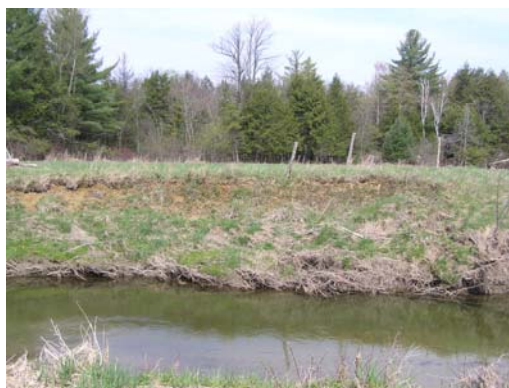
Figure 3. Active bank slumping noted May 2005 along banks treated with cedar revetments in 2003.

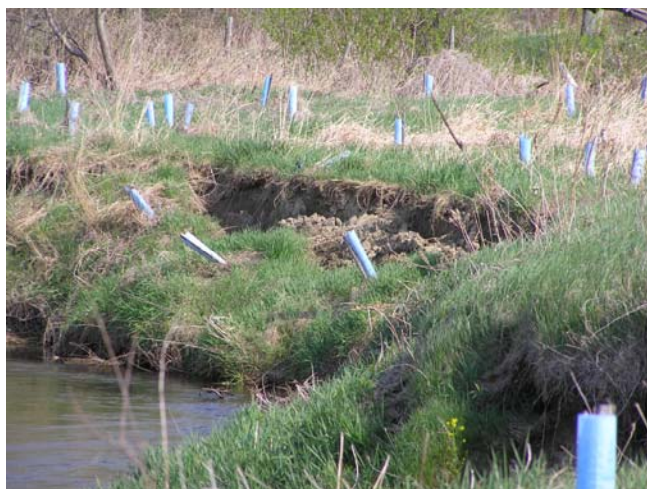
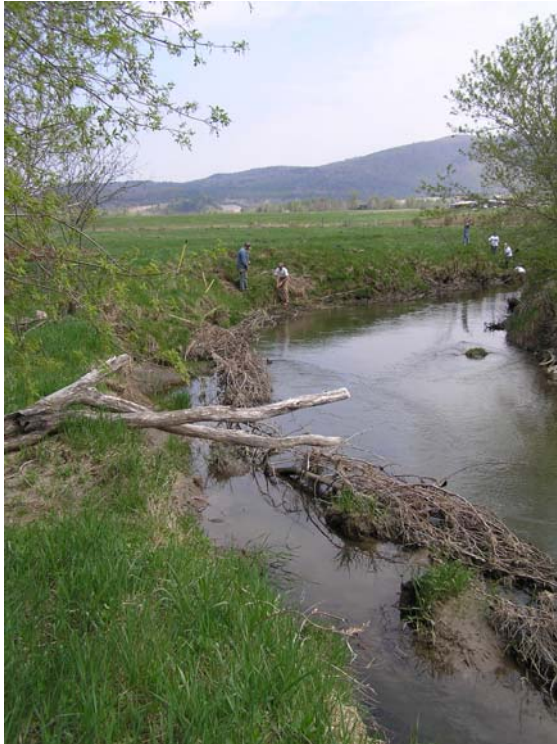
Figure 4. View upstream from Meander B in Map 1 (May 2005). Cedar revetments along right bank (facing downstream) installed in 2003 were laterally outflanked. Background: volunteers installing willow waddles along top of cedar revetments.

On some streambank sections (for example on approach to Meander Bend B in Map 1), the cedar revetments installed in 2003 were noted to be laterally outflanked (Figure 4). This bend is one of four bends along the profile that have radii of curvature much less than regime equations would predict for the given channel width (see Attachment A). Meanders are continuing to broaden and migrate, and the radius of curvature calculations detailed in Attachment A indicate those tighter meander bends (i.e., ones with very small radius of curvature) can be expected to erode more severely than others along the profile. Such increased erosion on approach to this tight meander bend may have contributed to lateral outflanking of the cedar revetments. It is also possible that vertical scour would have lead to undermining of the revetments in this location.

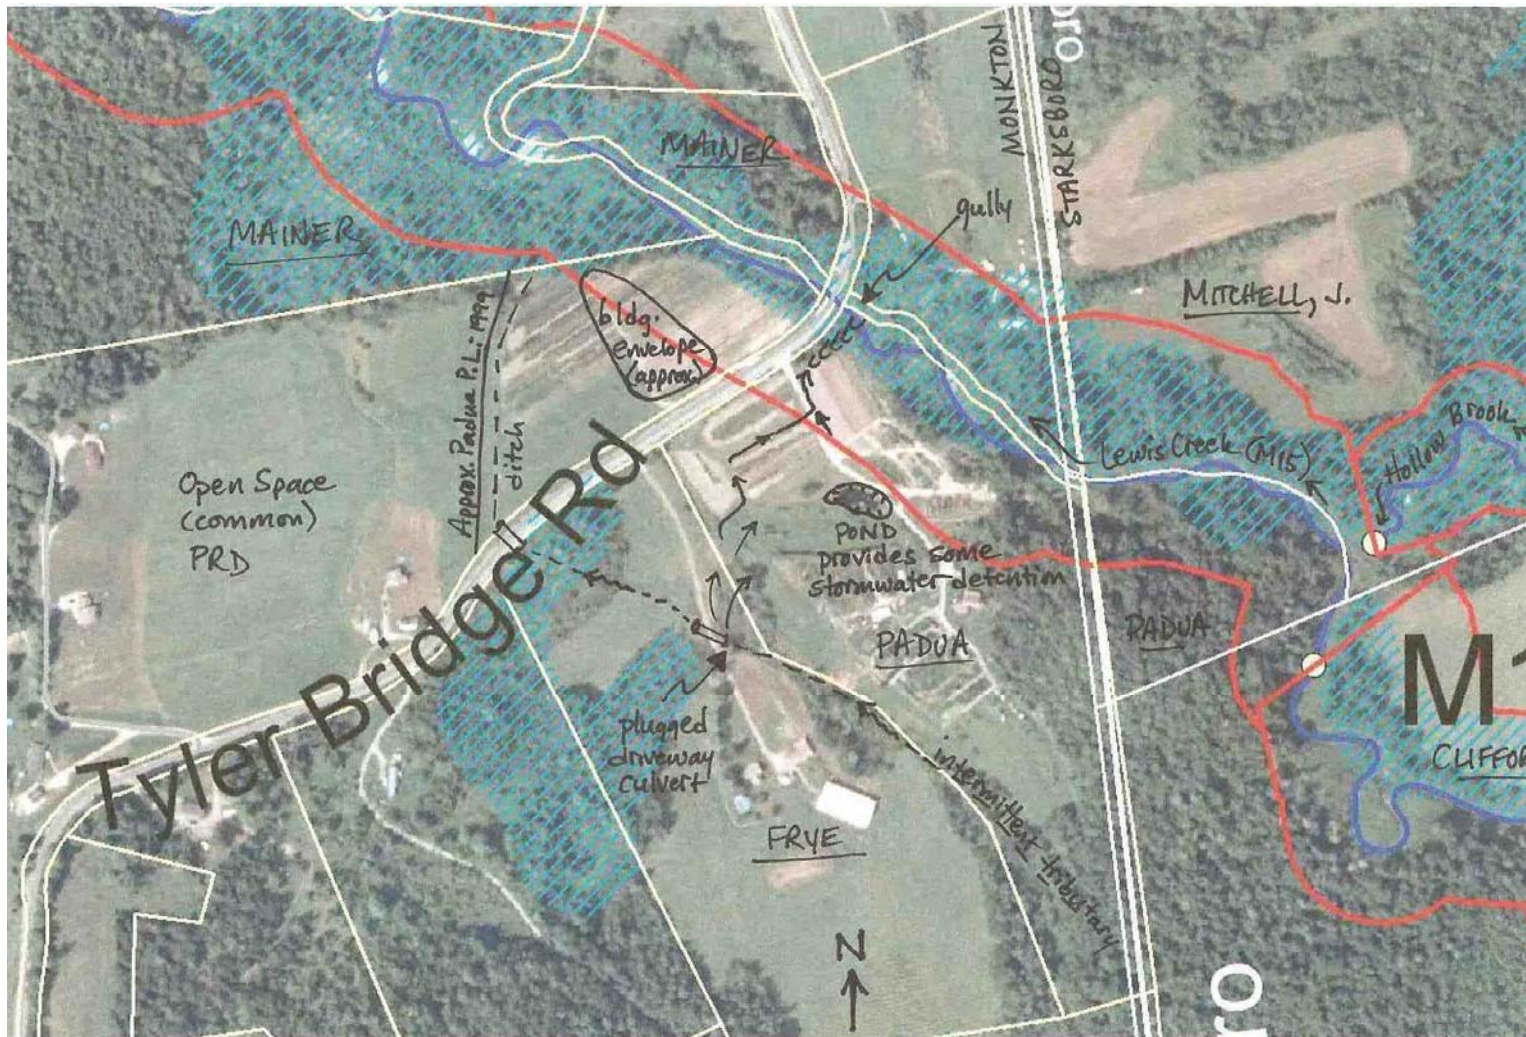
Figure 2. Drainage features in vicinity of Padua property (notes from 3 Dec 2007 meeting w/ John Padua – not field-verified). (2003 NAIP base image; red line indicates Phase 1 corridor [SGAT v.4.50]; turquoise hatched lines depict NWI wetlands; white lines are Monkton and Starksboro approximate parcel boundaries [not current]).

Kristen Underwood brought up the small gully erosion occurring along the left-bank of the Lewis Creek immediately upstream of the Tyler Bridge Road. John Padua noted that this small channel has begun to widen and deepen considerably in the last couple of years. He surmises that it is related to tributary drainage that has been diverted from a driveway culvert site on neighboring lands to the southwest owned by the Frye's. He and the Frye's have noted that the Frye driveway culvert has become blocked with sediment and debris, and a portion of the drainage from an intermittent tributary that previously drained to the northwest to a Tyler Bridge Road culvert and ditch along the western boundary of the northern Padua parcel, instead now is diverted to the Padua nursery lands. This diverted flow is picked up by drainage patterns within the nursery and is ultimately delivered to the small channel which joins the Lewis Creek just upstream of the Tyler Bridge Road (Figure 2).

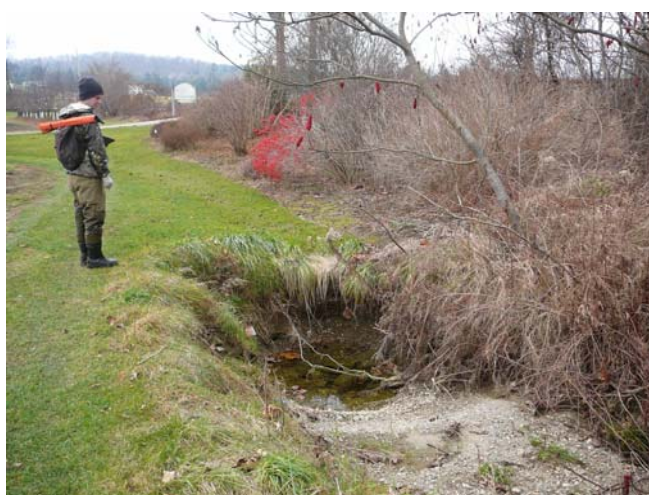
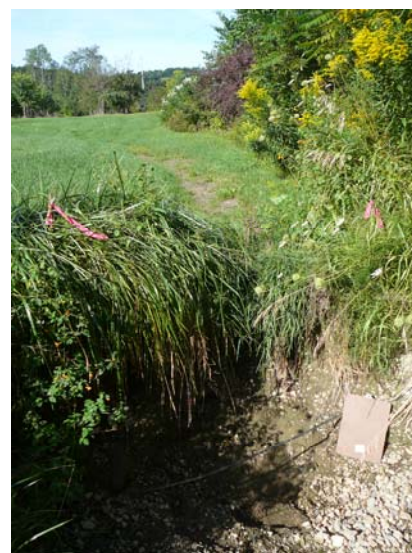
Figure 3. Location of headcut at transition from intermittent drainage swale to gully to Lewis Creek, view upstream. (a) 29 November 2006; (b) 27 August 2009.

Peter Lossmann (NRCS- Middlebury) and Kristen Underwood (SMRC) visited the Cobble Creek Nursery on 27 August 2009. John Padua stated that wet conditions in 2008 and especially in spring/ summer of 2009 have exacerbated drainage issues along the intermittent tributary/ drainage swale that passes through his nursery. The gravel driveway has been overtopped and washed out several times, and the headcut at the top of the gully has worked upstream revealing a buried phone line (at clipboard in Figure x-b). A buried power line is reportedly also in close vicinity of the phone line, but has not yet been exposed in the gully.

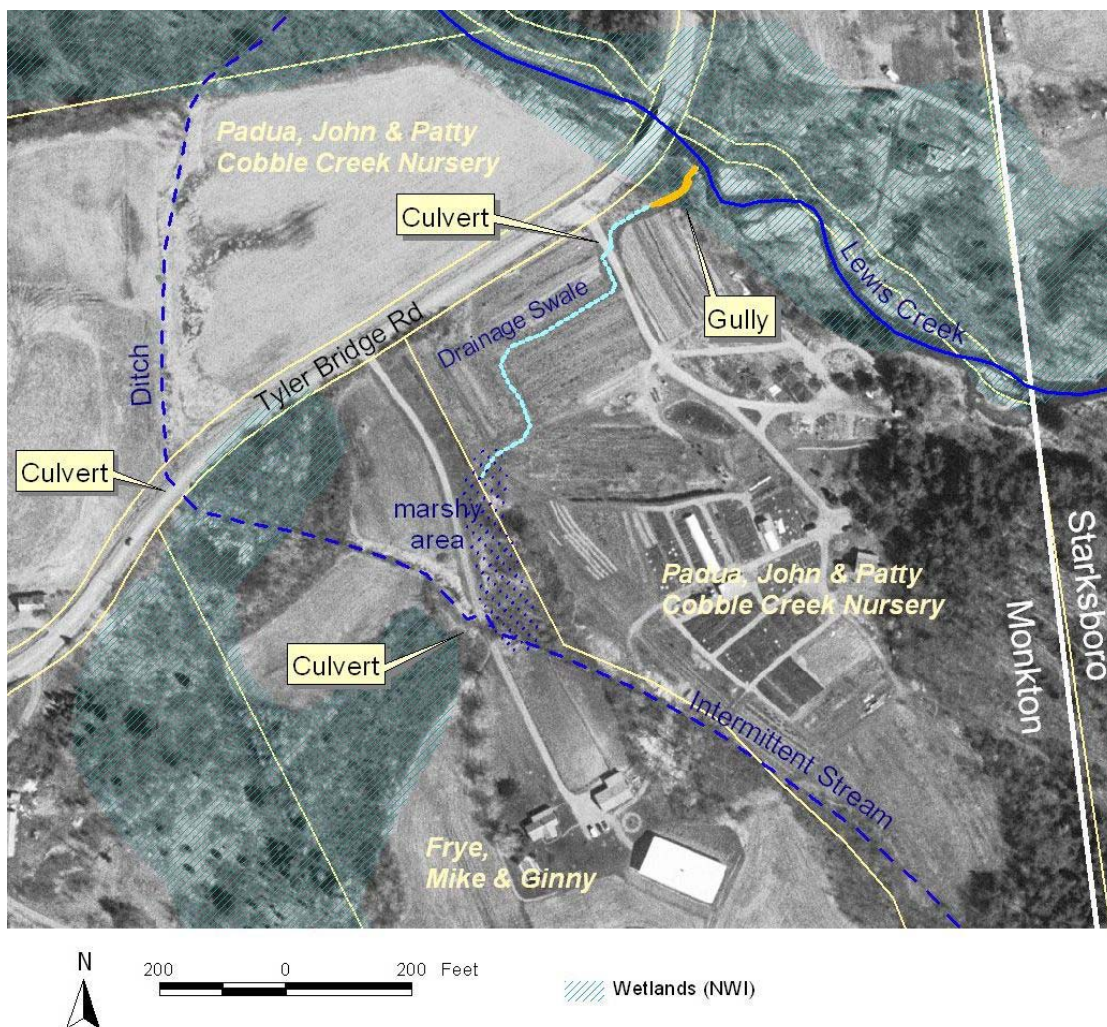
Figure 4. Existing drainage conditions, Padua and Frye properties, August 2009.

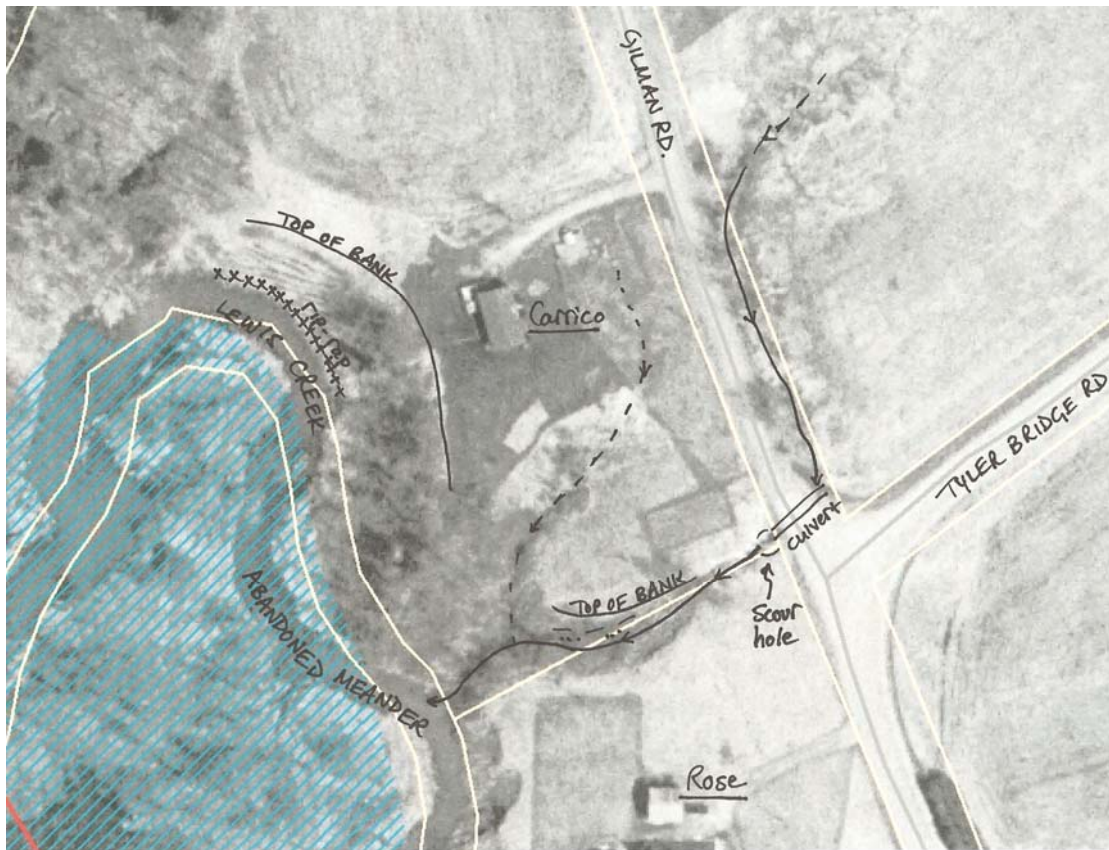
Figure 2. Drainage features in vicinity of Carrico property.

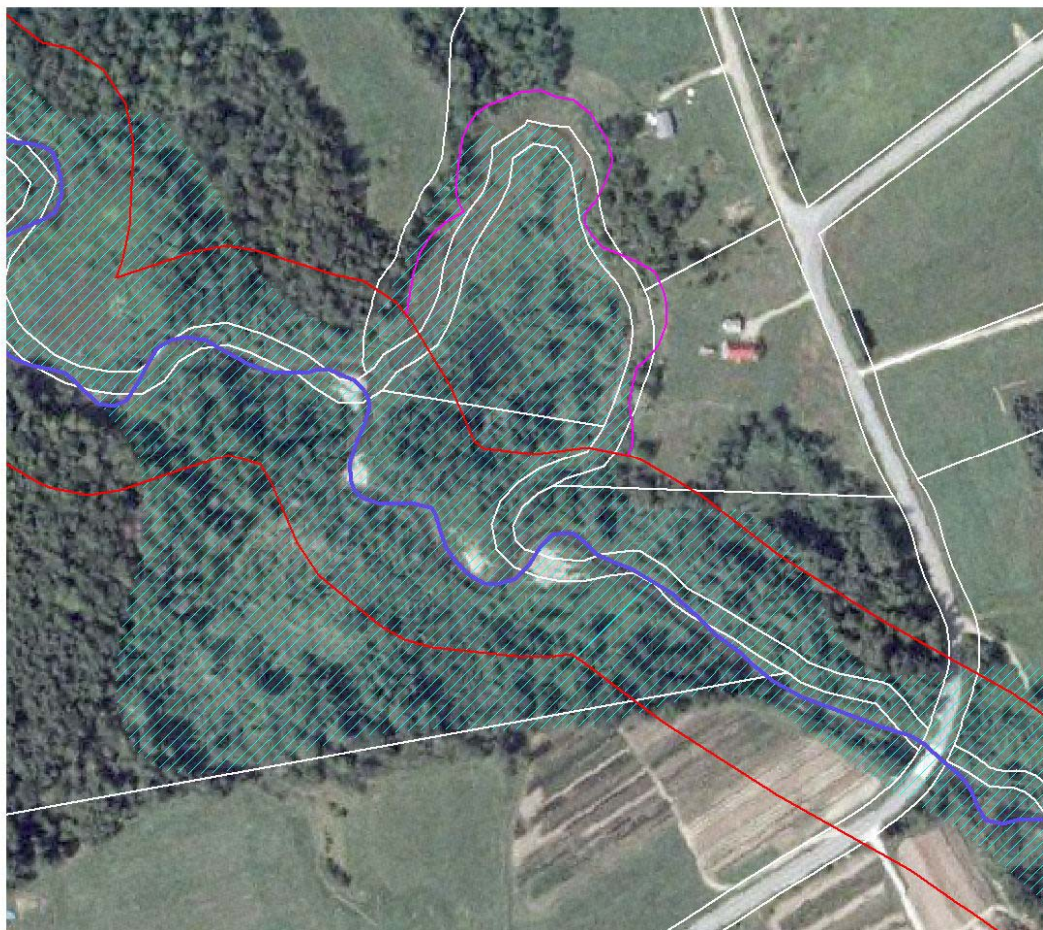
Figure 3. Potential extension of Lewis Creek corridor (in purple) to the top of the valley wall to encompass the abandoned meander.

Tony & Renee are open to possibilities, and would like to review a copy of the corridor plan. They would be open to hearing more about possible conservation options. Also discussed was the possibility that the Lewis Creek corridor might be expanded to include the area of the abandoned meander (see Figure 3).

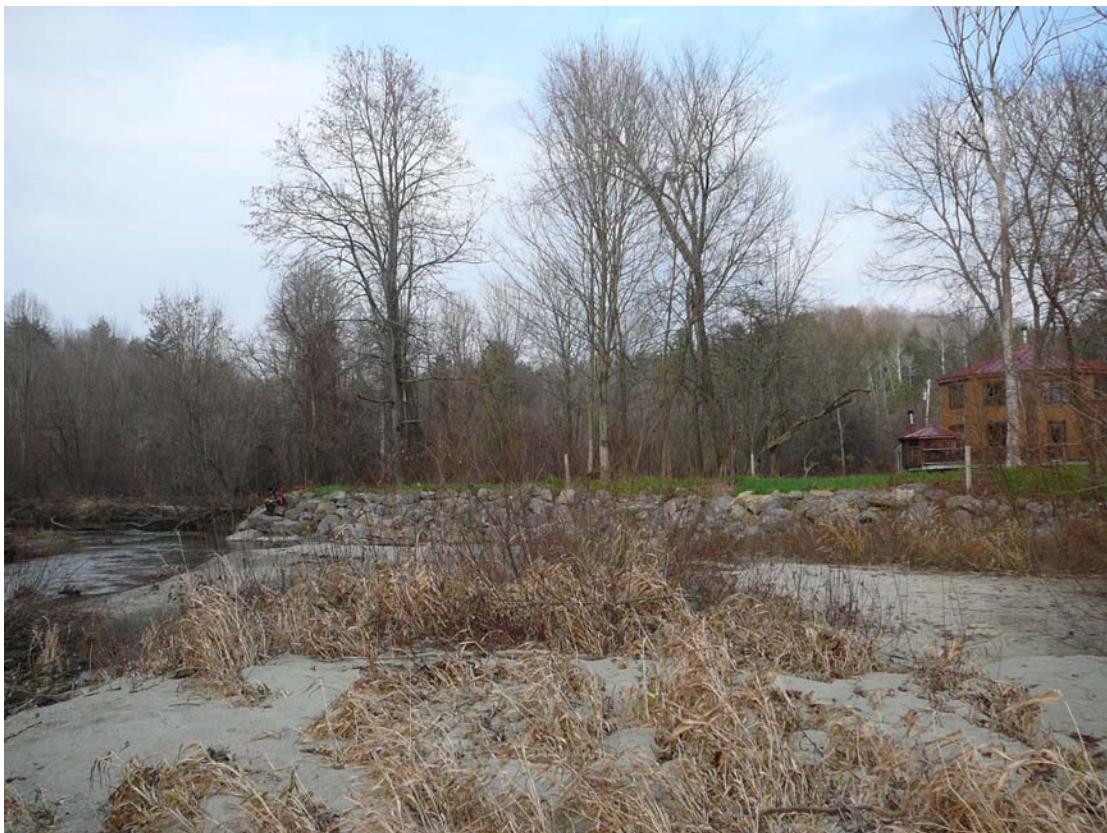
Figure 2. Rip-rap armoring installed circa 2006 along right bank at Dexter Lorange property off Lewis Creek Road in Hinesburg (Segment M15-A). View downstream, 29 November 2006.
