Water Quality Management Plan

Pond Brook Tributary, Lewis Creek Watershed

Monkton & Bristol, Addison County, Vermont

May 2013

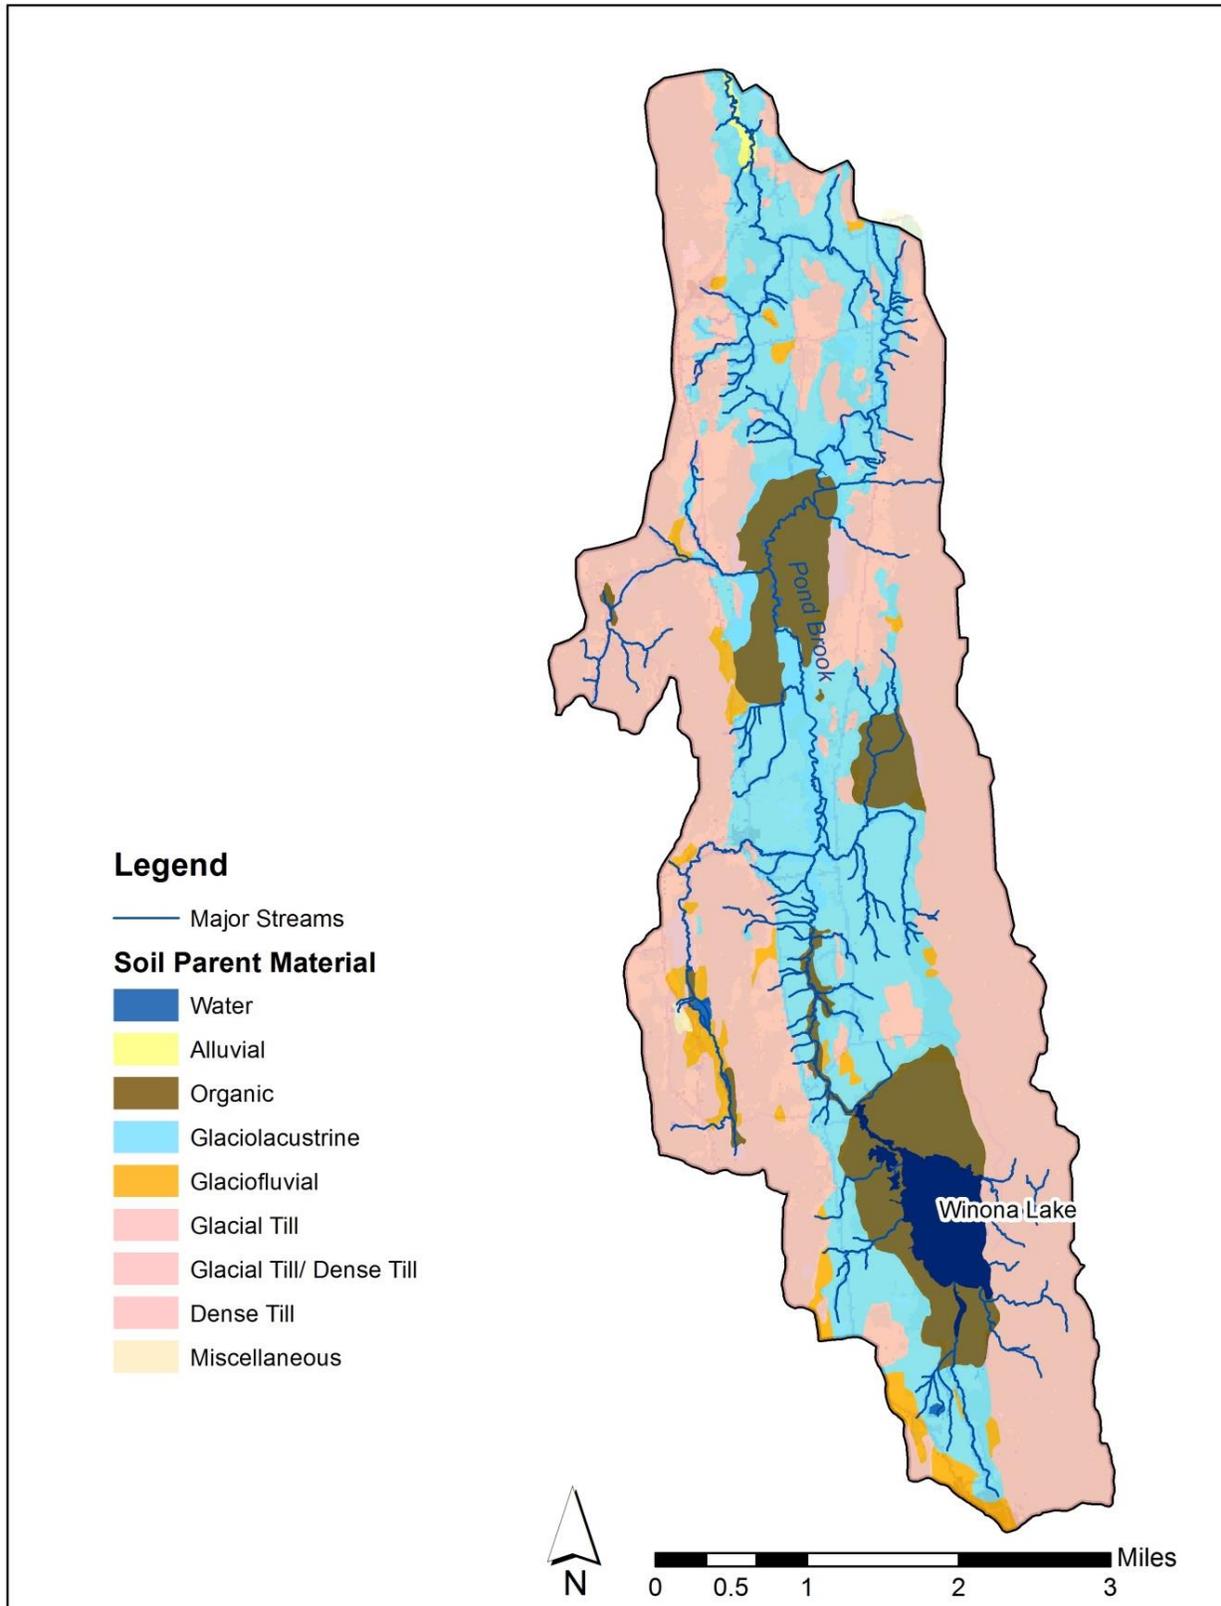
Figure 2. Soil parent material, Pond Brook subwatershed.

Soil survey mapping for the Pond Brook subwatershed (USDA, 2006; USDA, 2007) indicates soil type distributions consistent with mapped surficial geology. Figure 2 depicts the generalized soil types, grouped by geologic parent material. The upland, western and eastern margins of the catchment are dominated by soils derived from glacial till. The central portion of the subwatershed is dominated by silt loams which have their origin in silt and clay deposits of freshwater lake environments.

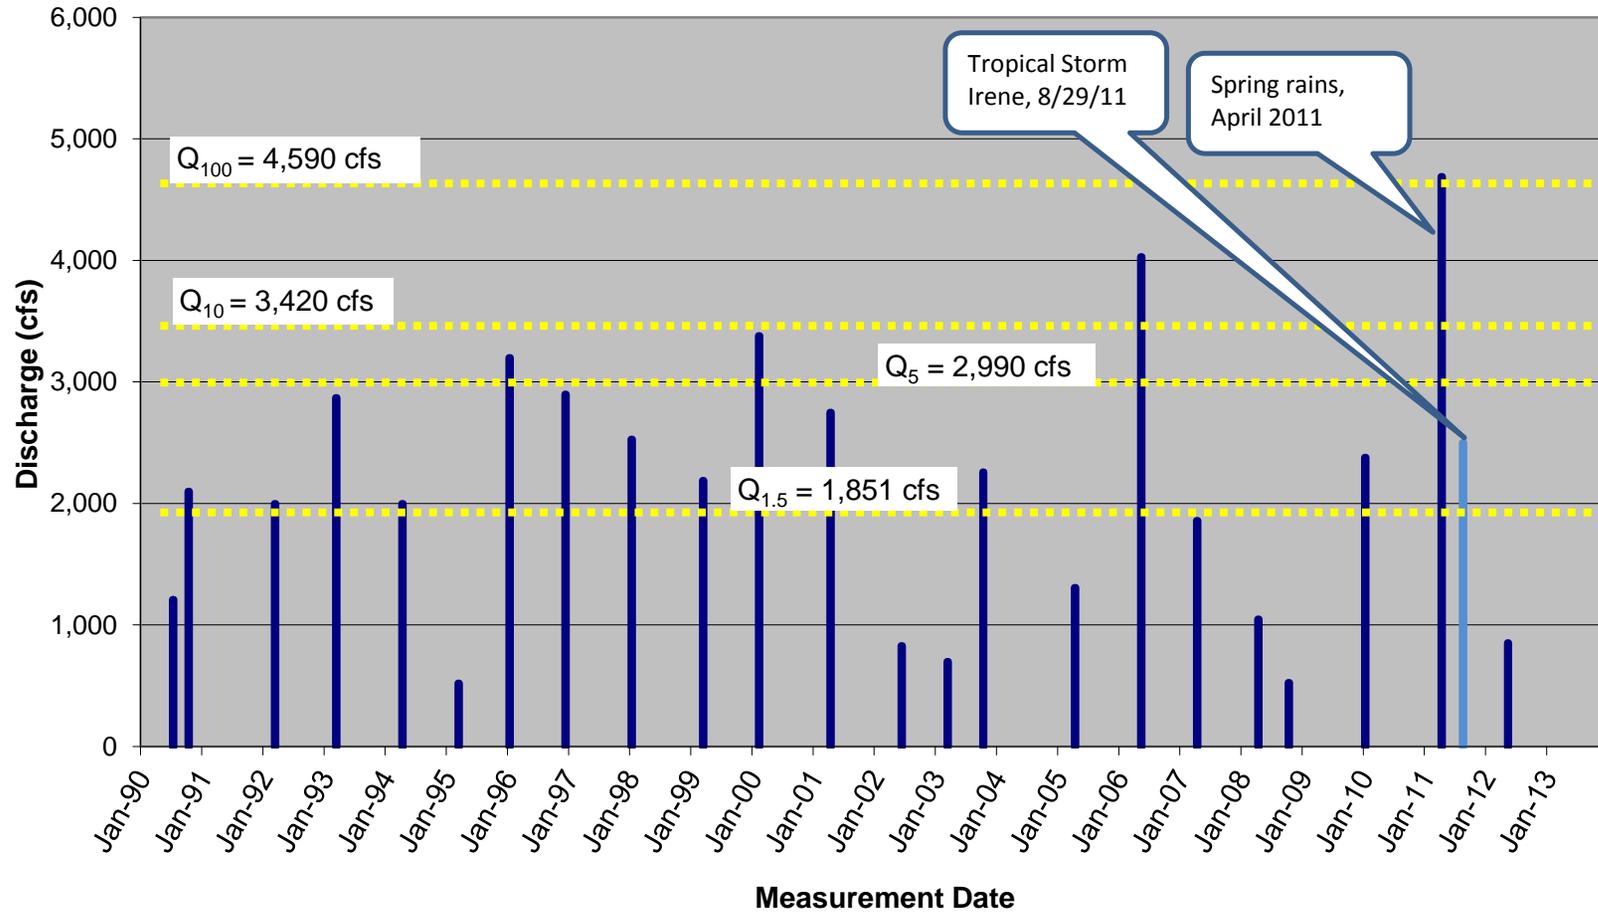
Figure 4. Recorded Peak Flows for Lewis Creek at North Ferrisburgh, VT gage, USGS Stn #04282780 (77.2 square miles) compared to estimated flood peaks after Olson (2002).

The Addison County region was affected by major flood events of 1913, 1927, 1936, 1938, 1973 and 1976 (USGS, 1990; VTDEC WQD, 1999). From the available record for the Lewis Creek gage, it is evident that the watershed sustained a significant flood event in April of 2011 (Figure 4). The maximum peak flow recorded was 4,690 cubic feet per second (cfs) on 27 April 2011. Based on USGS regression curves for Vermont streams (Olson, 2002; Table 2), this discharge corresponded to an approximate 100-year flow, or that size of storm with a 1% chance of occurring in any given year. This peak flow in April 2011 resulted from heavy spring rains and snow melt during a wetter-than-normal year. When Tropical Storm Irene hit the state later that year (28-29 August 2011), flows in Lewis Creek were relatively modest, peaking at 2,500 cfs, or approximately equal in magnitude to a 2-year storm (Figure 4; Table 2; USGS, 2012).

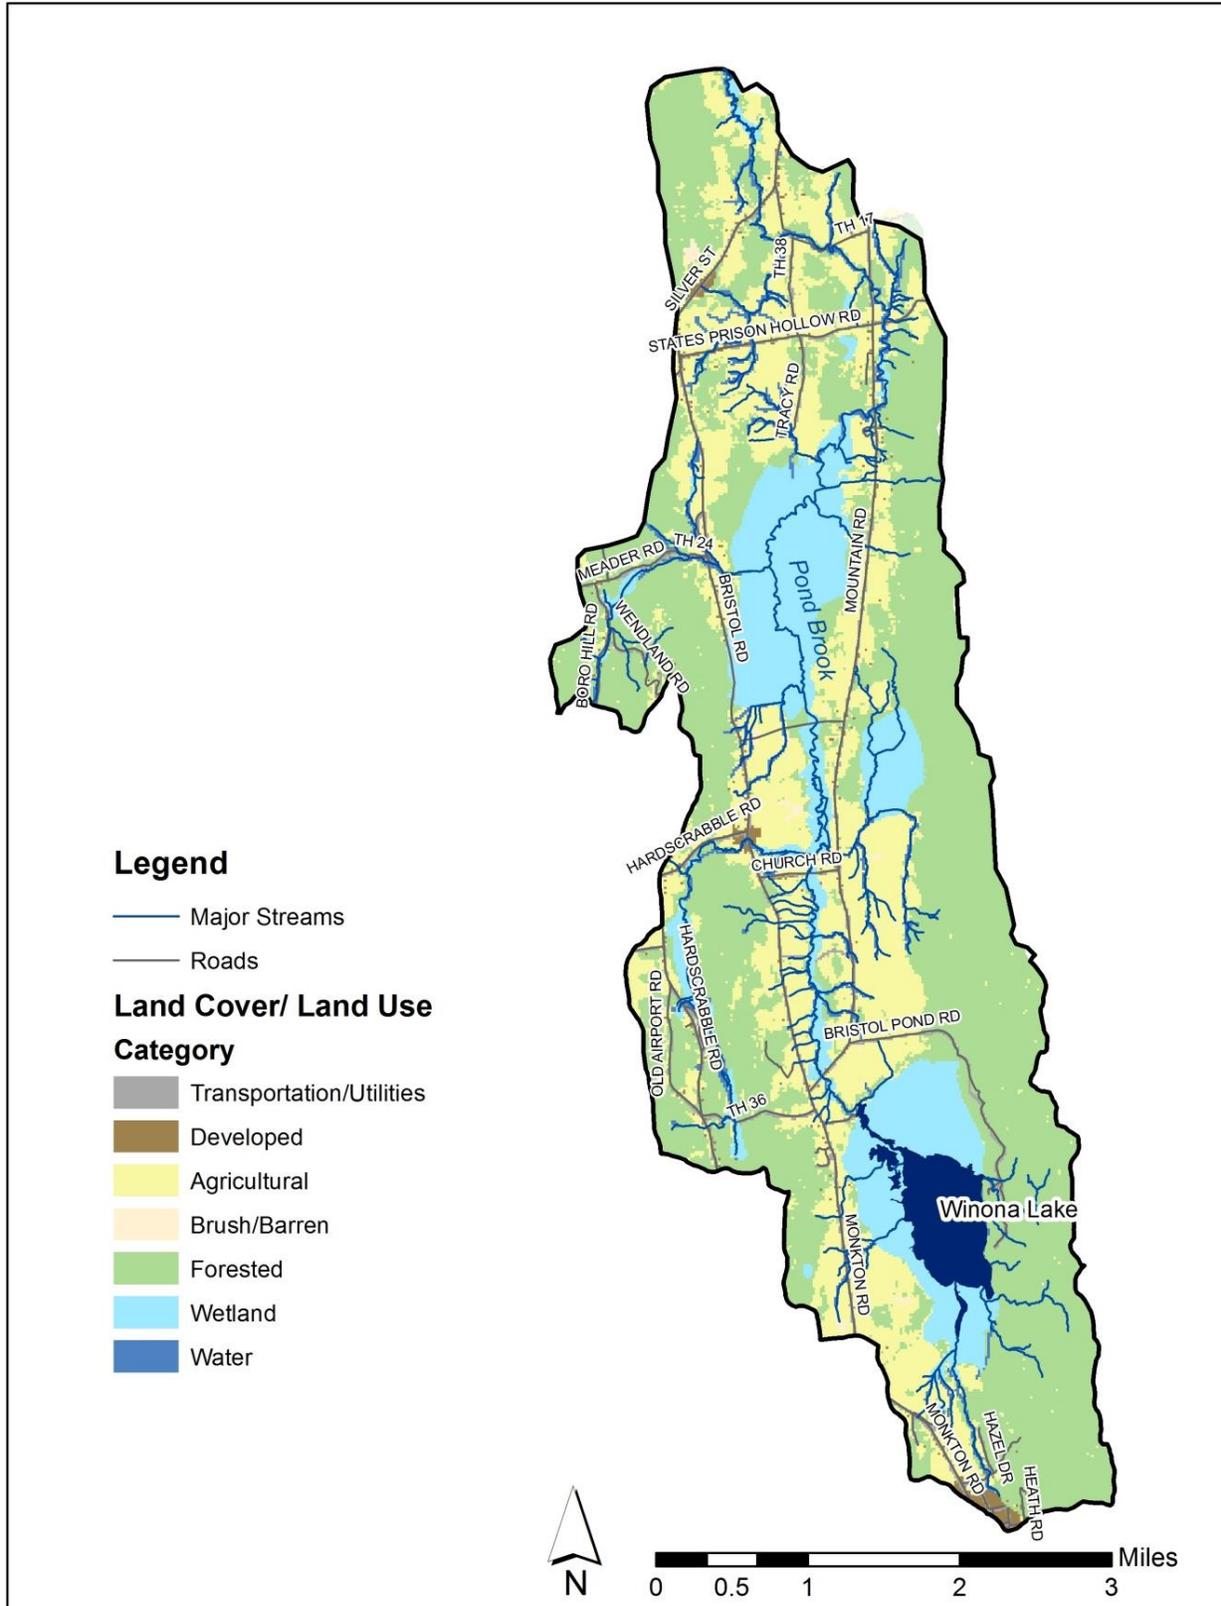
Figure 5. Generalized land cover / land use in the Pond Brook subwatershed. (2006)

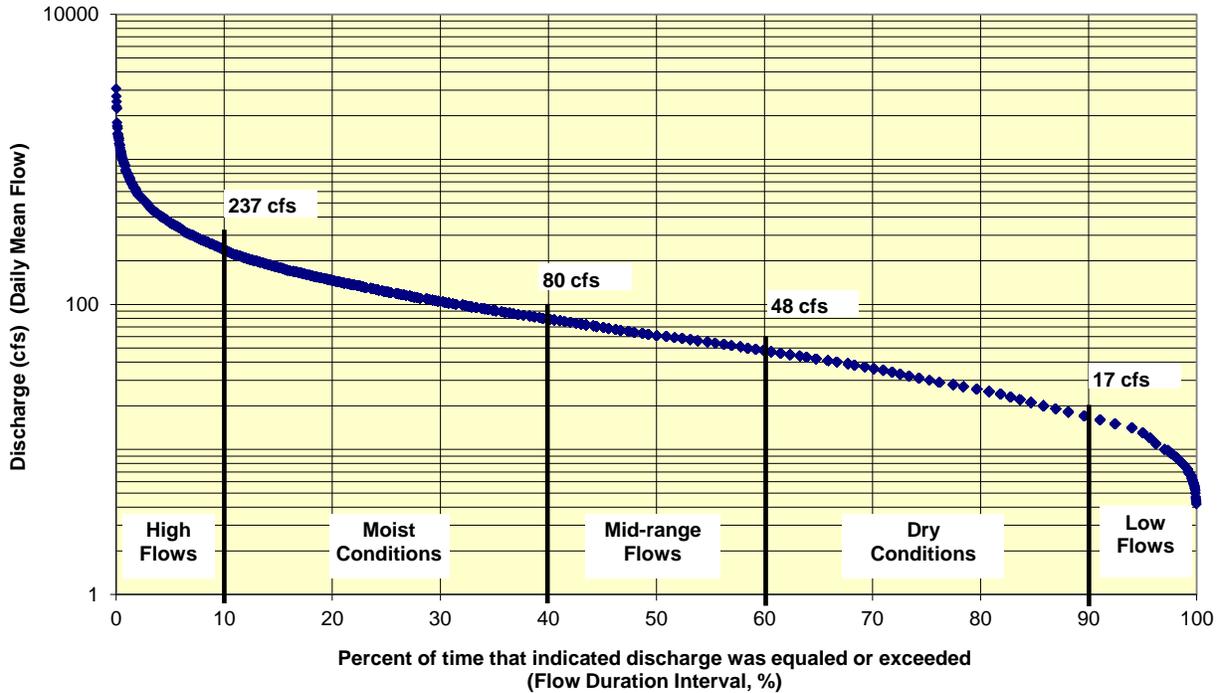
Figure 7. Flow Duration Curve for Lewis Creek at Ferrisburgh, VT (Water Years: 1991 – 2011; USGS Stn# 04282780; 77.2 sq mi).

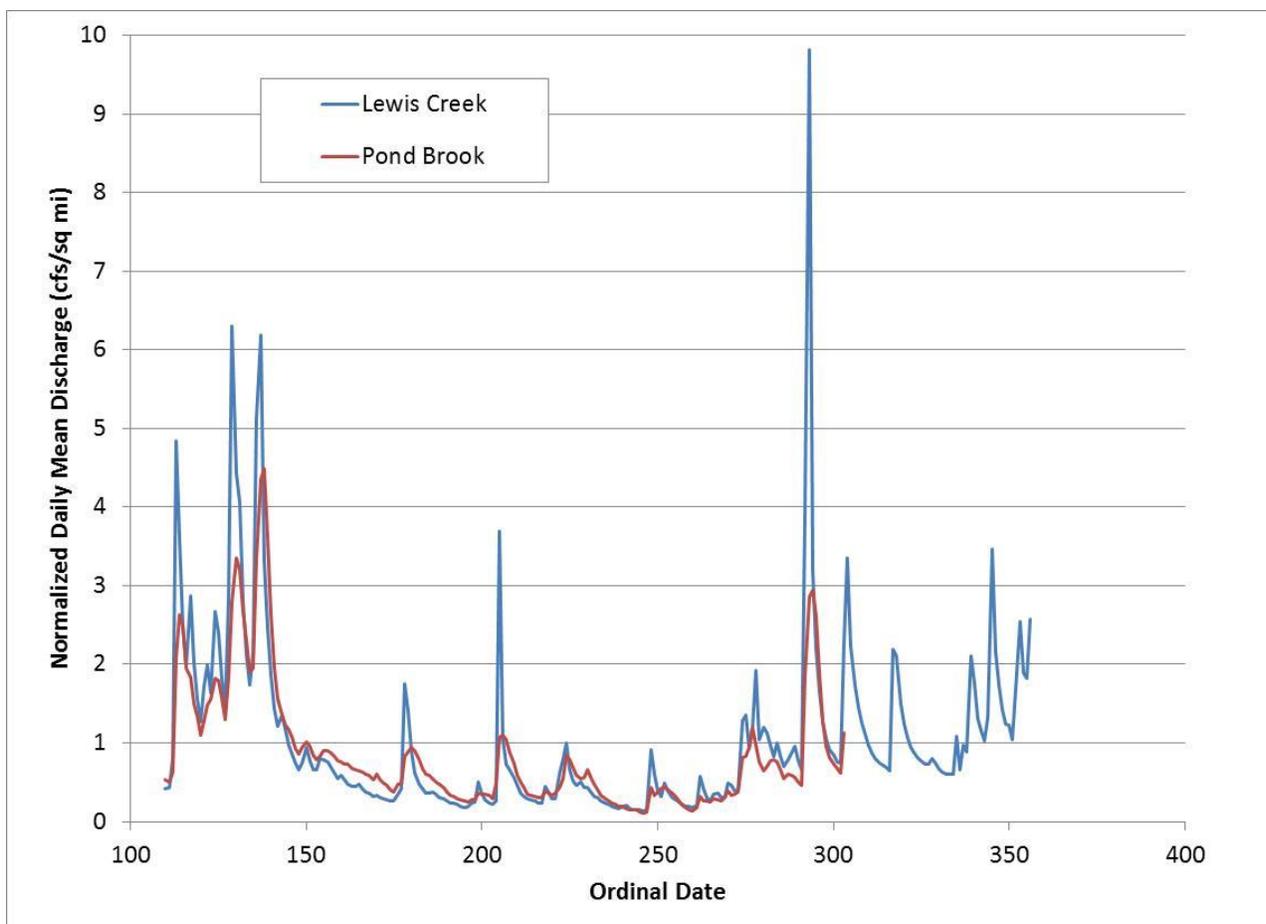
Figure 8. Daily Mean Flow on Lewis Creek (at the USGS gaging station) versus Pond Brook temporary gaging station – normalized by drainage area. Ordinal date of 100 is equivalent to 4/10/2012. Record for Pond Brook gage was terminated on ordinal date 303 (10/30/2012) due to a low battery. Record for Lewis Creek USGS gaging station ends on ordinal date 356 (12/22/2012) due to onset of ice in the channel.

Figure 8 presents the daily mean flows (DMF) recorded at the Pond Brook station relative to DMF recorded at the USGS streamflow gaging station at the Route 7 crossing of the Lewis Creek main stem. Values are normalized to the upstream drainage area at each gage – 17.5 square miles for the Pond Brook and 77.2 square miles for the Lewis Creek. Based on this six months of record from 20 April through 30 October 2012, the Pond Brook appears to have a somewhat less flashy response to rain events than the overall Lewis Creek watershed. Peaks are lower in magnitude and somewhat broader on a unit-area basis. Factors contributing to this pattern may include storage and attenuation of flows in Bristol Pond and the large instream wetland complex at reach T3.03 on the Pond Brook.

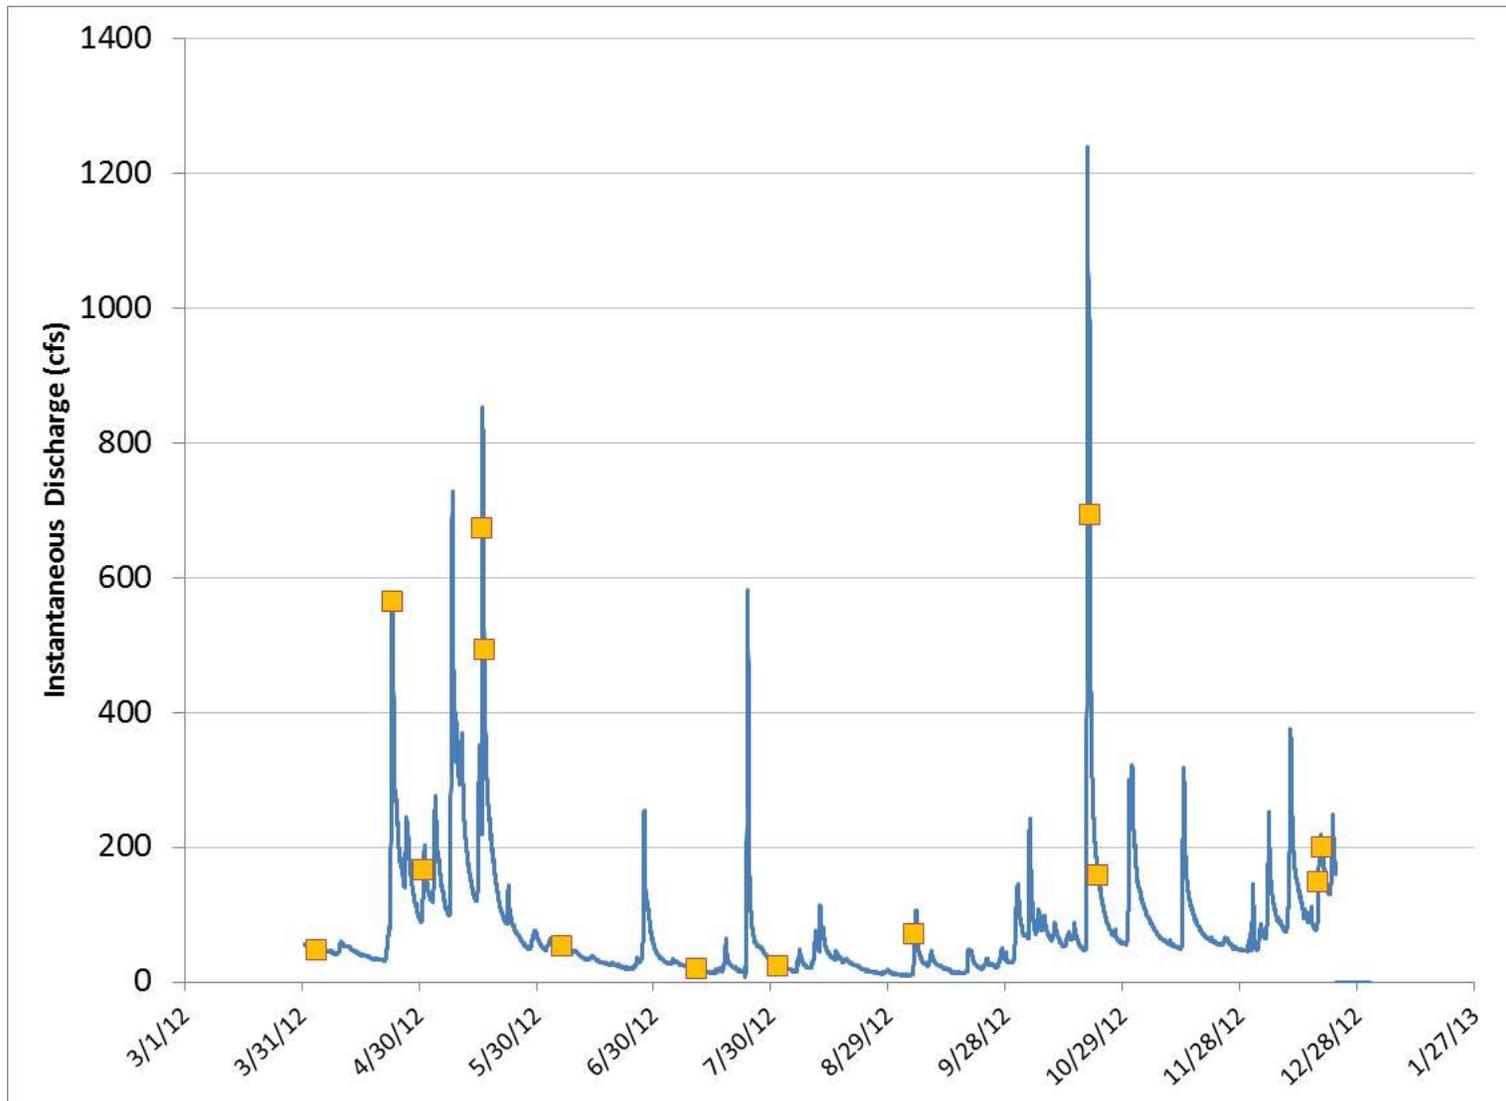
Figure 10. 2012 Sampling Events versus Instantaneous Discharge measured at the Lewis Creek USGS streamflow gaging station.

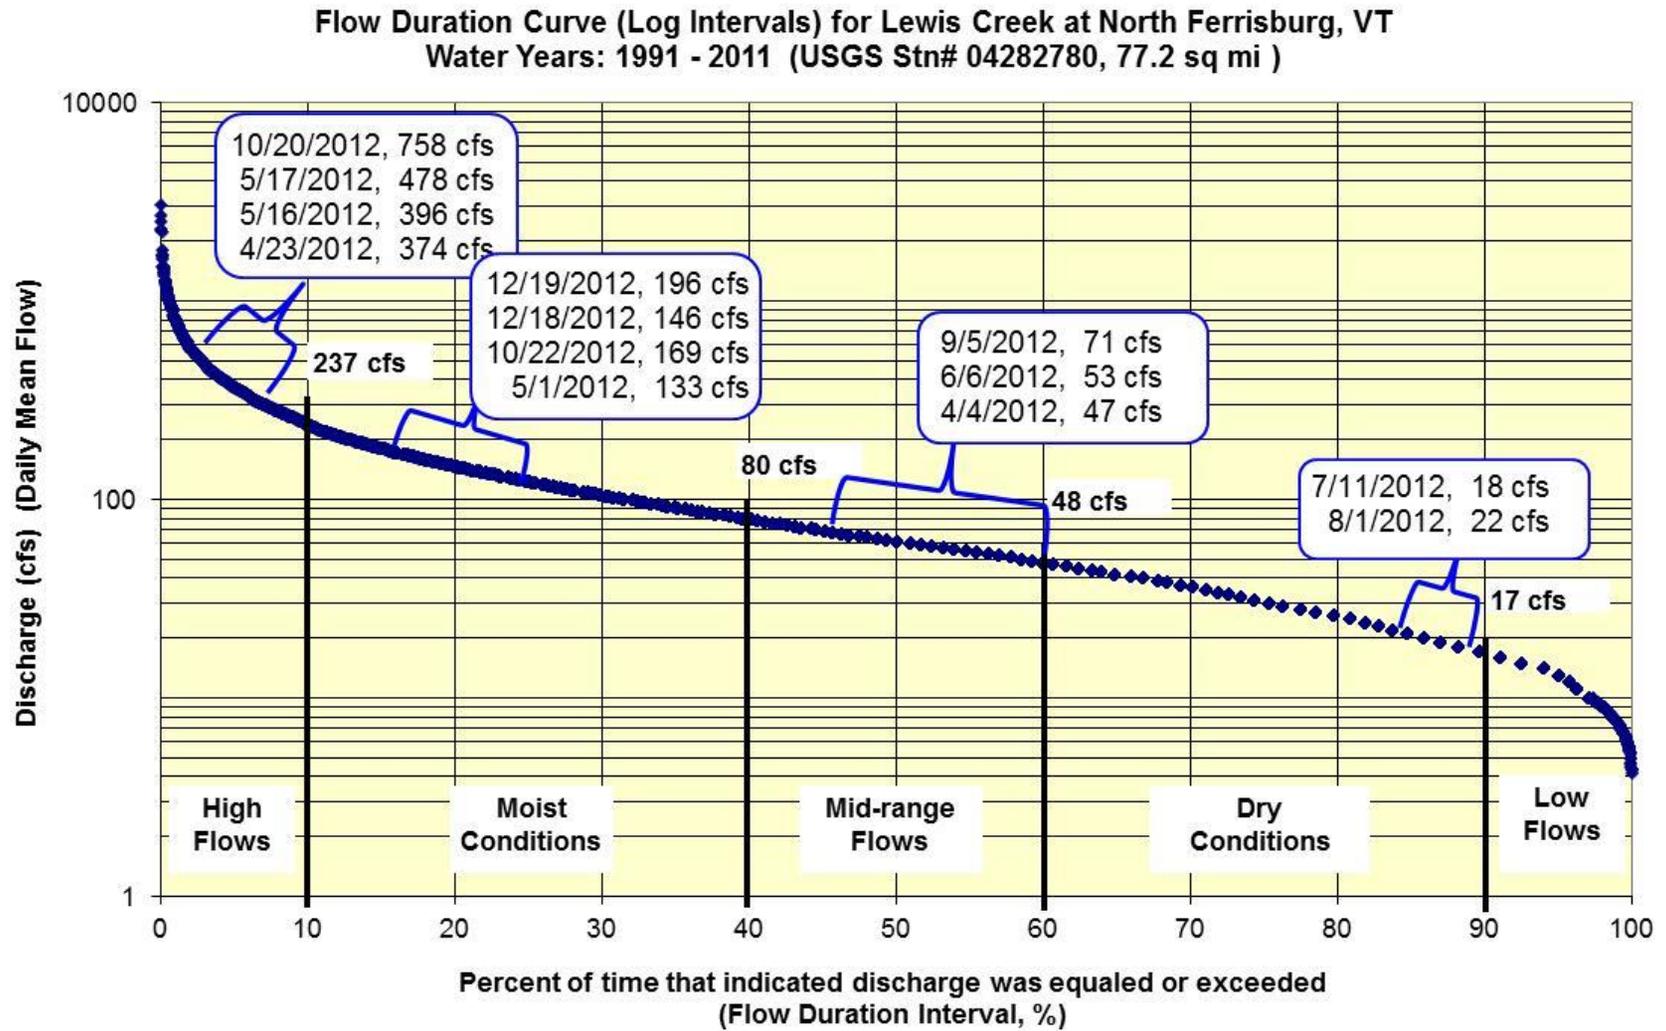
Figure 11. 2012 Sampling Events with respect to Flow Duration Interval for the Lewis Creek USGS streamflow gaging station.

Figure 11 presents the flow duration curve for the Lewis Creek watershed, annotated with the 2012 season sample dates. Spring sampling dates (April 4, May 1) coincided with low to moderate stages in area rivers associated with spring rains and snow melt (Table D-3 in Appendix B). Summer sampling dates (June 6, July 11, August 1 and September 5) generally coincided with low to base flow conditions (Figure 11; Table D-3 in Appendix D). The July 11 and August 1 dates corresponded with near 7Q10 flow conditions in Lewis Creek (and other area rivers, e.g., Little Otter Creek and the Otter Creek at Middlebury). The storm events sampled in Pond Brook of Lewis Creek (April 23, May 16 & 17, October 20 & 22, and December 18 & 19) represented discharges of 20.6% Flow Duration Interval or less (Figure 11).

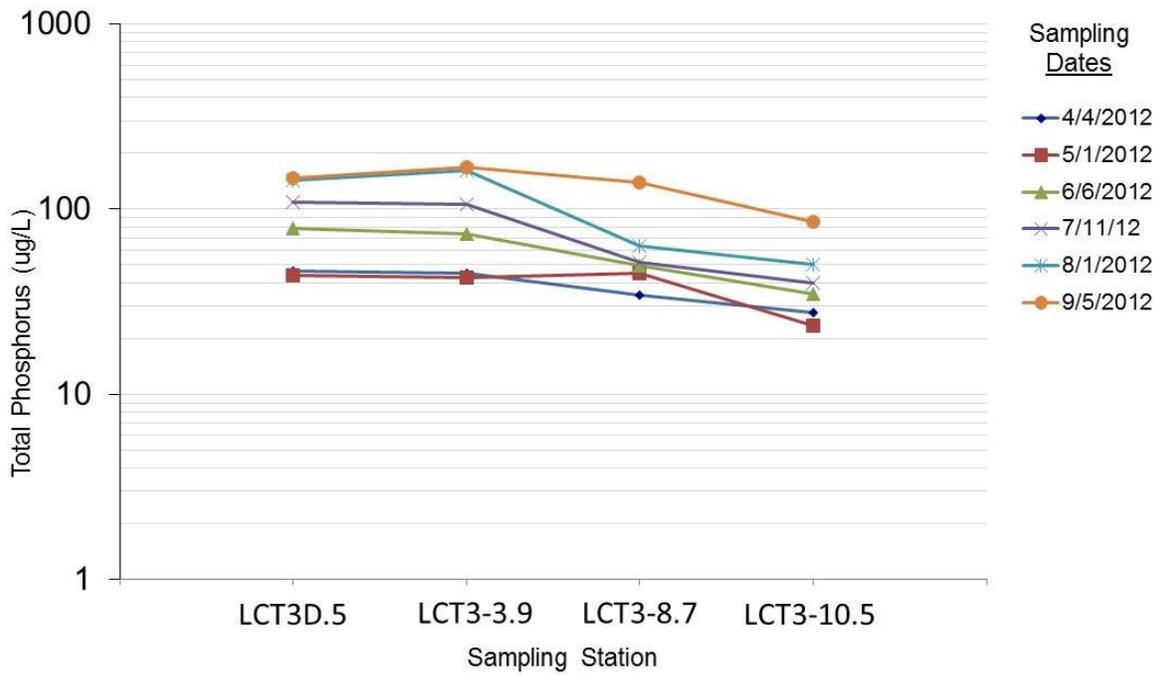
Figure 12a. Total Phosphorus concentrations during scheduled sampling events (low- to moderate-flow conditions), Pond Brook, 2012.

Figures 12a and 12b show total phosphorus (TP) concentrations during regularly-scheduled, low- to moderate-flow conditions from upstream (right) to downstream (left) for the stations along the Pond Brook and the Lewis Creek main stem, respectively. During these generally low-flow conditions, Pond Brook TP concentrations (at LCT3D.5) were greater than the main stem concentrations (at LCR14) on April 4, June 6, July 11, and August 1 and may have accounted in part for the increase in TP concentrations on the main stem between stations LCR14 and LCR9.9. An increasing trend in phosphorus concentration was evident with distance downstream. Results for the main stem sampling sites were consistent with historical trends.

TP was detected at low to moderate concentrations during the six scheduled spring and summer sampling dates, ranging from 5 to 282 ug/L, with an average of 51 ug/L (Appendix F). The mean concentration of TP for the four low-flow summer sample dates (June 6, July 11, August 1, and September 5) at six of the seven Lewis Creek main stem sites (all except LCR27.8) exceeded the proposed criteria of 44 ug/L for the warm-water medium gradient (WWMG) wadeable stream ecotype in Class B waters (VTDEC WQD, 2009). This finding suggests the potential for impacts to Aquatic Life Support and Aesthetics uses of these waters. Mean values were particularly influenced by the elevated concentrations detected on September 5. While flows on this date were low, preceded by near 7Q10 flow conditions in the previous few days, a hard rain fell in the watershed during the evening previous to this sampling event, resulting in turbid waters observed by volunteer samplers.

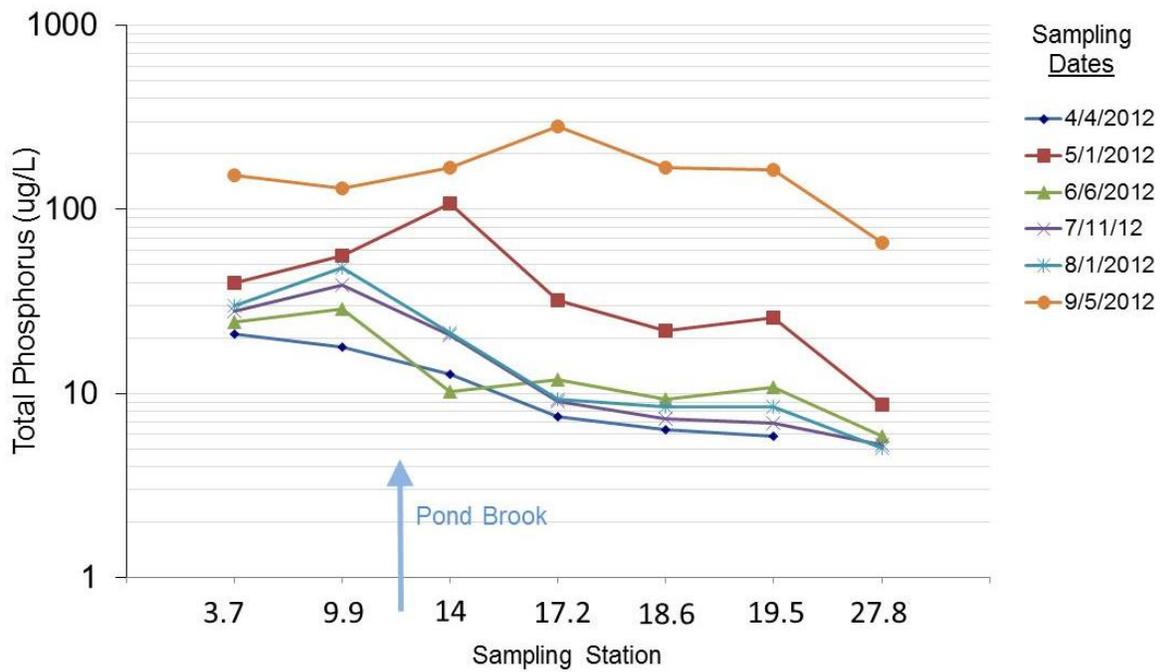
Figure 12b. Total Phosphorus concentrations during scheduled sampling events (low- to moderate-flow conditions), Lewis Creek, 2012.

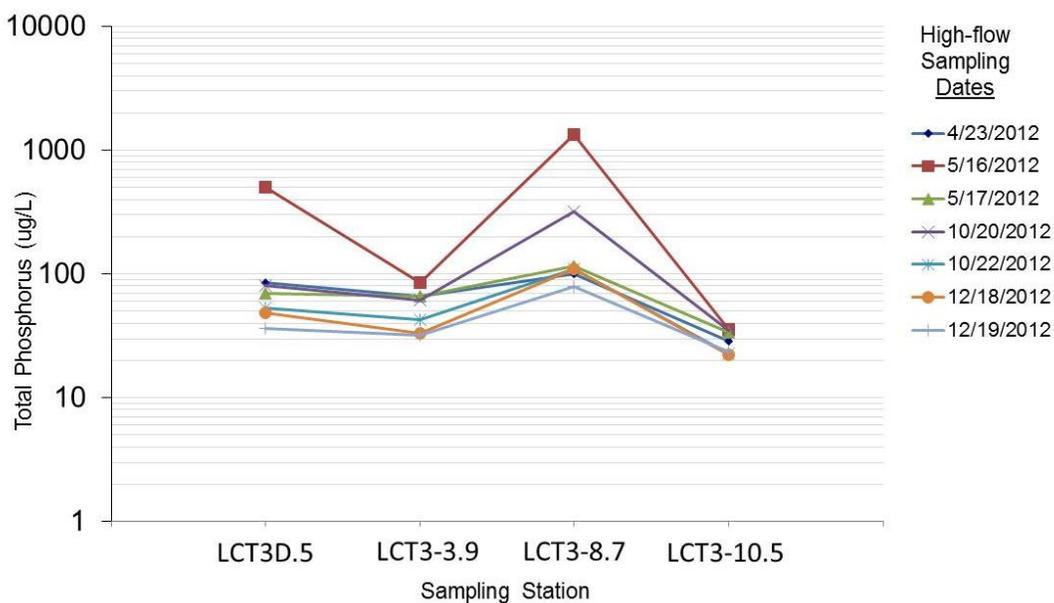
Figure 13. Total Phosphorus concentrations during high-flow conditions, Pond Brook, 2012.

TP concentrations on the Pond Brook during high-flow sampling events are presented in Figure 13. Results for 2012 indicate a spike in TP concentrations between river mile 10.5 and 8.7 for each event, in contrast to the low-flow sampling events. Concentrations ranged from 78.7 to 1,330 ug/L at station LCT3-8.7 (Appendix F). Sampling results for the May 16/ May 17 storm event were particularly revealing. A thunderstorm in the late afternoon hours of May 16 resulted in fairly intense precipitation falling on/ near the Pond Brook watershed – radar indicated up to 1 inch of rain within one to two hours. Sampling results for May 16 indicated a substantial spike in TP (as well as TSS, turbidity, and TN) between the uppermost Mountain Road station (LCT3-10.5) and Church Road station (LCT3-8.7). A similar (but lower-magnitude) increase in concentration was apparent between the lowermost Mountain Rd station (LCT3-3.9) and the Silver Street station (LCT3D.5). Windshield surveys revealed that rill & gully erosion was prevalent on Layn Farm corn fields just upstream of Church Rd during the May 16 storm event. Direct runoff from corn fields to the Pond Brook was also documented at the Church Rd crossing (field on the west just downstream of the crossing).

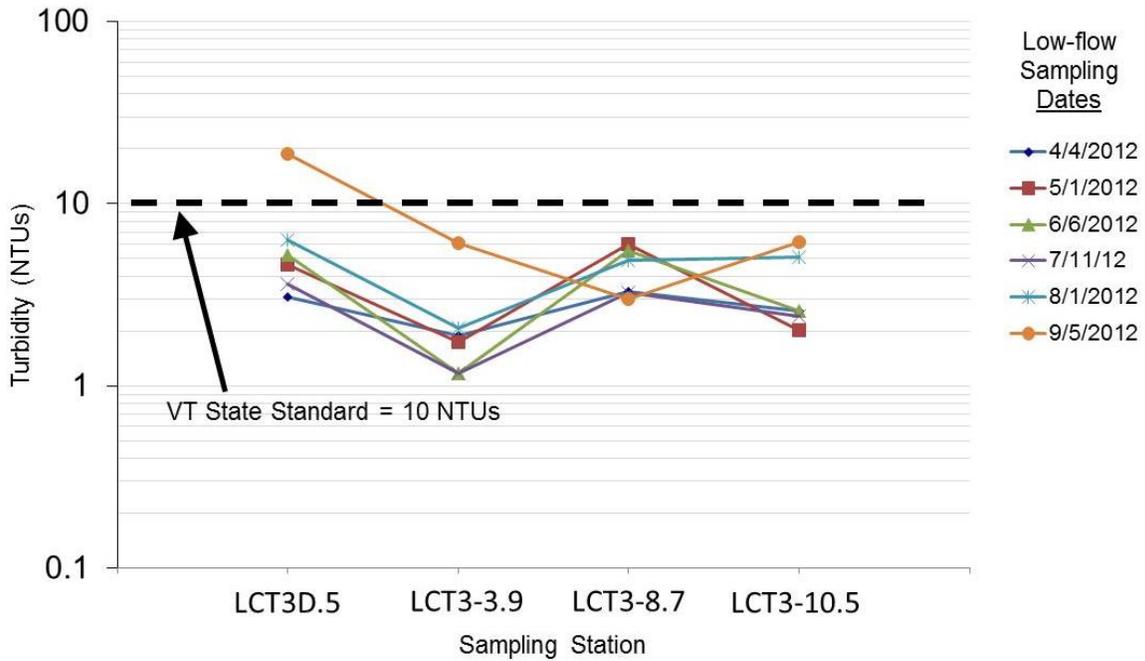
Figure 14a. Turbidity concentrations during regularly-scheduled events (low- to moderate-flow conditions), Pond Brook, 2012.

Figures 14a and 14b show turbidity concentrations during low- to moderate-flow conditions from upstream (right) to downstream (left) for the stations along the Pond Brook and the Lewis Creek main stem, respectively. During these generally low-flow conditions, Pond Brook TP concentrations (at LCT3D.5) were greater than the main stem concentrations (at LCR14) on April 4, June 6, July 11, and August 1 and may have accounted in part for the increase in turbidity concentrations on the main stem between stations LCR14 and LCR9.9. An increasing

Turbidity levels in the Pond Brook on the same spring and summer dates ranged from 1.2 to 18.7 NTUs, slightly higher than turbidity on the Lewis Creek main stem (as measured at LCR14). Except for the September 5 date, a slight decrease in turbidity is evident from the Church Street crossing (8.7) to the downstream Mountain Road crossing (3.9). This may indicate the sediment attenuation role of the large wetland complex between these two stations. The pattern may also reflect dilution from groundwater and/or tributary sources between stations.

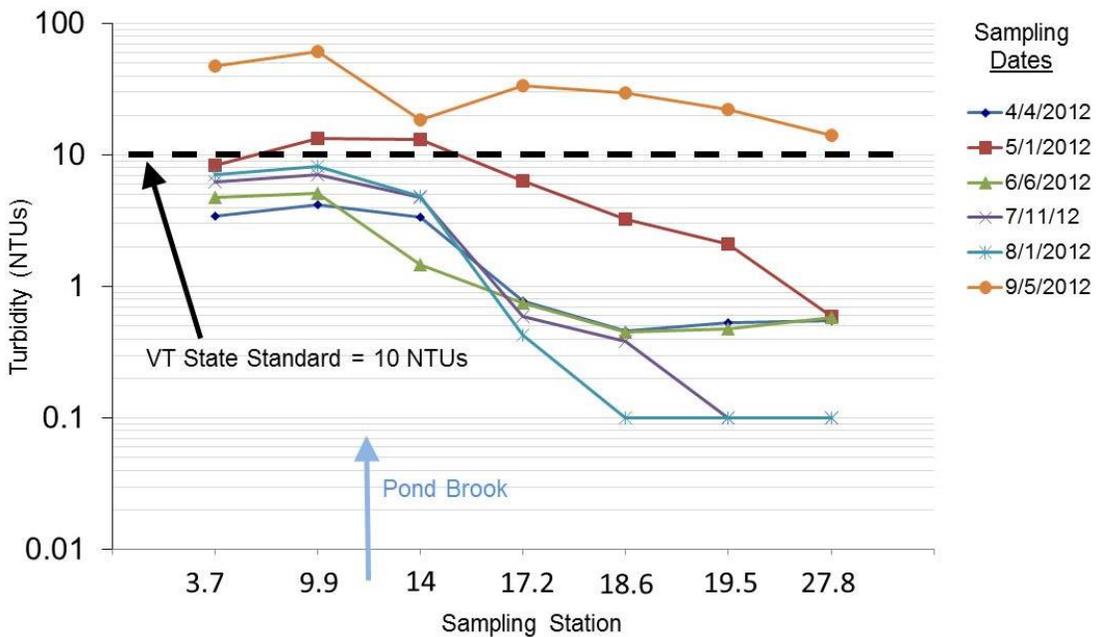
Figure 14b. Turbidity concentrations during regularly-scheduled events (low- to moderate-flow conditions), Lewis Creek, 2012.

Turbidity levels in the Lewis Creek at the sampled stations ranged from <0.2 to 61.4 NTUs, with a mean level of 8.0 NTUs for the six sample dates (Appendix F). Turbidity levels exceeded the Vermont state standard of 10 NTUs (for Class B cold-water fisheries) at stations LCR9.9 and LCR14 on May 1; flows were moderate due to spring rains. All sites exceeded the standard during low flow conditions on September 5, and may indicate the influence of algae or other organic matter. While flows on this date were low, preceded by near 7Q10 flow conditions in the previous few days, a hard rain fell in the watershed during the evening previous to this sampling event, resulting in turbid waters observed by volunteer samplers. A slight increasing trend in turbidity was evident with distance downstream (Figure 14b).

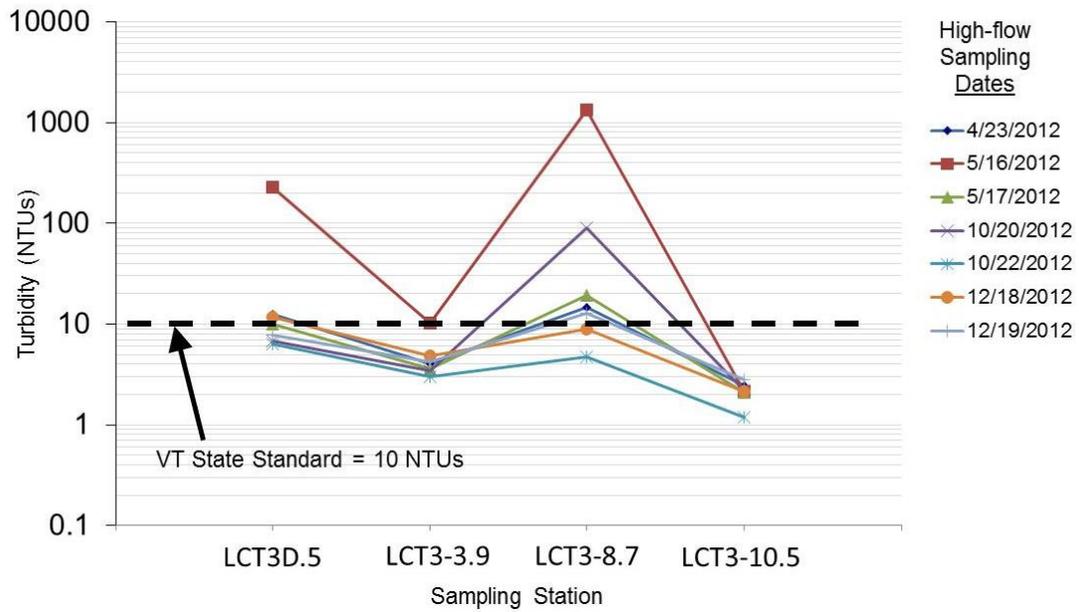
Figure 15. Turbidity concentrations during high-flow conditions, Pond Brook, 2012.

Total suspended solids (TSS) were also sampled in the Pond Brook tributary during low-flow and high-flow events in 2012. High-flow events were defined as having a flow duration interval (FDI) of 40% or less ("moist conditions" or "High flows" on the Flow Duration Curve, Figure 11). Low-flow events were defined as FDI between 40 and 100% ("mid-range flows", "dry conditions", or "low flows" on the Flow Duration Curve). Figure 16 indicates a reasonable correlation between TSS and turbidity results.

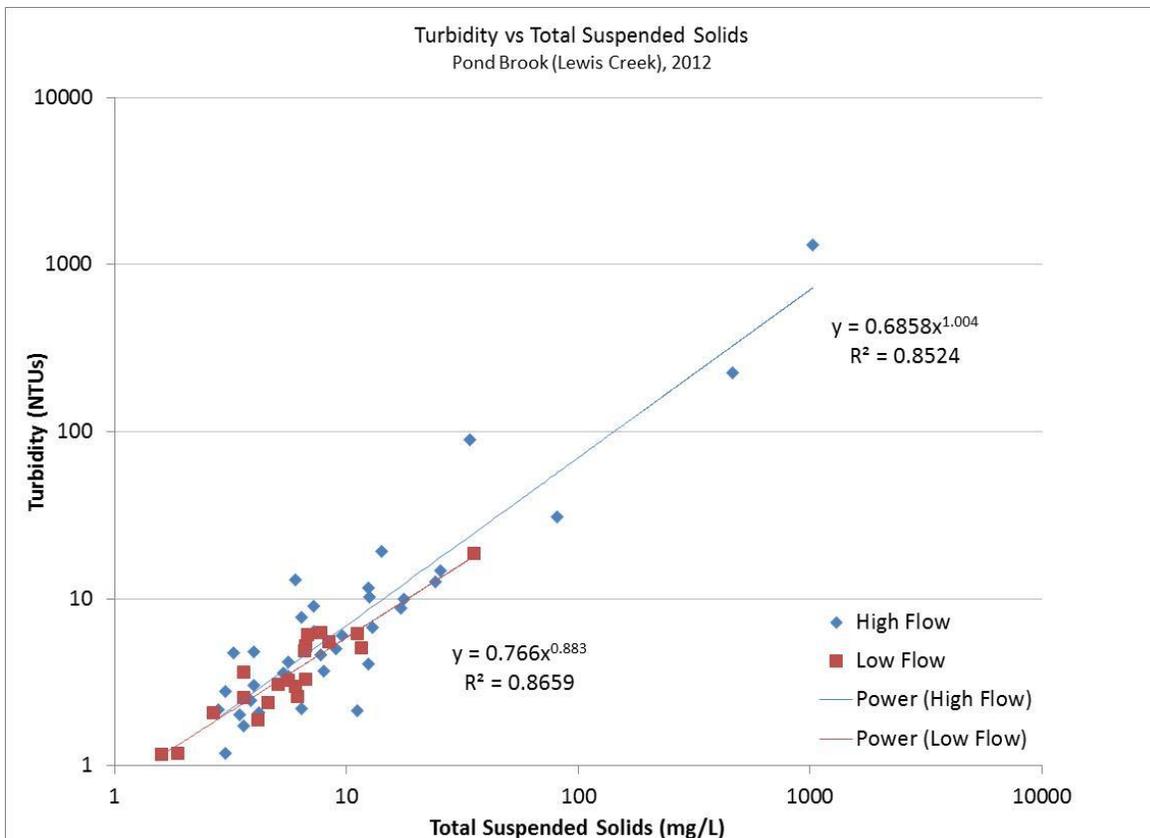
Figure 16. Turbidity versus Total Suspended Solids, Pond Brook, 2012.

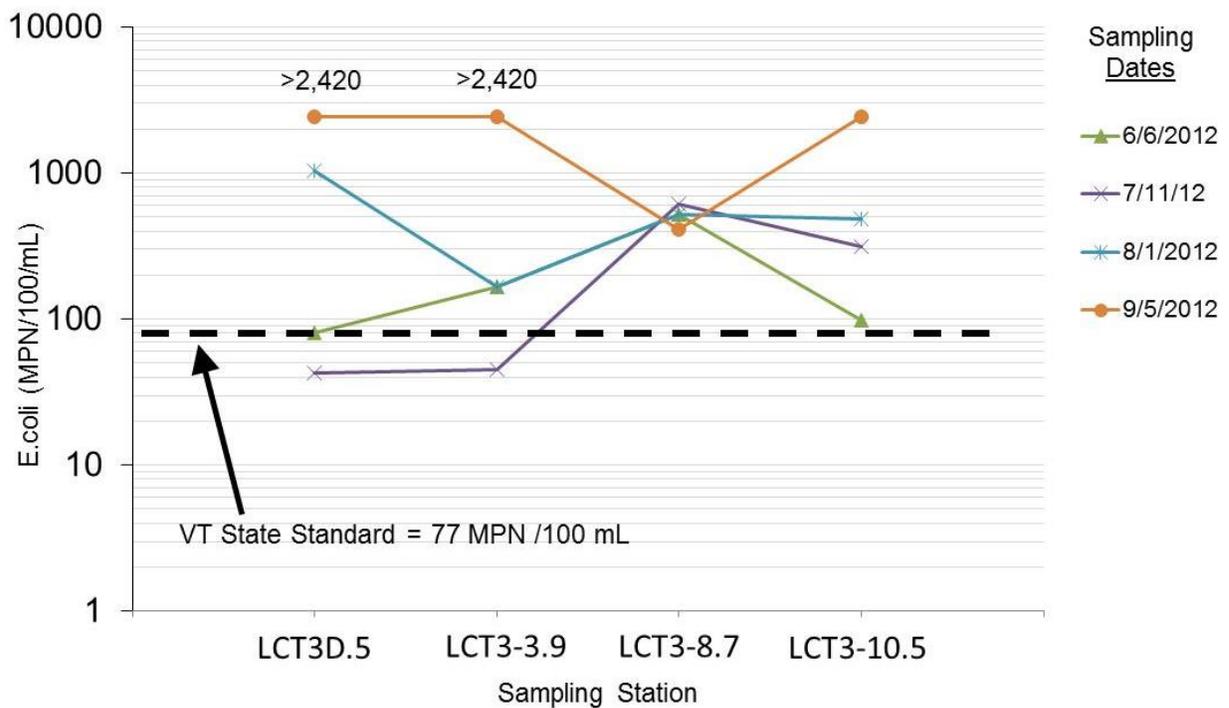
Figure 17. *E. coli* counts during low-flow conditions, Pond Brook, 2012.

E. coli was tested at the four Pond Brook stations during scheduled summer sampling events only, and not during high-flow events. Except for two downstream stations (LCT3-3.9 and LCT3-D.5) on July 11, counts at the four Pond Brook stations exceeded the state standard of 77 organisms/100 mL (Figure 17). *E. coli* counts can become elevated particularly during low-flow conditions in the warmer summer months. A similar occurrence of elevated *E. coli* counts was noted at Lewis Creek main stem sampling stations in historic drought years – e.g., 1993 and 1995.

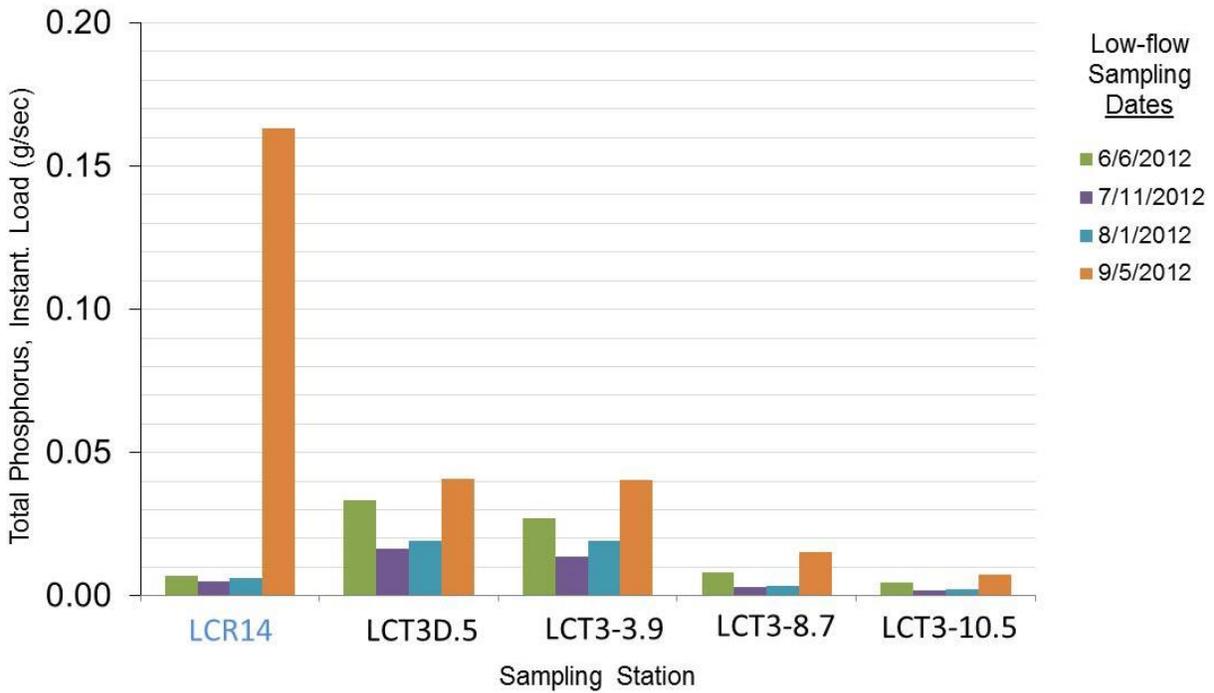
Figure 18a. Instantaneous Load Total Phosphorus during Low-Flow Sampling Events, Pond Brook stations versus Lewis Creek main stem station LCR14.

Instantaneous loads of TP by station are illustrated for the low-flow sampling dates in Figure 18a, and for the high-flow sampling dates in Figure 18b. Similarly, TSS loads for low-flow and high-flow conditions are graphed in Figures 19a and 19b, respectively.

During low-flow conditions, a general increasing trend in TP loading is apparent with distance downstream in the Pond Brook. Low-flow trends for TSS loading are not less apparent. During high-flow conditions, instantaneous loads for both TP and TSS load reflect the pattern shown by concentration data. An increase in constituent loading is evident between the uppermost Mountain Road station (LCT3-10.5) and Church Road station (LCT3-8.7). Instantaneous loading is much lower at the lowermost Mountain Rd station (LCT3-3.9). A similar (but lower-magnitude) increase is evident between station LCT3-3.9 and the Silver Street station (LCT3D.5). This pattern may suggest attenuation of sediment and nutrients in the instream wetlands that characterize the watershed downstream of LCT3-8.7

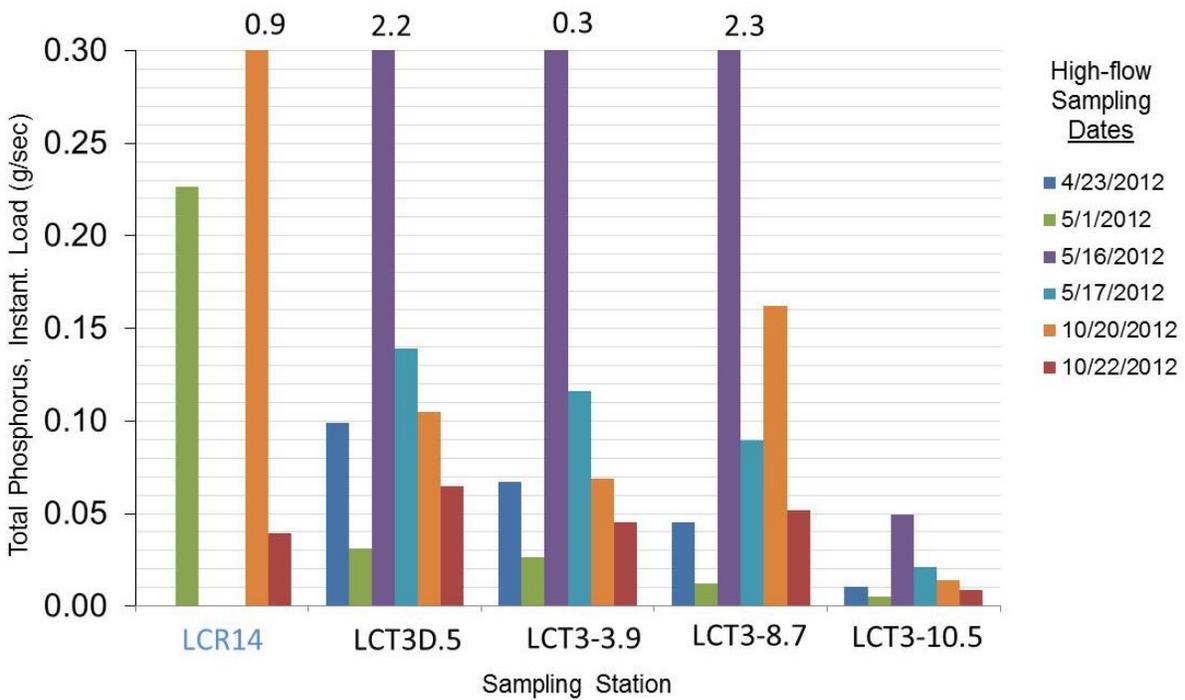
Figure 18b. Instantaneous Load Total Phosphorus during High-Flow Sampling Events, Pond Brook stations versus Lewis Creek main stem station LCR14.
