Water Quality Management Plan

Pond Brook Tributary, Lewis Creek Watershed

Monkton & Bristol, Addison County, Vermont

May 2013

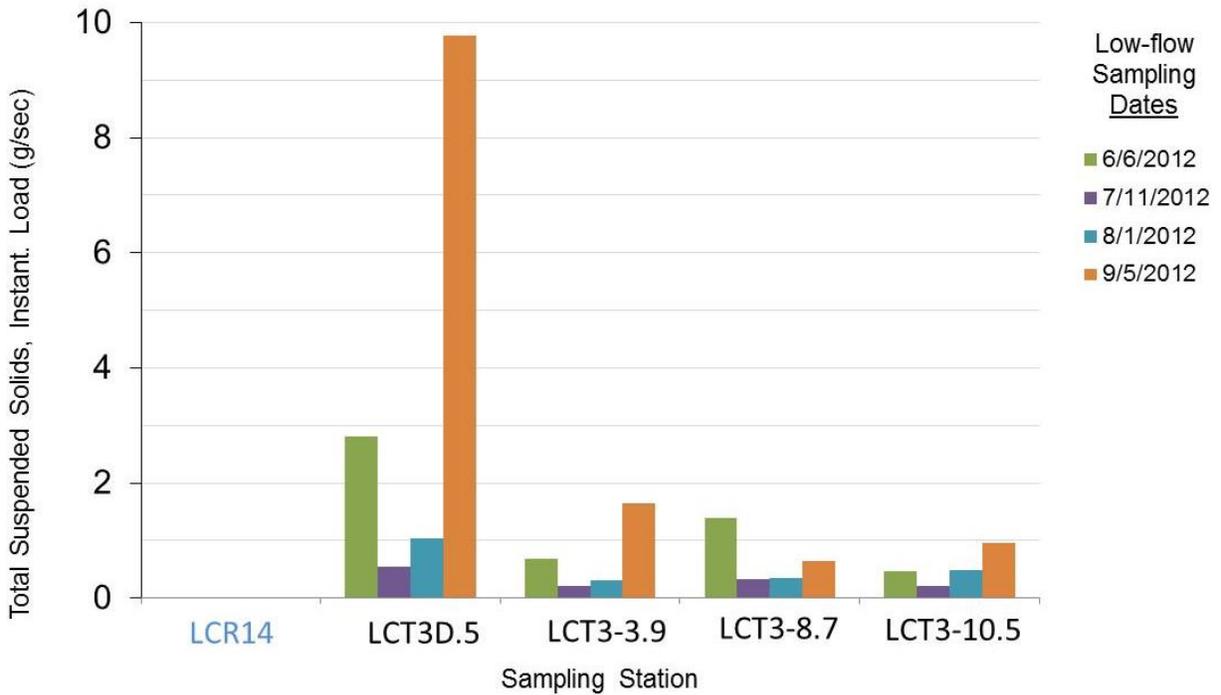
Figure 19a. Instantaneous Load Total Suspended Sediments during Low-Flow Sampling Events, Pond Brook stations versus Lewis Creek main stem station LCR14.

Instantaneous loads of TP by station are illustrated for the low-flow sampling dates in Figure 18a, and for the high-flow sampling dates in Figure 18b. Similarly, TSS loads for low-flow and high-flow conditions are graphed in Figures 19a and 19b, respectively.

During low-flow conditions, a general increasing trend in TP loading is apparent with distance downstream in the Pond Brook. Low-flow trends for TSS loading are not less apparent. During high-flow conditions, instantaneous loads for both TP and TSS load reflect the pattern shown by concentration data. An increase in constituent loading is evident between the uppermost Mountain Road station (LCT3-10.5) and Church Road station (LCT3-8.7). Instantaneous loading is much lower at the lowermost Mountain Rd station (LCT3-3.9). A similar (but lower-magnitude) increase is evident between station LCT3-3.9 and the Silver Street station (LCT3D.5). This pattern may suggest attenuation of sediment and nutrients in the instream wetlands that characterize the watershed downstream of LCT3-8.7

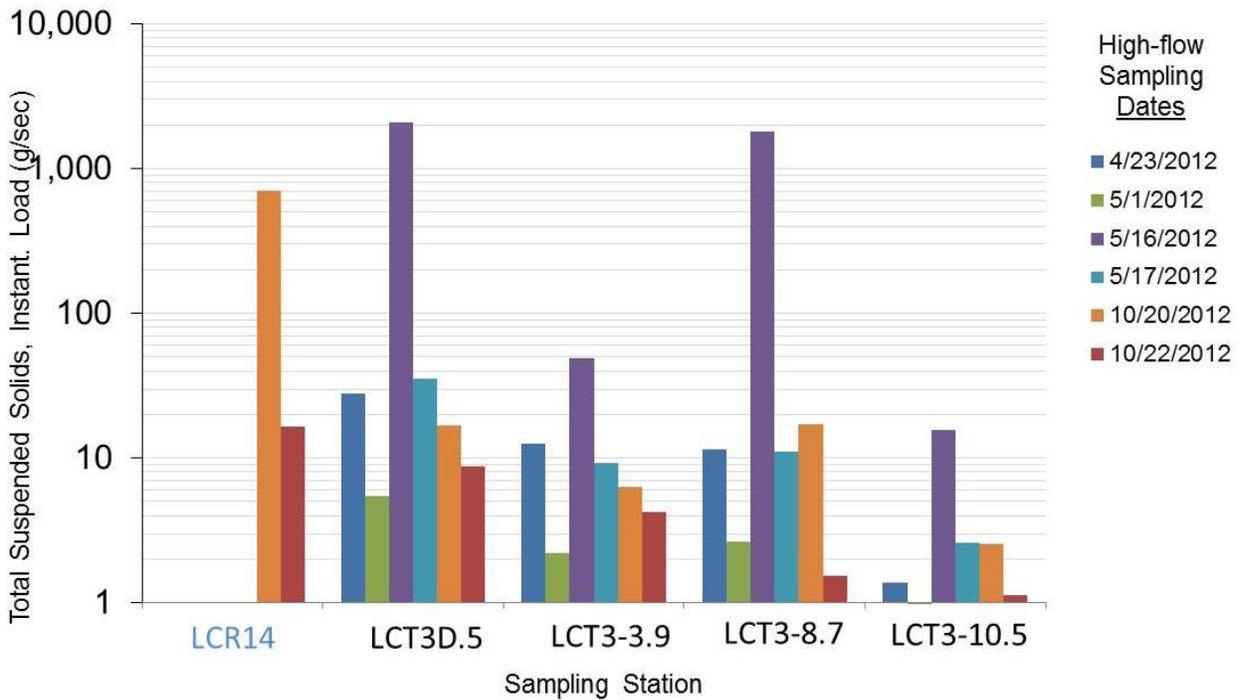
Figure 19b. Instantaneous Load Total Suspended Sediments during High-Flow Sampling Events, Pond Brook stations versus Lewis Creek main stem station LCR14.
