## **APPENDIX G**

### **Reach Narratives**

## **G.1 Lewis Creek Main Stem**

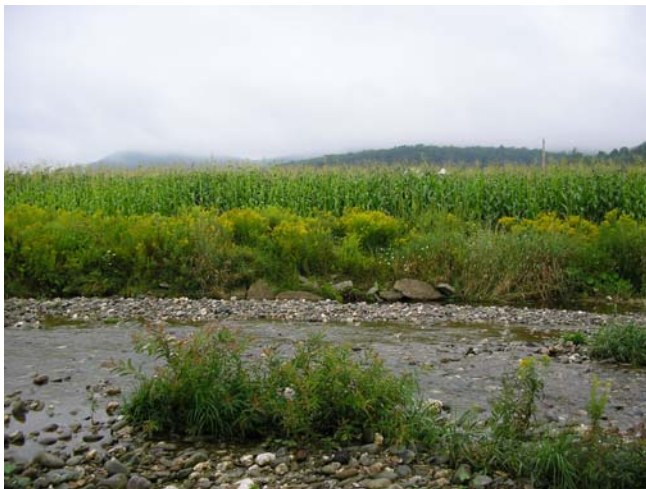
*Figure G-4.*

*Site of new meander along M22 (Site B in Figure G-3) which is extending into adjacent corn fields downstream of Hillsboro Rd. Topsoil, streambank sediments and nutrients are eroding and being transported down-river.*

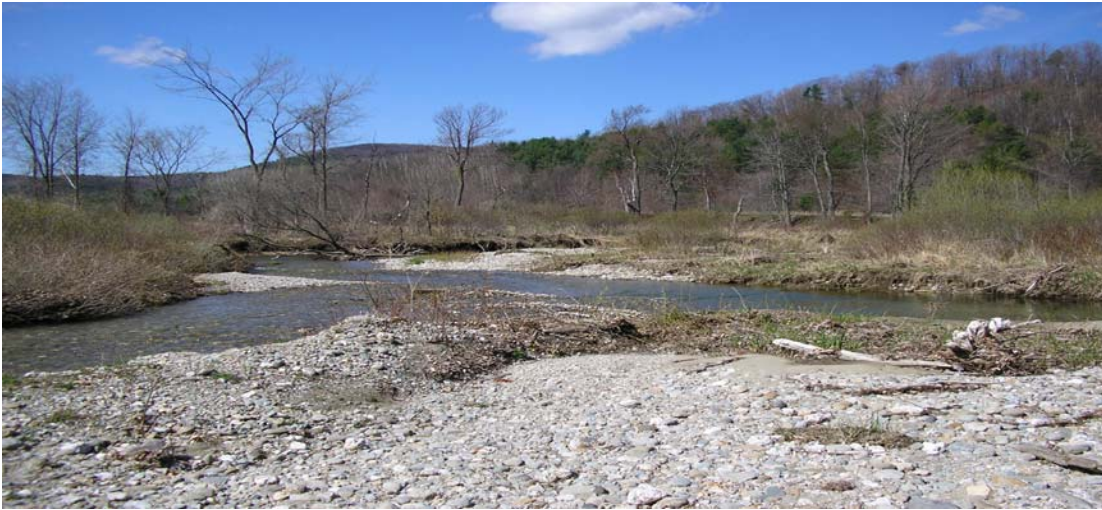
*Figure G-5. Area of active channel adjustment downstream of the Route 116 crossing (M22, view to west, Site A in Figure G-3)*

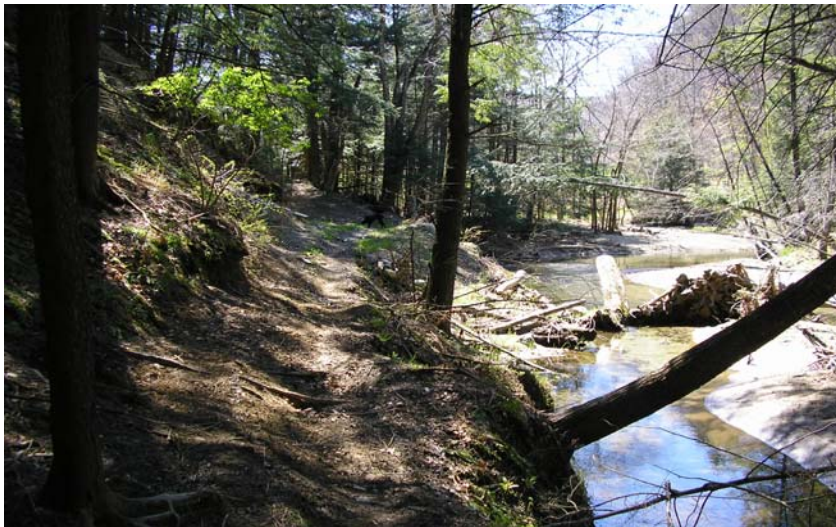
*Figure G-7.  
Area of ATV use downstream  
from Tatro Road bridge.  
Vehicles use the banks and also  
ford the stream in this area.  
Trees are collapsing in the  
stream, and sediment is  
washing into the creek from this  
unvegetated path  
(M20-A, view upstream).*

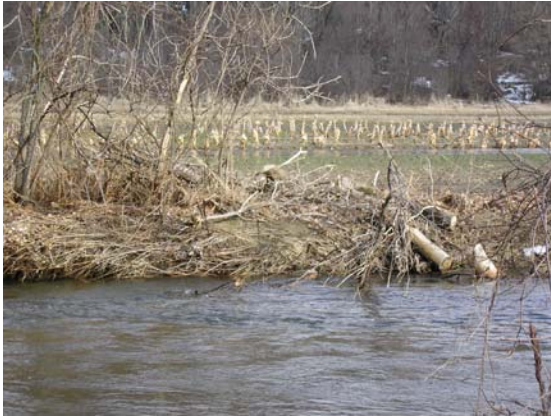
*Figure G-10. Lewis Creek near “bank full” during early spring. Fields often flood briefly at this time. Old brussell sprout stalks are still standing (M19-B).*

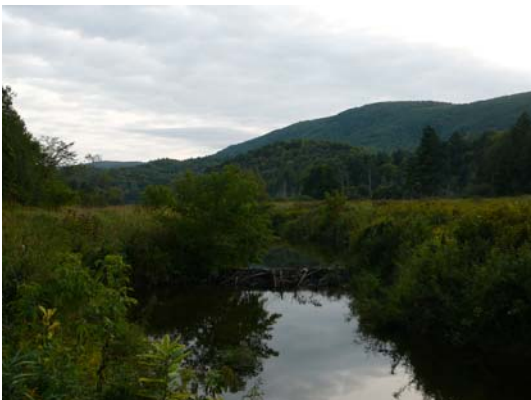
*Figure G-14. View upstream (south) from center of LaRue property; beaver dam in foreground; Hogback Mountain in background.*

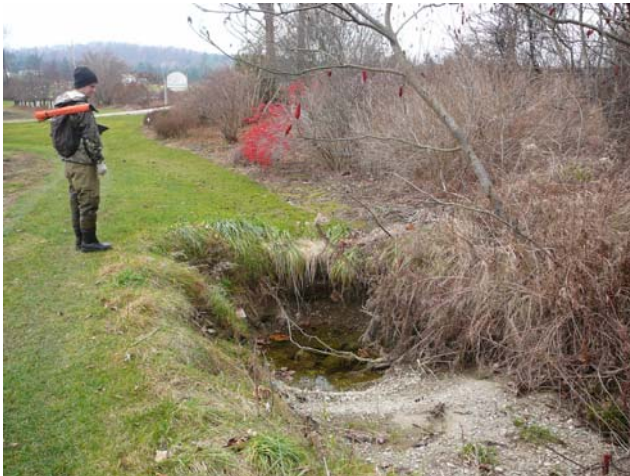
A gully was observed along the LB of the Lewis Creek approximately 125 feet upstream of the Tyler Bridge Road. The gully extends approximately 75 feet upstream from its confluence with Lewis Creek, and ranges in depth from approximately 5.5 feet near the confluence to 2.5 feet near the head cut (at the upper extent of the gully; see Figure G-18). The width of the gully ranges from approximately 8 to 4 feet.

*Figure G-18. LB stormwater channel from commercial tree nursery in Segment M15-B just upstream of the Tyler Bridge Rd. With the addition of drainage diverted from an upstream residential property, this channel has developed into an erosional gully that has deposited gravels and sands in the Lewis Creek channel.  
29 November 2006.*

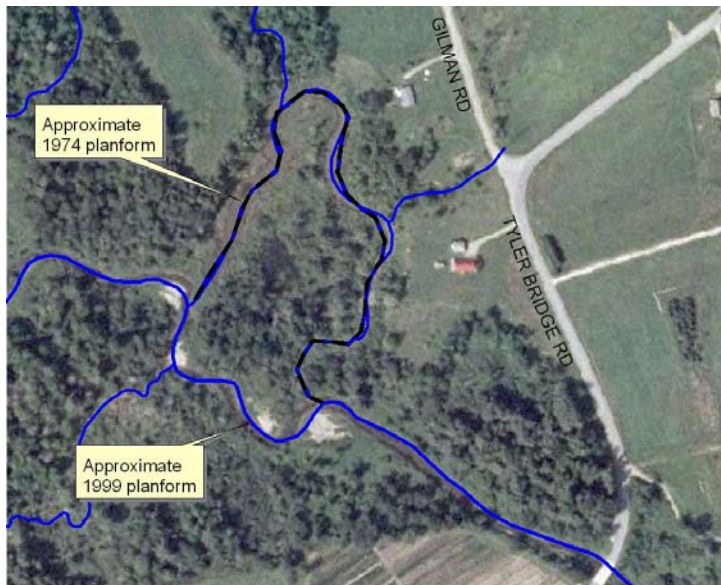
Between 1994 and 1995, a Lewis Creek channel avulsion occurred downstream of the Tyler Bridge Rd bridge and resulted in the loss of approximately 1000 ft of channel length as a large tortuous meander was abandoned by the Lewis Creek (Figure G-19). No bedrock grade controls exist within the reach to prevent headward migration of incision following this avulsion. However, no head cuts were observed upstream of this avulsion site in the reach (November 2006). It is possible that the low overall channel gradient ( $\sim 0.1\%$ ) moderated the potential for incision. Also, recent meander extension elsewhere in the segment has added to the channel length. The potential for incision may also have been offset by active aggradation. Streambank erosion within the segment and in upstream reaches (including the Hollow Brook) is contributing coarse sediment fractions (bed load) within the segment. Aggradation is particularly evident local to beaver dams, debris jams and entrained large woody debris. The channel is locally overwidened in vicinity of these features. Discontinuous pockets of incipient floodplain are evident at a slightly lower elevation than the surrounding floodplain – being built through active channel widening and planform adjustments.

*Figure G-19. Abandoned meander downstream of the Tyler Bridge Rd bridge in Segment M15-B. Review of annual fly-over images at the NRCS Middlebury office indicates that this avulsion occurred over a period of time from 1994 to 1995. Cut off of this broad meander resulted in a net loss of 1,000 ft of channel length. The avulsion and subsequent channel adjustments may have contributed to recent aggradation in downstream Segment M15-A. ( Base image is dated 2003)*

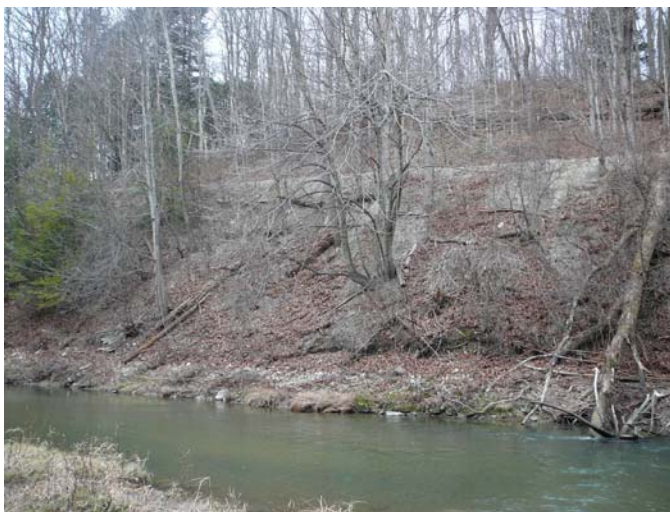
*Figure G-22.  
Sediments from the  
Lewis Creek Road  
enter the Lewis Creek  
as a result of overland  
runoff along the RB,  
reach M14.*

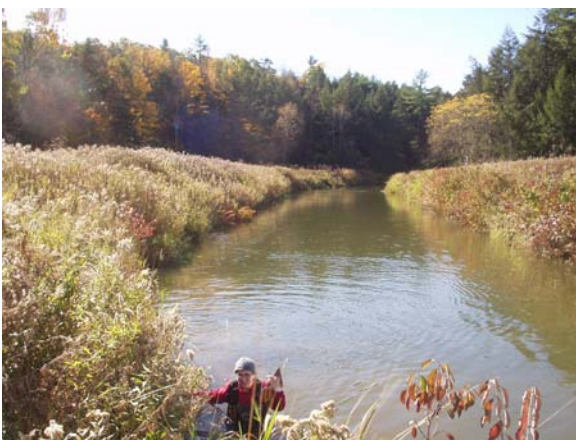
Segment A was scheduled for assessment in 2004, but was not assessed due to extensive beaver impoundments. One beaver dam was located mid-segment and impounded a channel length of approximately 1600 feet. The remaining downstream end of the segment was impounded by a beaver dam located in downstream reach M11.

Figure G-26. Segment M12-A, impounded by beaver dams, 18 October 2004, Hinesburg.

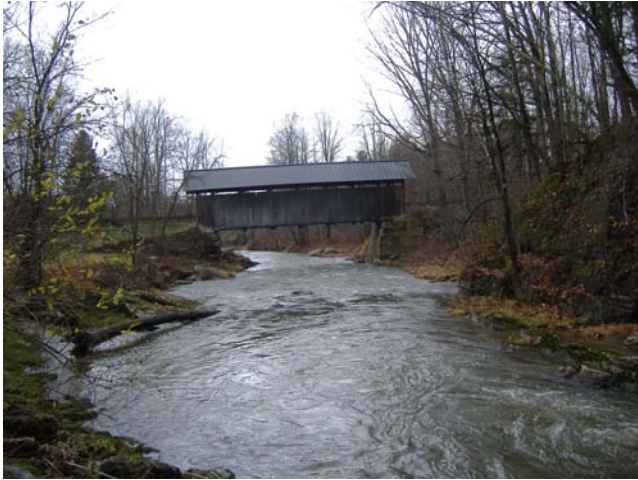
Segment F is the short section of bedrock-controlled channel located upstream and slightly downstream of the Seguin Covered Bridge (c. 1850) which carries Roscoe Road over Lewis Creek. Sediments of glacial till origin are mapped along both banks of the channel and in the LB and RB corridors (USDA). Channel-spanning bedrock is exposed in a short waterfall approximately 250 feet upstream of the bridge and in a low-profile "ledge" outcropping approximately 70 ft upstream of the bridge. Vertical bedrock walls are present along RB at and downstream of the falls. Bedrock is also exposed along the LB in a more shallow profile downstream of the falls. Historically, a grist mill and black smith shop were located in vicinity of the falls (Beers, 1869). Short sections of rip-rap armoring reinforce the concrete-capped laid-up-stone abutments of the Seguin bridge, which are slightly undersized with respect to the reference channel width. Stormwater inputs were observed along the RB, both upstream and downstream of the bridge (road ditches terminating at the bridge) and along LB downstream of the bridge where a road ditch culvert is directed under Roscoe Road. Due to the bedrock nature of the channel, this segment was not assessed. A B1c-step/pool provisional stream type was assigned.

*Figure G-29. Sequin Covered Bridge (aka Upper Covered Bridge) on segment M10-F of Lewis Creek.*

*View downstream from bedrock falls, 15 November 2006.*

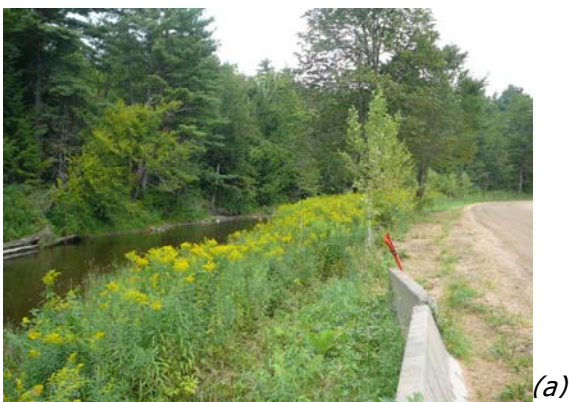
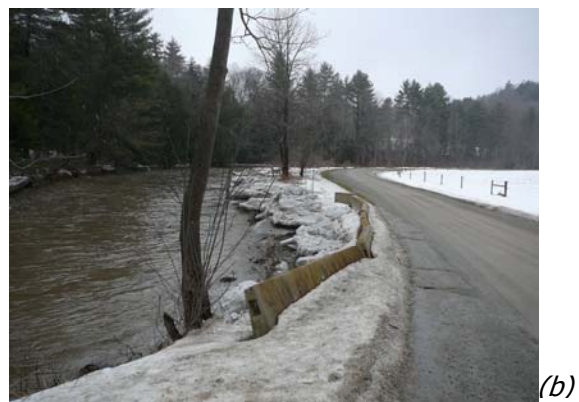
The linear planform of this segment and close encroachment of Roscoe Road (along LB) suggest possible historic channelization. Rip-rap armoring has been installed in a few locations along the LB to reinforce the bank along this road; and a low berm is present between the road and the channel for an approximate length of 320 feet. High water in February 1990 reportedly overtopped the road and resulted in bank slumping near the downstream end of the segment where a small, unnamed tributary joins the Lewis Creek via a culvert under the road; concrete Jersey Barriers were placed along the road for traffic safety (Illick, 2009). Road ditch runoff along the southeast side of Roscoe Road also drains to the Lewis Creek via this LB tributary culvert. In 2000, tree revetments were installed along a 50-foot length of the LB in this location through cooperative efforts of the US Fish & Wildlife, Lewis Creek Association, and the town of Charlotte (Illick, 2009). In the 9 years since installation, sediments have accumulated along the LB and appear to have stabilized the bank in this location. Meanwhile, LB erosion has increased in a location approximately 450 ft upstream, resulting in the wooden-post guard rail along Roscoe Road slumping toward the channel.

*Figure G-30. Segment M10-E at Jersey barriers along Roscoe Rd, view upstream:  
(a) 19 August 2009; (b) 26 January 2010 following ice jam flooding the prior evening.*

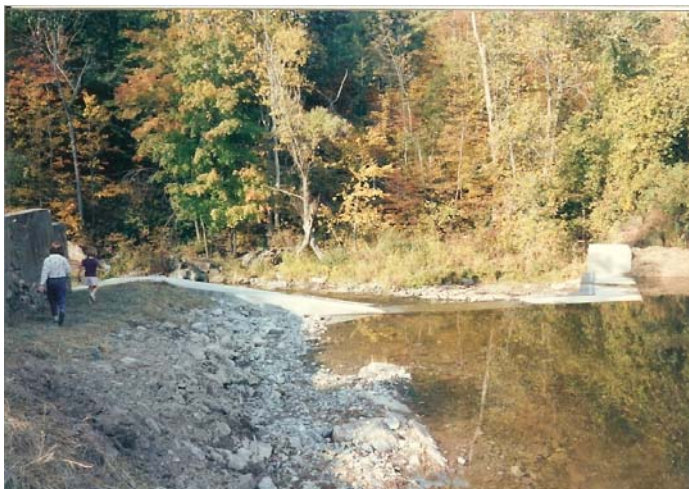
*Figure G-33. Scott Pond Dam following refurbishment in October 1992, view downstream.*

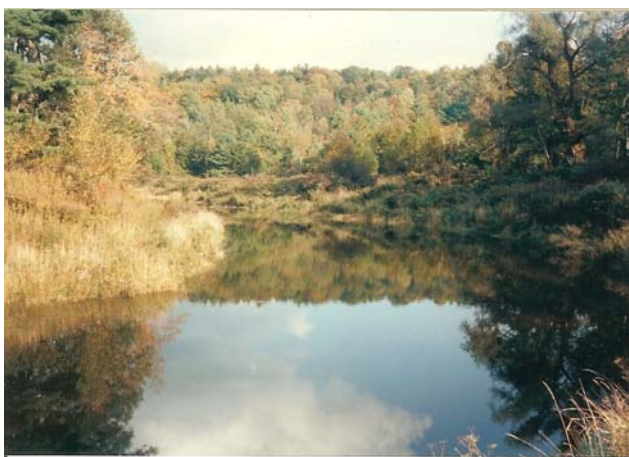
Figure G-35. View upstream of Scott Pond Dam, Segment M09-B.

(a) No apparent impoundment associated with breached dam condition prior to refurbishment, Summer 1992. Source: M. Illick

(b) Impounded channel following dam refurbishment, October 1992. Source: M. Illick

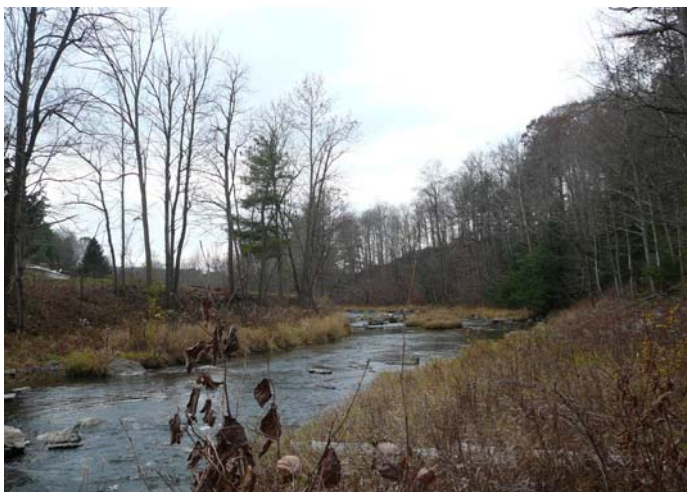
The natural transport functions of this reference Semi-confined reach have been enhanced due to the incised and entrenched condition. This reach remains susceptible to catastrophic erosion in a high flood event. Depending on the operational status of the Scott Pond dam, this upstream structure may serve to impound and attenuate flows to an extent, thus reducing the peak and intensity of flows in the downstream channel. Hydrologic and hydraulic analyses would be required to understand the nature and extent of potential attenuation functions offered by the dam.

*Figure G-36. View downstream  
from Scott Pond Dam,  
Segment M09-A.  
3 November 2009.*

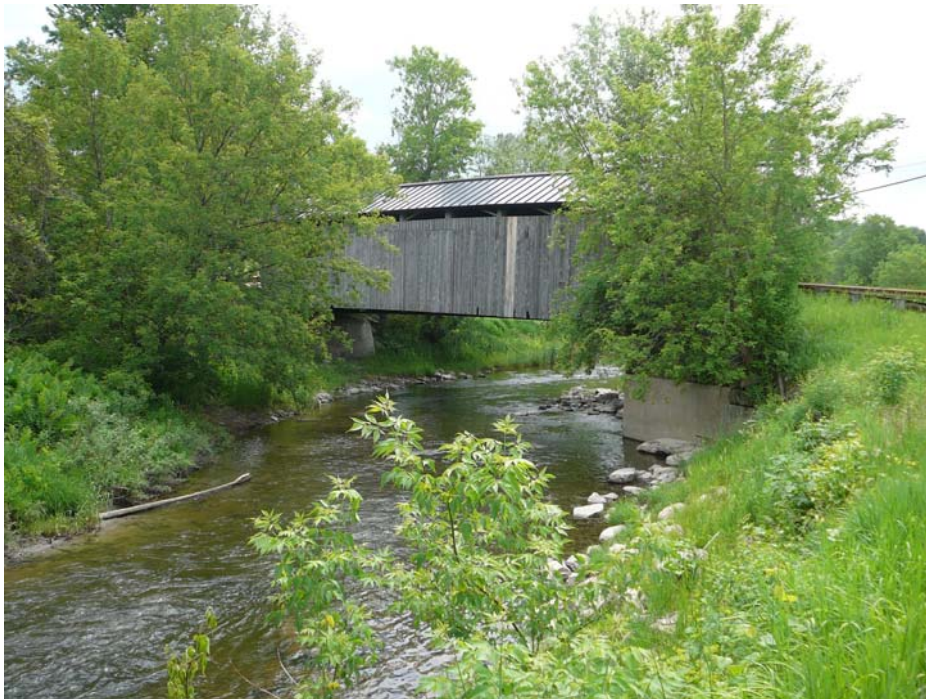
The Quinlan Covered Bridge was originally constructed circa 1850 of timber decking / framing. Steel trusses were installed as additional supporting members and stone abutments were faced and capped with concrete during refurbishing efforts in recent decades. The measured span of the abutments is 69.2 feet, and the clearance of this structure to the channel bed is 14.8 feet. This bridge span is approximately 82% of the measured upstream (M09) bankfull width. The Lewis Creek approaches the bridge span at a moderate angle and the RB abutment protrudes into the channel.

Spear Street encroaches along the RB upstream of the Quinlan Covered Bridge; berms have been constructed and rip-rap armoring has been installed over the years to protect this road and constrain the channel on approach to the bridge. The local landowner noted that the LB of the channel upstream of the bridge was reinforced with rip-rap in the early 1970s; at about that time, the streambank along the left side of the channel downstream of the bridge was also lowered and stepped to create a more gradual overall slope (Morse, 2009).

*Figure G-38. Quinlan Covered Bridge, view downstream.  
Reach M08. 11 June 2009.*

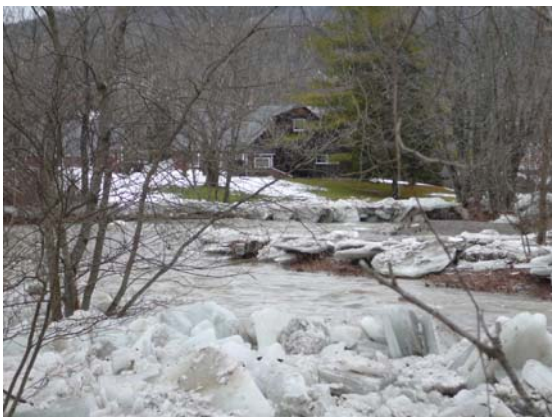
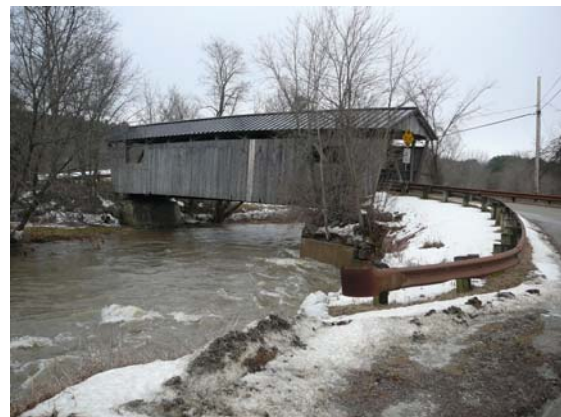
Figure G-40. Ice jam flooding event of 25 January 2010, vicinity of the Quinlan Covered Bridge (reach M08). (top) extent of inundation flooding and ice shed; (bottom left) view downstream to Morse residence from LB along Lewis Creek Rd; (bottom right) view downstream to Quinlan covered bridge from Spear Street on 26 January 2010 (receding water levels).

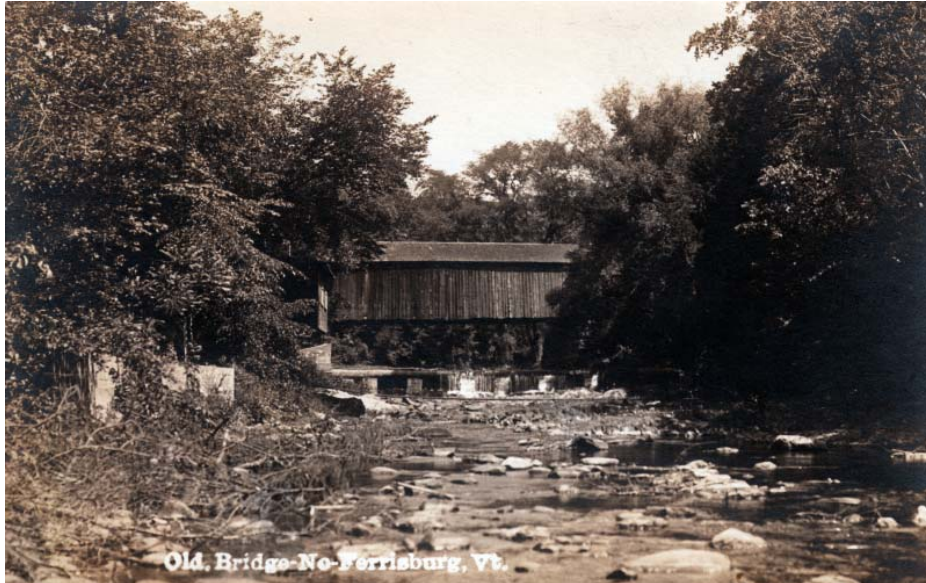
including a grist mill, saw mill, and woolen mill. A historic photograph of the former covered bridge crossing of Old Hollow Road depicts a low-head dam below the bridge (Figure G-42). This dam is no longer present.

Figure G-42. Old Hollow Road crossing, North Ferrisburg, view upstream. circa 1870 to 1950. Low-head dam visible below bridge. Reach M07. Source: VT Landscape Change webpage.

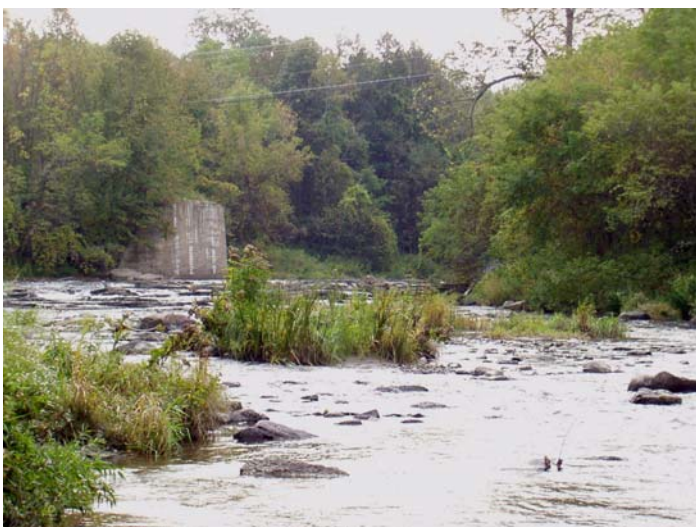
Figure G-46.  
Channel-spanning bedrock  
falls upstream and  
downstream of the  
abutments of the former  
Route 7 alignment.

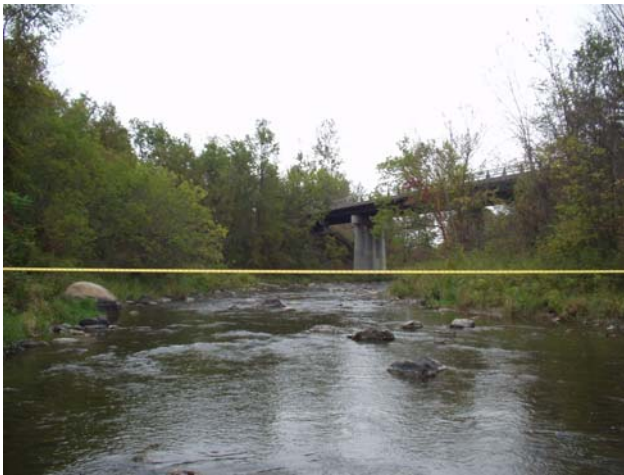
Figure G-47.  
Cross section measured  
approximately 250 feet  
downstream of Route 7  
bridge, reach M05 (view  
upstream).

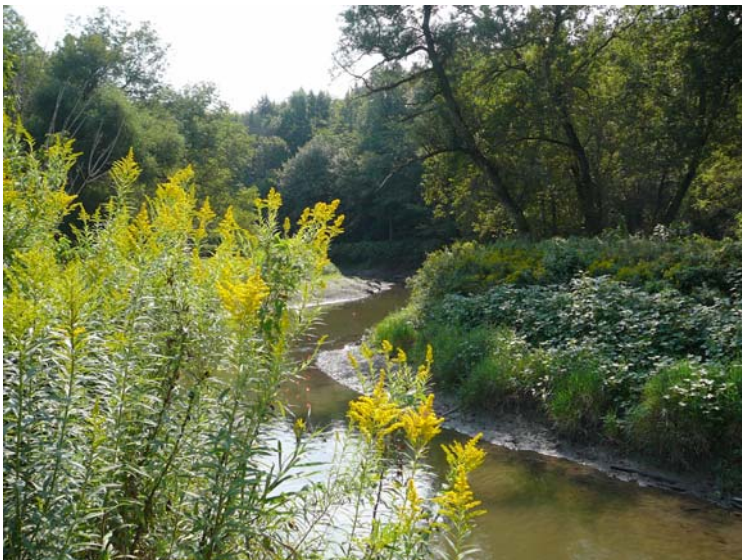
A Good habitat condition was assigned following the RHA. Minor to moderate deposition throughout the reach has resulted in some filling of pools. Sediment is soft underfoot in locations of aggradation above large woody debris and/or debris jams. Streambanks, particularly along the outside of meander bends, are actively eroding and contain little stabilizing vegetation. Reach M04 is a documented location of freshwater mussels.

*Figure G-50.  
Mid-point of Reach  
M04, September 2006.  
View upstream.*

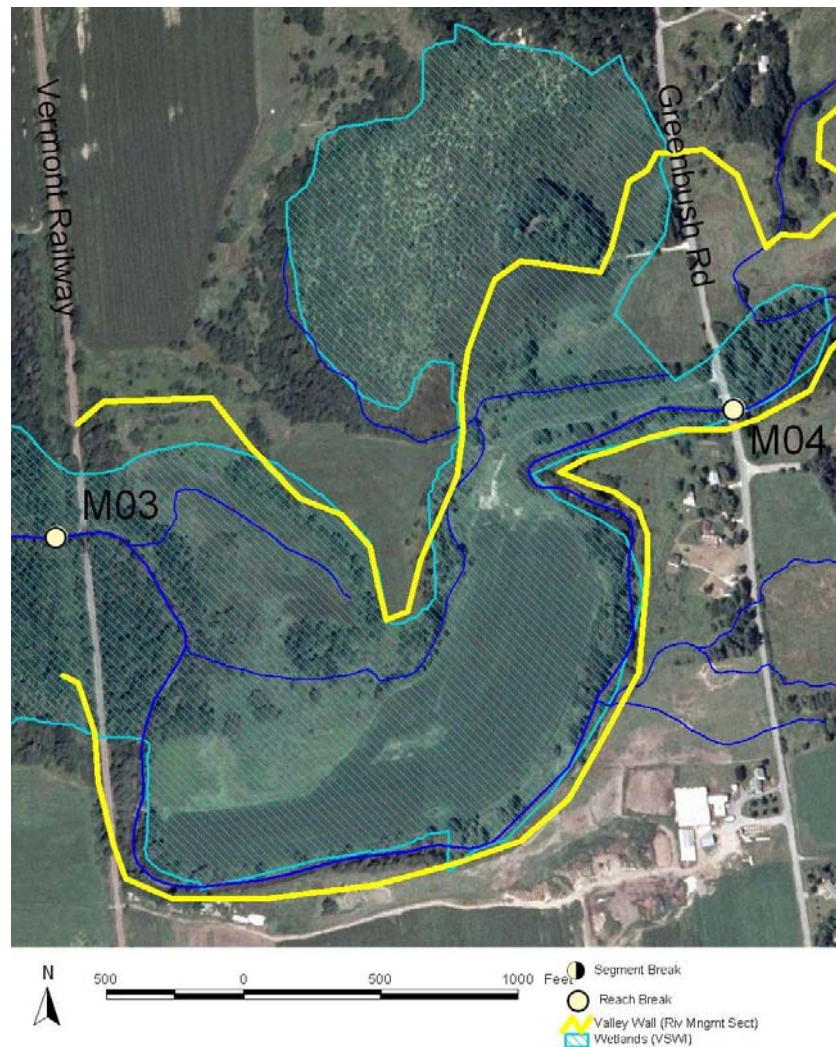
Reach M03 is 5,471 feet in length and extends from the Greenbush Road bridge crossing downstream to the Vermont Railway crossing (Figure G-51). As discussed in a previous section, reach M03 may be influenced by backwater effects from Lake Champlain during years of very high lake levels. Soil types in the floodplain nearest the channel are mapped as frequently-flooded Hadley very fine sandy loams, Limerick silt loams and Winooski very fine sandy loams of alluvial origin (USDA). Fine sandy loams of glaciolacustrine origin dominate the areas farther from the channel. Wetlands are mapped over an area approximately 500 to 900 feet wide and contiguous with the channel (NWI).

Figure G-51. Reach M03 flows west from the Greenbush Road crossing to the Vermont Railway railroad crossing. Base photo: 2003.

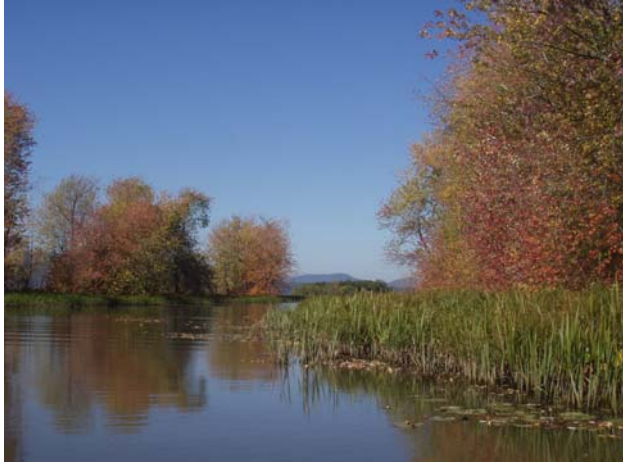
*Figure G-56(a) - left.  
Reach M01, upstream from  
Hawkins Bay. The Lewis Creek  
channel is influenced by effects of  
fluctuating lake levels, which have  
modified fluvial process and form.*

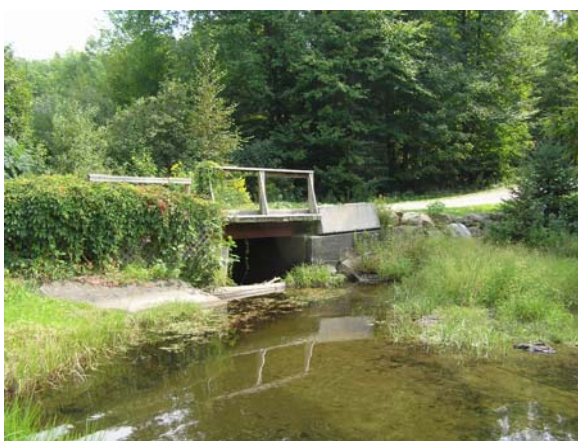
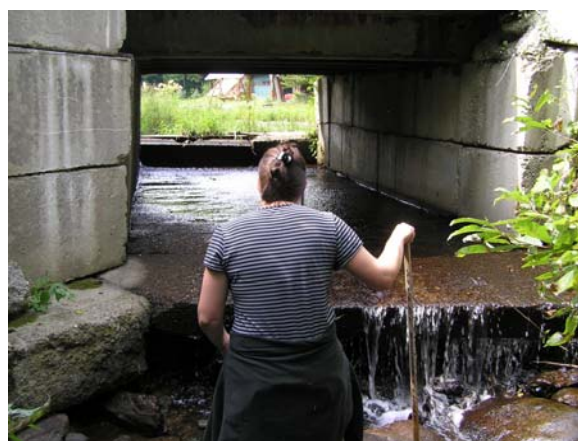
- The bridge driveway crossing is constructed over a small dam with apparent flashboards which impounds a relatively wide, but shallow, pond at a residential property.

*Figure G-59. Bridge / dam on Hollow Brook in segment T4.05-D. (a) view downstream to the inlet. (b) view upstream to the outlet (concrete apron). 8 September 2005.*

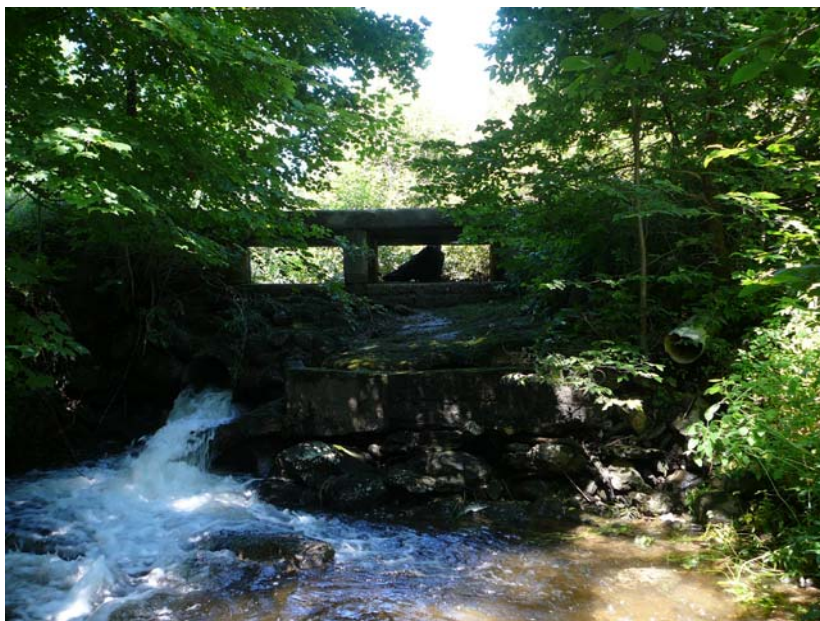
Figure G-60. Culvert / dam on Hollow Brook segment T4.05-D.

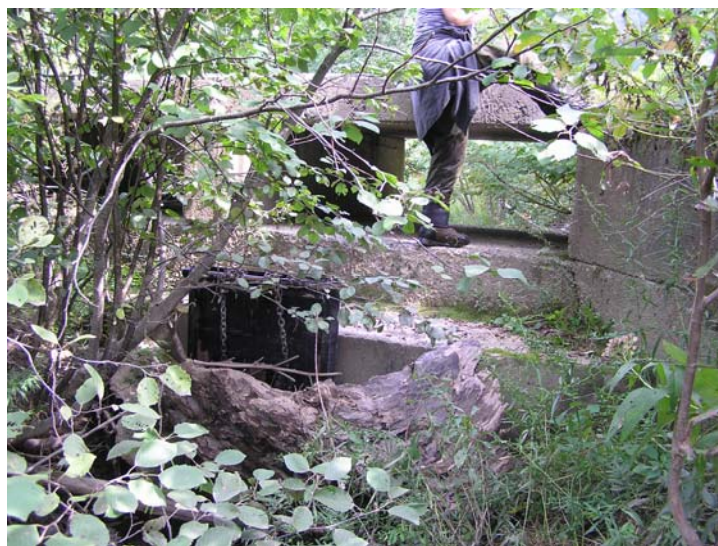
(a) View upstream to culvert outlet;  
**25 July 2008.**  
Overflow culvert at picture right. Steel trap door at culvert inlet in raised (open) position. Moderate impoundment of channel flows observed in thickly vegetated wetlands area immediately upstream of dam.

(b) View downstream to culvert inlet;  
**8 September 2005.**  
Steel trap door at culvert inlet in lowered (closed) position.

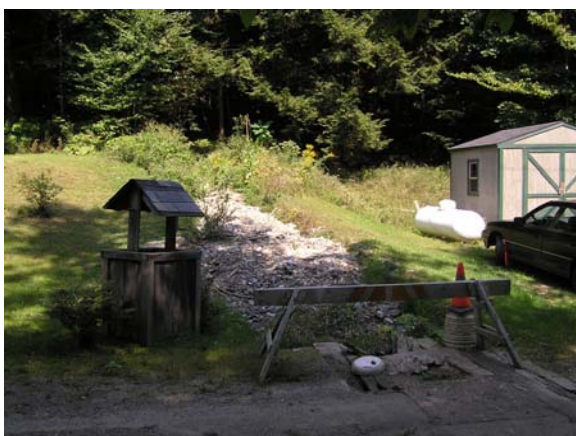
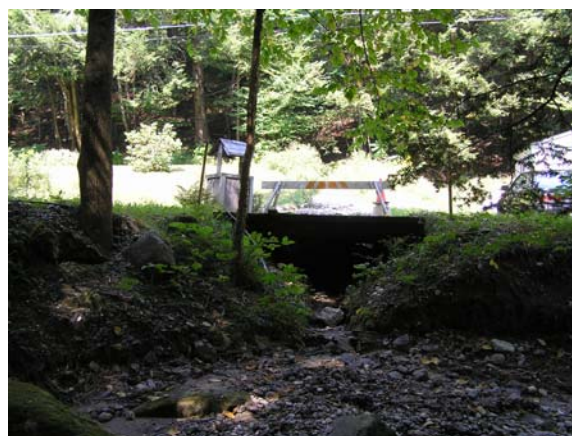
A LB ephemeral tributary at the mid-point of Segment A is associated with a "delta" of sediment in Hollow Brook during the original September 2005 assessment. A small bridge provided a driveway crossing of this tributary to access a mobile home. In September 2005, this tributary channel was choked with gravel sediments. As of July of 2008, this tributary channel had been dredged and the small bridge was no longer present (see Figure X-x). This ephemeral tributary (in Starksboro) may receive stormwater runoff from ditches along Lincoln Hill Road (in Hinesburg) approximately 300 feet to the north and 140 feet upslope. The recently dredged (and now entrenched) cross section of this channel will be a source of increased sediment runoff to the Hollow Brook. It is also possible that headward incision will rejuvenate erosion and widening on upstream segments of this ephemeral tributary, leading to additional sediment delivery.

Figure G-61. LB ephemeral tributary choked with sediment and causing damage to small driveway bridge. Hollow Brook segment T4.05-A (a) view upstream of driveway crossing. (b) view upstream from "delta" at confluence with Hollow Brook to driveway bridge outlet. 8 September 2005.

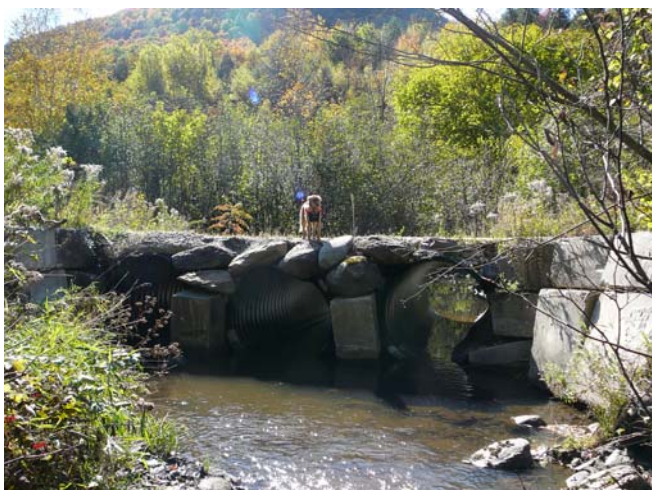
*Figure G-64.  
Triple-culvert driveway crossing of  
Hollow Brook at 1237 Hollow Rd at  
the upstream end of Segment  
T4.02-B. Reinforced with boulders  
and concrete blocks.  
View downstream, 10 October 2008.*

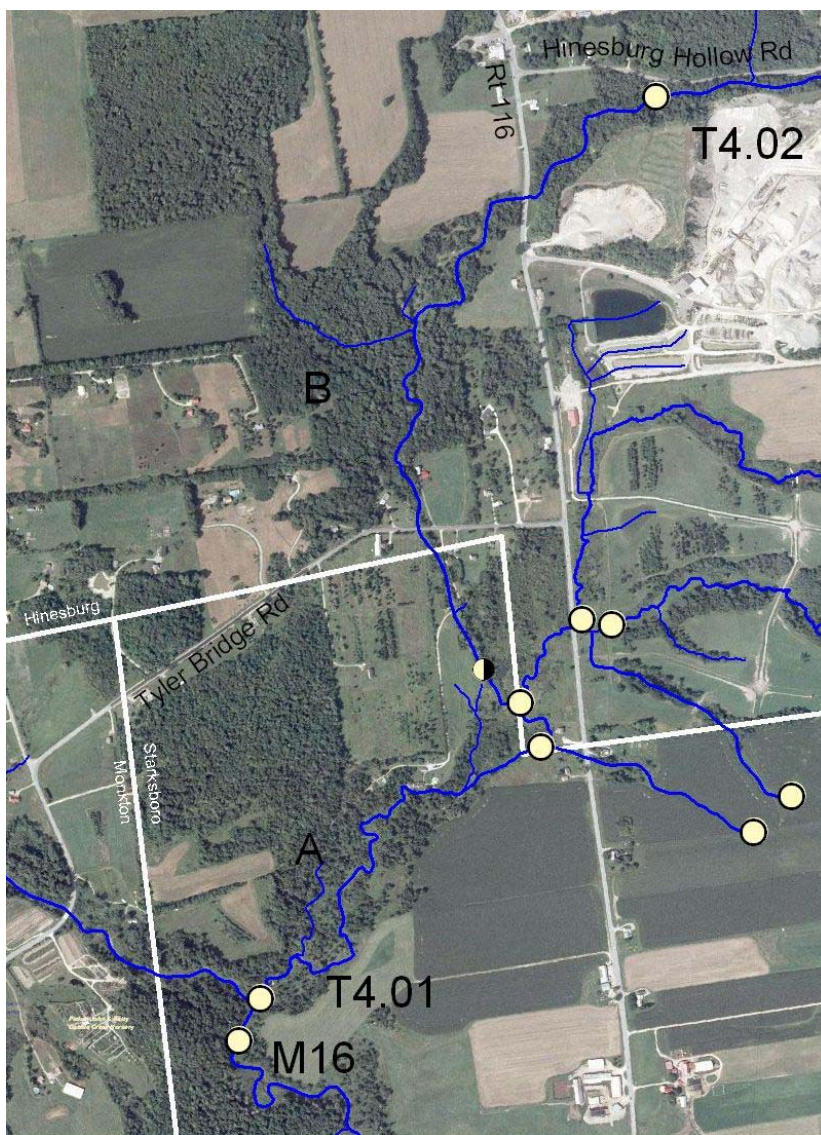
- Segment B – 5,235 ft, est. 1.2% gradient, C4-plane bed channel (reference: C4-riffle/pool);
- Segment A – 4,415 ft, est. 0.5% gradient, subreach of E4-dune/ripple reference stream type departed to a C4-dune/ripple.

Figure G-66.  
Segmentation of  
reach T4.01,  
Hollow Brook.
