INCREASING AQUATIC HABITAT KNOWLEDGE AND STEWARDSHIP IN THE LEWIS CREEK WATERSHED

Lewis Creek Watershed | Starksboro, Hinesburg, Monkton, Charlotte, and Ferrisburgh, Vermont

January 14, 2020

Completed for the Lewis Creek Association

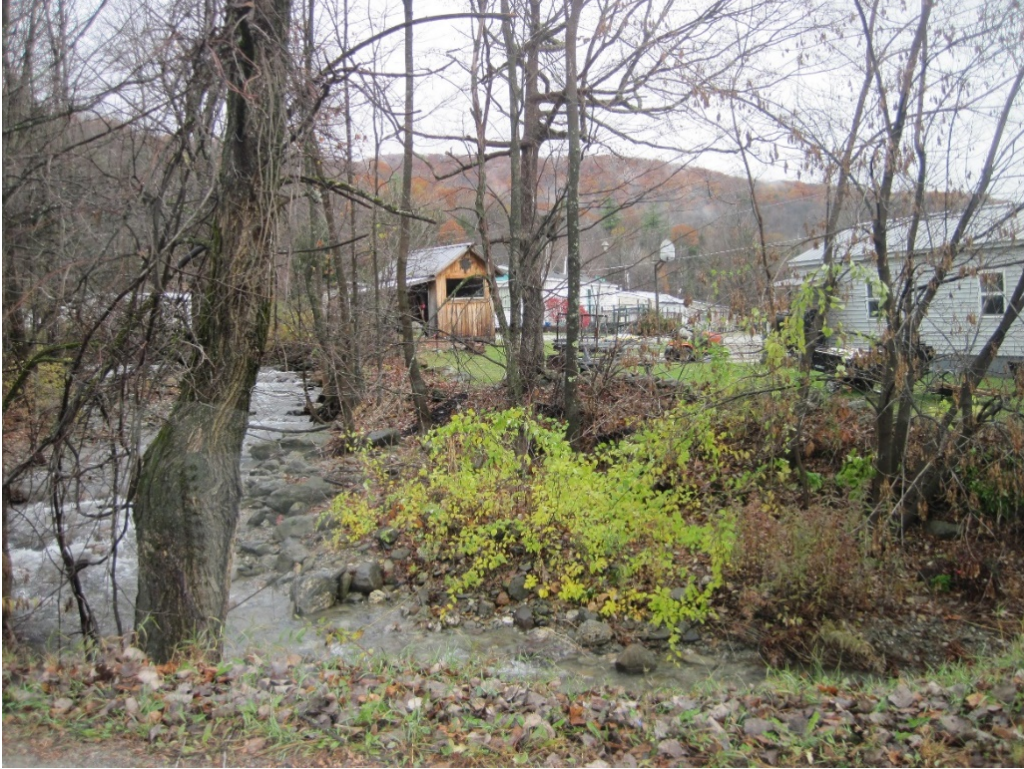
Lazy Brook Mobile Home park has encroached on the channel with development, roads, homes, and an informal rock berm on the river left (looking downstream) side of the channel. The floodplain on river right is accessible during flooding. There is no action recommended at the rock berm due to high risk to downstream homes if the berm is removed and the presence of connected floodplain on the far side of the river.

Lazy Brook Mobile Home park adjacent to Hollow Brook, looking upstream from Sugar Hollow Lane culvert.

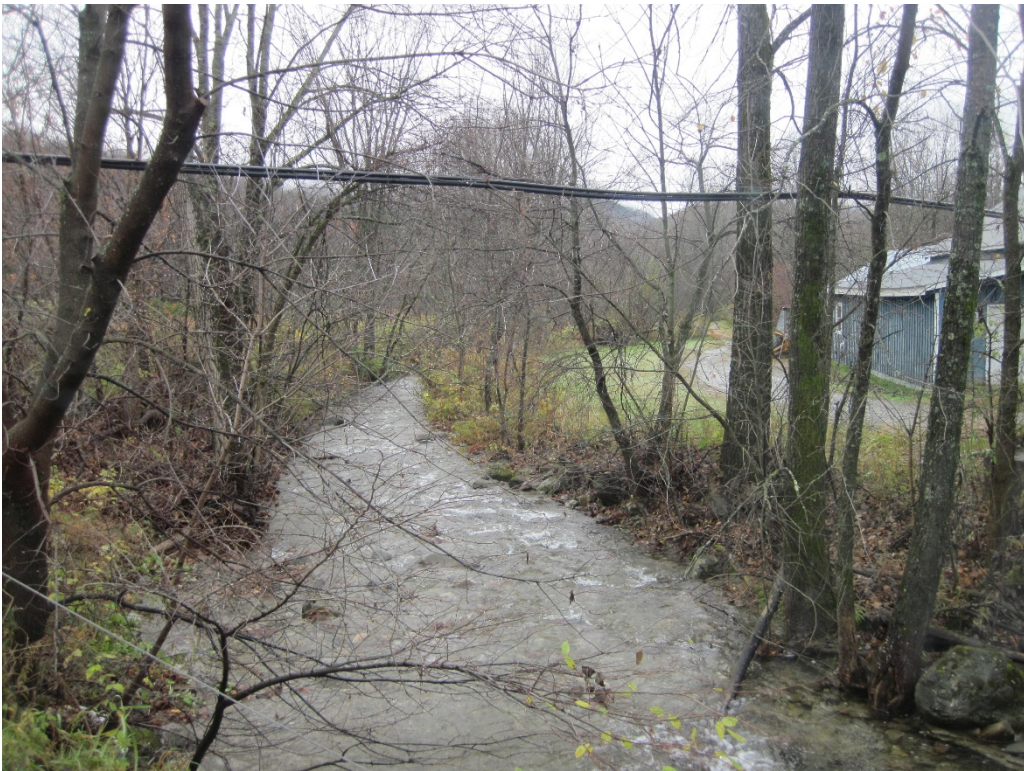
Hollow Brook has been straightened and natural riparian vegetation has been reduced due to historic and present agricultural fields downstream of Sugar Hollow Road. Adding large wood to the channel to create instream cover and planting a riparian forest over 1,800 feet to restore the shade canopy is recommended. The large wood additions will also encourage channel (re)meandering through the meadow to regain dynamic equilibrium at a stable channel slope to reduce erosion and allow the channel to naturally form and maintain instream habitat. A river corridor easement is proposed to protect this work and limit further vegetation removal and encroachments. A 50-foot minimum width forest area on both sides of the channel is recommended, but considered a minimum width as many sources recommend a 100 to 300 foot wide buffer to support all life functions of riparian species.

Straightened channel with limited riparian buffer, looking downstream from Sugar Hollow Lane culvert.

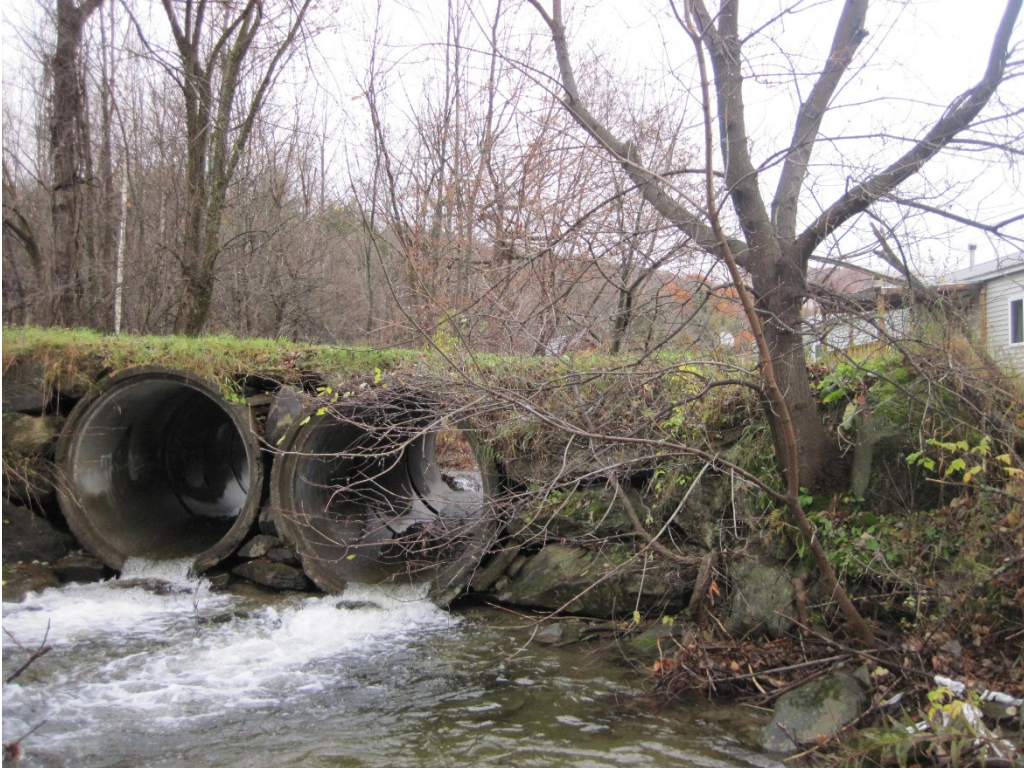
A double culvert passes under Sugar Hollow Lane that is perched, trapping sediment upstream, and blocking fish passage. The landowner reports that they regularly have to remove wood caught at the upstream side of the culvert and that the culvert has been overtopped. The landowner is interested in replacing the culvert but has not pursued the project due to the high cost and the need to access private land that runs along the right side of the stream. A home is located immediately upstream of the culvert and is at risk of flooding and erosion damage if the culvert is clogged. It is recommended that this culvert is replaced with a larger structure that matches the stream geomorphology and provides aquatic organism passage.

Sugar Hollow Lane culverts, viewed from downstream.

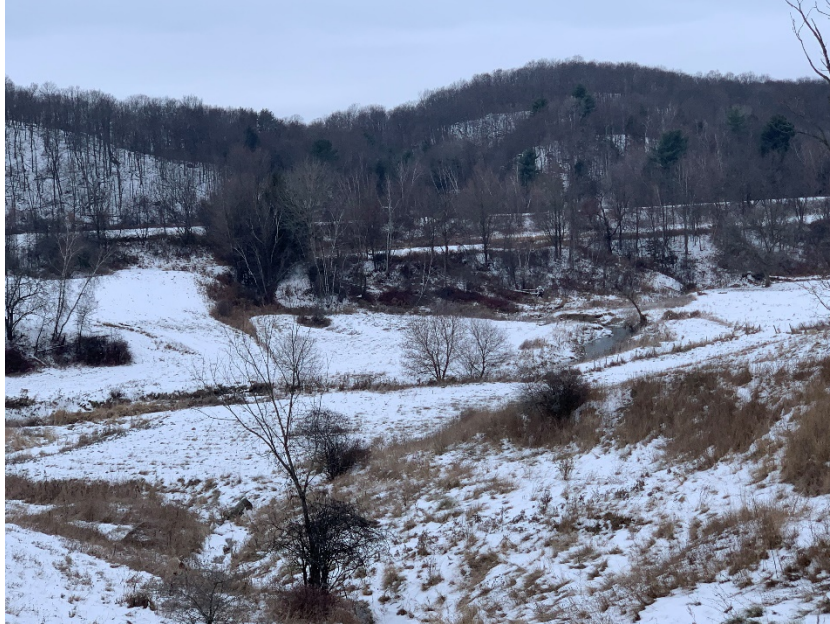
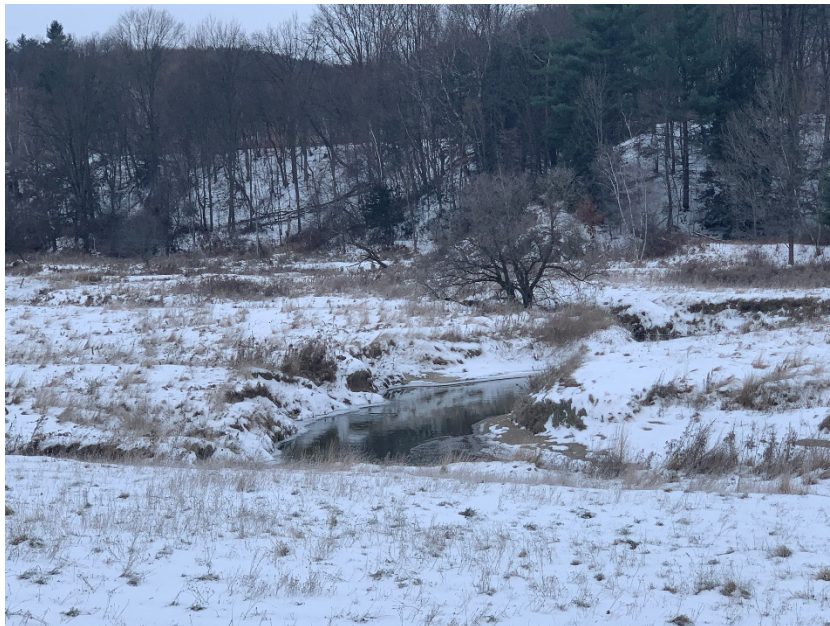
The Lewis Creek mainstem through the upper half of assessment reach M16 and all of M17A was formerly impacted by direct cow access. The banks of the stream are trampled and raw with erosion. The near bank and buffer vegetation has almost no woody vegetation and a tree canopy does not exist. Refugia are absent from the channel. Cows are no longer in the channel due to a change in farm operations that provides an opportunity for buffer restoration. The riparian area should be revegetated with native forest at least 50 feet on each side of the channel. Large wood should be added to the channel to enhance instream habitat.

Lewis Creek viewed from Route 116 looking downstream.

Lewis Creek channel viewed from Route 116.

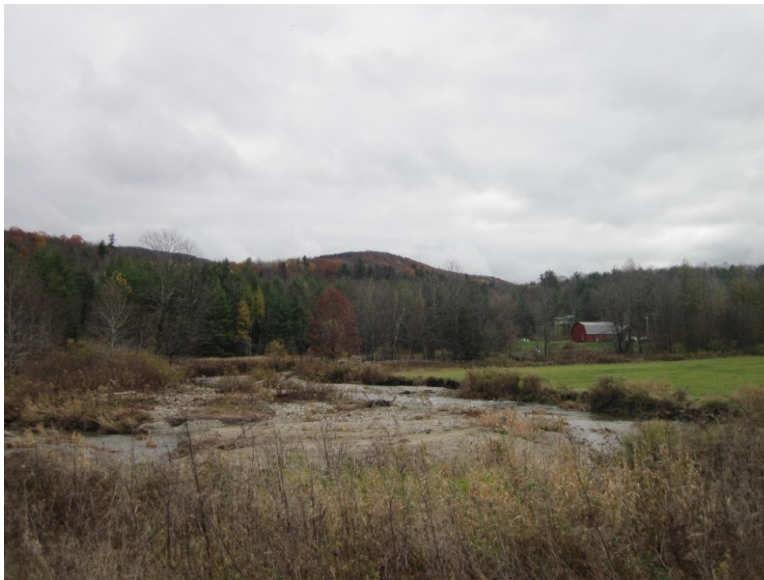
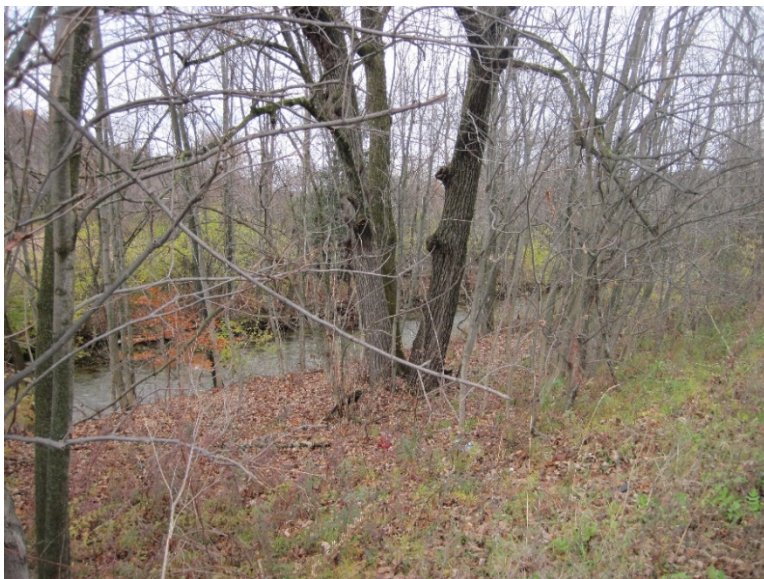
Reach M22 of Lewis Creek (beginning 500 feet upstream of Hillsboro Road, extending through the Hillsboro Road and Route 116 crossings, and extending 700 feet downstream of Route 116) is located in a broad, low-gradient valley just downstream of a steep, forested headwater reach. This area is the first major gap in the riparian vegetation moving downstream from the headwaters on the mainstem of Lewis Creek (VTANR, 2019). Limited trees and shrubs exist leading to a lack of shade canopy and limited roughness in the riparian buffer that would filter runoff. The river channel is expected to be dynamic in this area based on the break in valley slope where sediment deposition is the driving process and the river will regularly adjust its path as it carves through recent deposits. Planting a riparian forest over 2,200 feet of channel, addition of large wood to the channel downstream of Route 116 to enhance instream habitat and stabilize the channel, and a river corridor easement recommended.

Lewis Creek viewed from Route 116 looking upstream.

Lewis Creek viewed from Route 116 looking downstream.

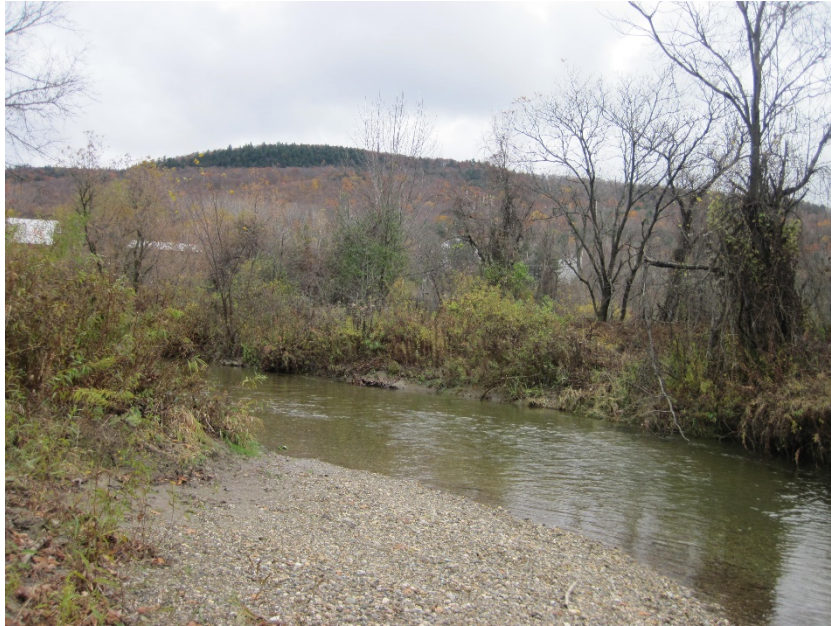
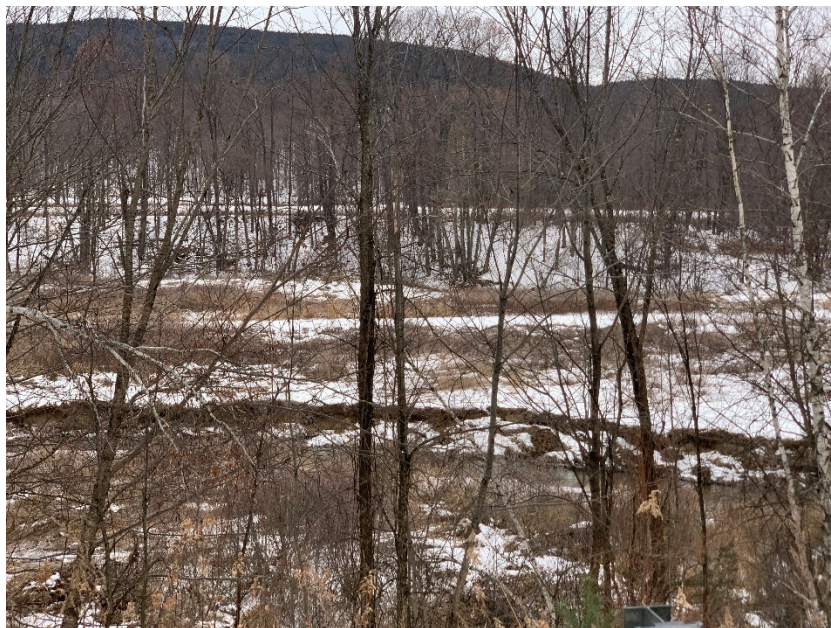
Reach M19 of the Lewis Creek mainstem channel (near the ballfields at State Prison Hollow Road) was historically cleared and has a baseball field and park in the right floodplain. The near bank vegetation has shrub vegetation with only a few trees. The lack of large trees near the channel limits both the shade canopy and large wood habitat features in the channel. Limited refugia are present without instream wood and overhanging vegetation. Planting additional shade trees over 3,000 feet of the channel is recommended. The buffer should be at least 50 feet wide on each side of the channel. Adding large wood to the channel to increase instream cover is recommended.

Lewis Creek Mainstem near State Prison Hollow Road ballfields.

Lewis Creek Mainstem upstream of State Prison Hollow Road ballfields.

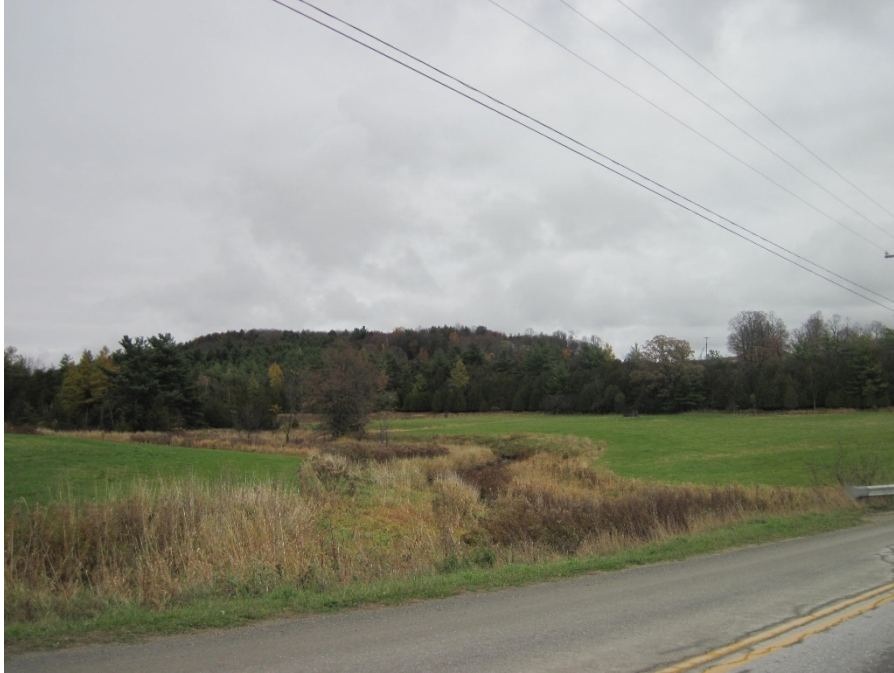
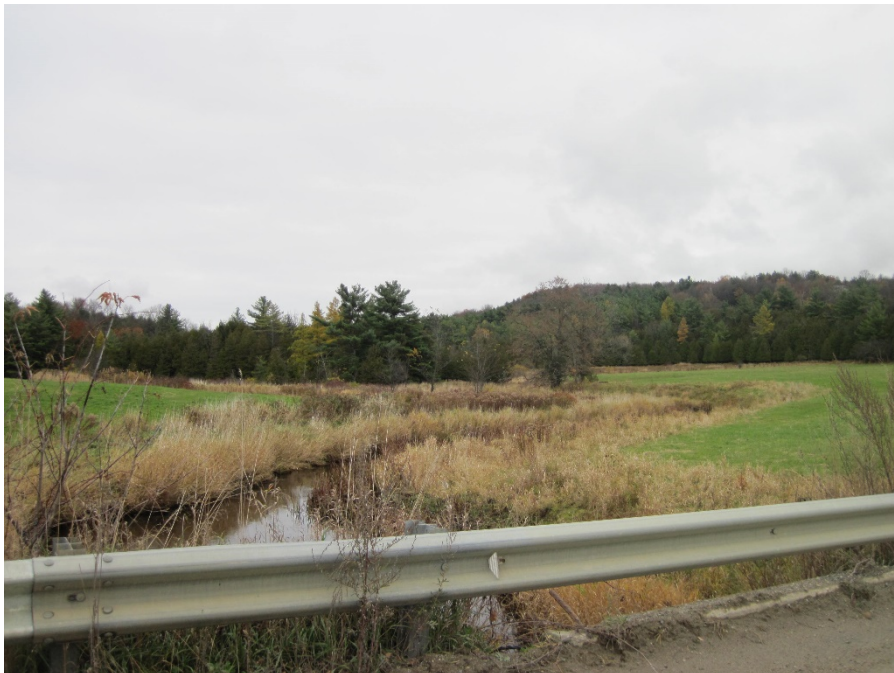
Pond Brook near State's Prison Hollow Road flows through agricultural fields and has minimal to no woody buffer. This riparian area should be revegetated over 3,000 feet to create a naturally (re)vegetated buffer that is at least 50 feet wide. Replanting the buffer with native shade trees and designating a no-mow area is recommended.

Pond Brook at State's Prison Hollow Road, looking downstream.

Pond Brook at State's Prison Hollow Road, looking upstream.

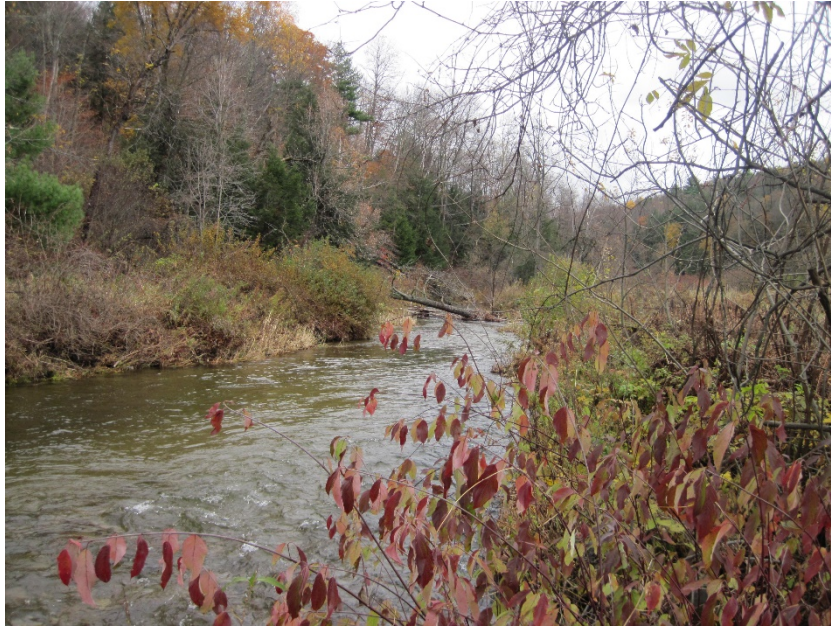
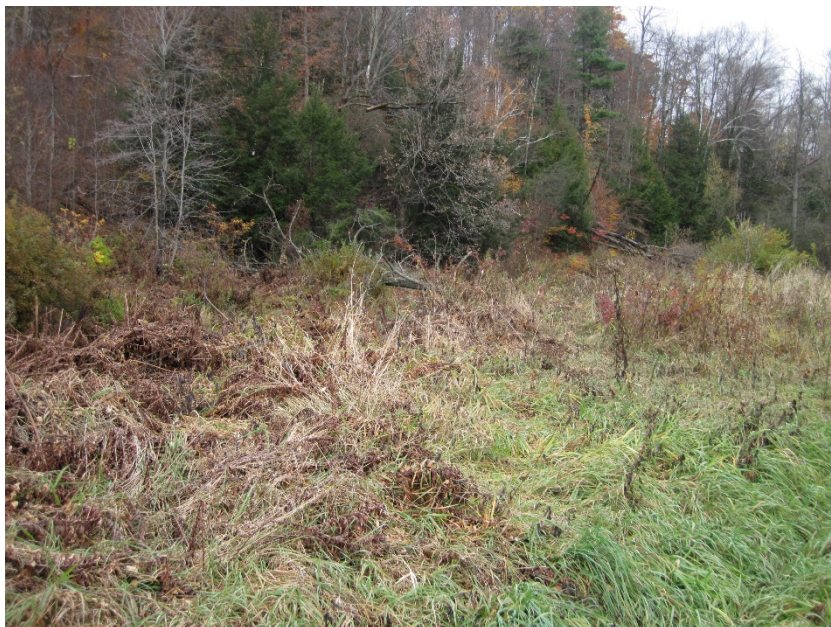
Segment M17C of the Lewis Creek mainstem (State’s Prison Hollow Extension Road) completely lacked refugia. Upstream of the road crossing the right bank riparian area is mowed lawn with a small strip of trees on the riverbank. Downstream of the road crossing the right bank riparian area is a meadow that appears to have recently been used for agriculture and is not currently being used. Replanting the buffer with native shade trees and designating a no-mow riparian area is recommended. The buffer should be at least 50 feet wide on each side of the channel.

Lewis Creek channel downstream of State’s Prison Hollow Road Extension, viewed looking downstream.

Lewis Creek right floodplain downstream of State’s Prison Hollow Road Extension.

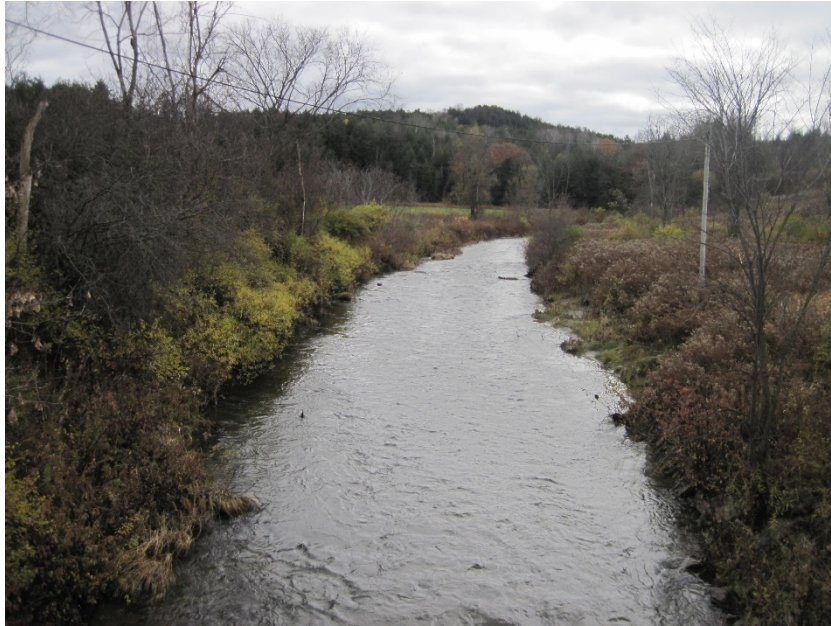
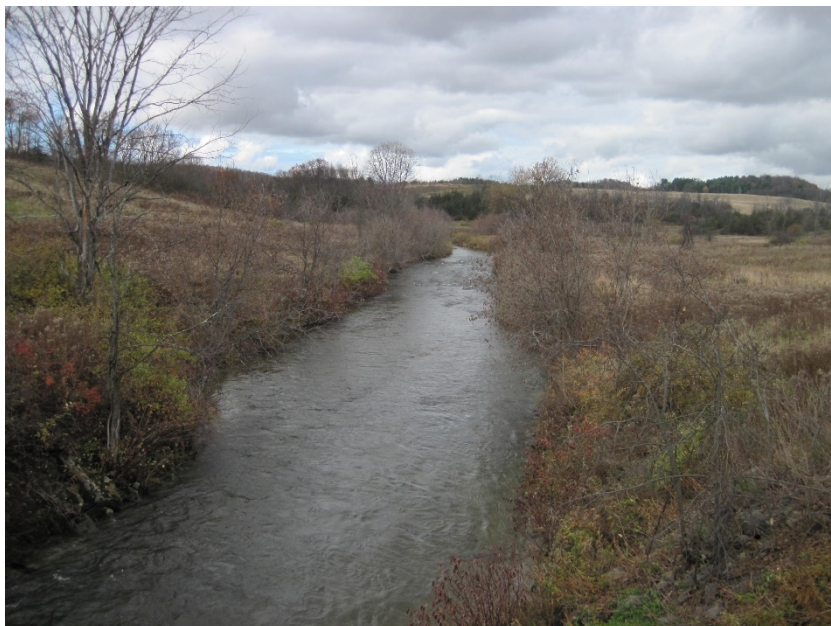
Reach M13 of Lewis Creek (Silver Street) is one of the larger riparian vegetation gaps along the mainstem Lewis Creek (VTANR, 2019). Tree canopy and shrub layers are limited both in density and width, providing little shade or filtering. This riparian area should be revegetated and the proposed buffer should be at least 50 feet wide on each side of the channel. Replanting with native shade trees and designating a no-mow riparian area is recommended. Addition of wood to the stream is recommended to enhance instream habitat.

Lewis Creek viewed from Silver Street looking upstream.

Lewis Creek viewed from Silver Street looking downstream.

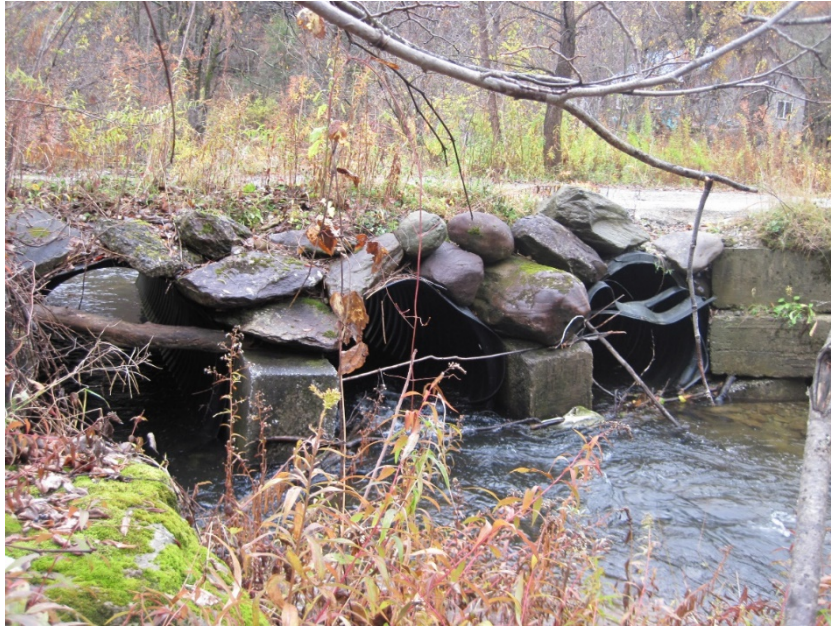
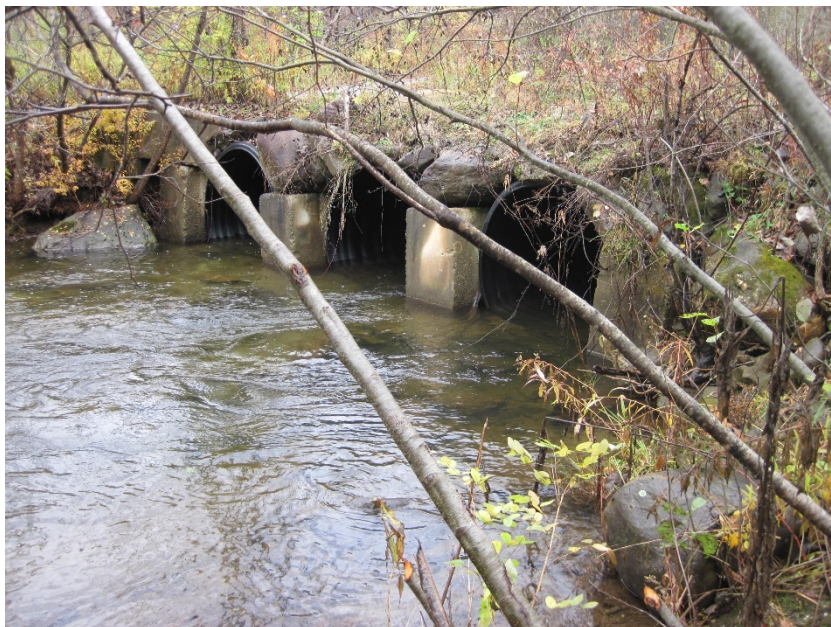
Hollow Brook flows through a triple pipe culvert that passes under a driveway that is trapping sediment and debris upstream and has created a large scour pool downstream. The culverts are not perched and do not appear to be a fish passage issue at this time. The presence of older abutments indicate that there is likely a history of erosion and driveway washouts at this location. Replacement of this crossing with a geomorphically compatible structure is recommended. The structure should be replaced following future damages and would be required to meet standards outlined in the Vermont Stream Alteration Permit.

Driveway culvert viewed from downstream.

Driveway culvert viewed from upstream.
