**Quinlan Bridge Area Alternatives Analysis
to Reduce Flood and Erosion Risks
Charlotte, Vermont**

April 2010

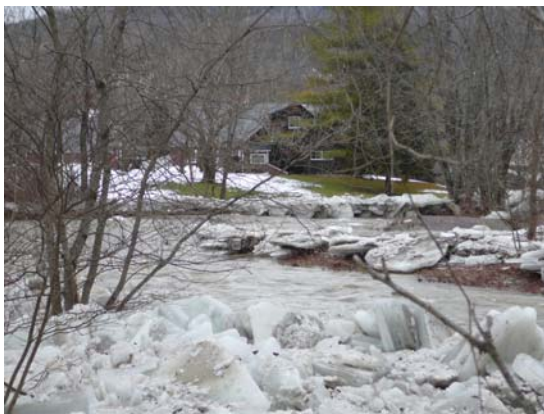
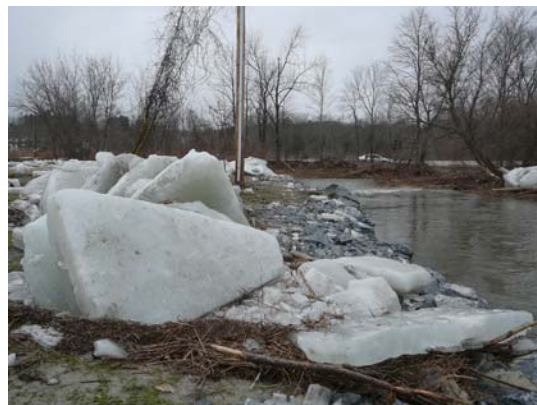
Figure 3. Ice jam flooding event, 25 January 2010. (a) approximate extent of inundation and ice shed; (b) view downstream to Morse residence as flood waters receded on 26 January 2010; (c) view downstream along south streambank at Morse property on 28 January 2010.

A moderate break-up ice jam flood occurred in the vicinity of Quinlan Bridge that peaked around 8:00 PM on 25 January 2010 (Illick, 2010). The location of the jam was approximately 100 feet upstream of the Quinlan Bridge (Morse, 2010). Inundation flooding and ice shedding impacted a wide area upstream of the bridge (see Figure 3a), including the left-bank wetland along Lewis Creek Road, backwater areas to the northeast of the bifurcated channel, and extensive areas on the Morse residential property. Water and ice filled the pull-off along Spear Street to the north of the bridge, and water had just begun to overtop Spear Street approximately 125 feet upstream of the bridge before the jam released and flood levels lowered. The flood lasted for several hours.

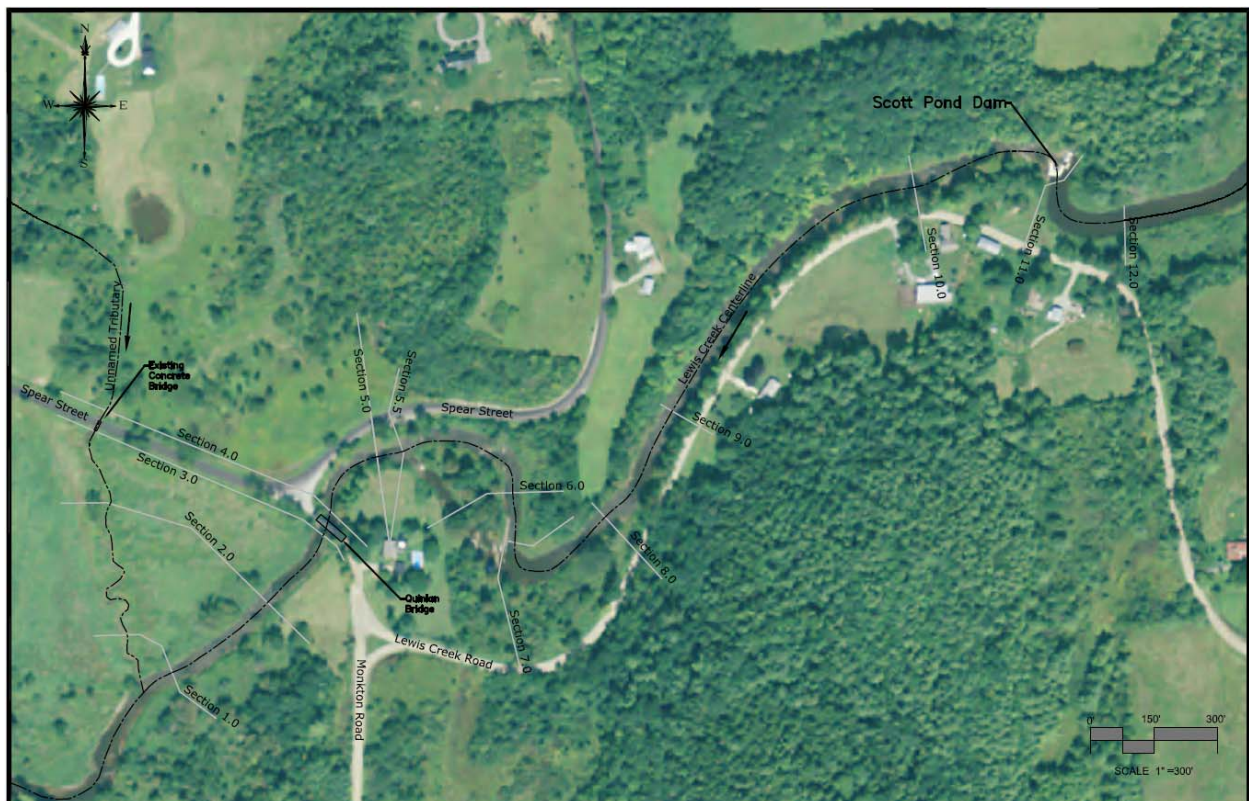
Figure 4: Cross section locations used in hydraulic modeling.

Cross sections were chosen in the field to represent major changes in channel and floodplain configuration. Contraction/expansion coefficients and friction values (i.e., Manning's N) were determined during field assessments. Roughness values for the channel ranged between 0.03 and 0.05, while floodplain roughness ranged between 0.04 to 0.08. Normal water surface elevation (i.e., the depth of flow in the channel is constant and the slope of the water surface matches the channel bottom) was used for the upstream and downstream boundary conditions.

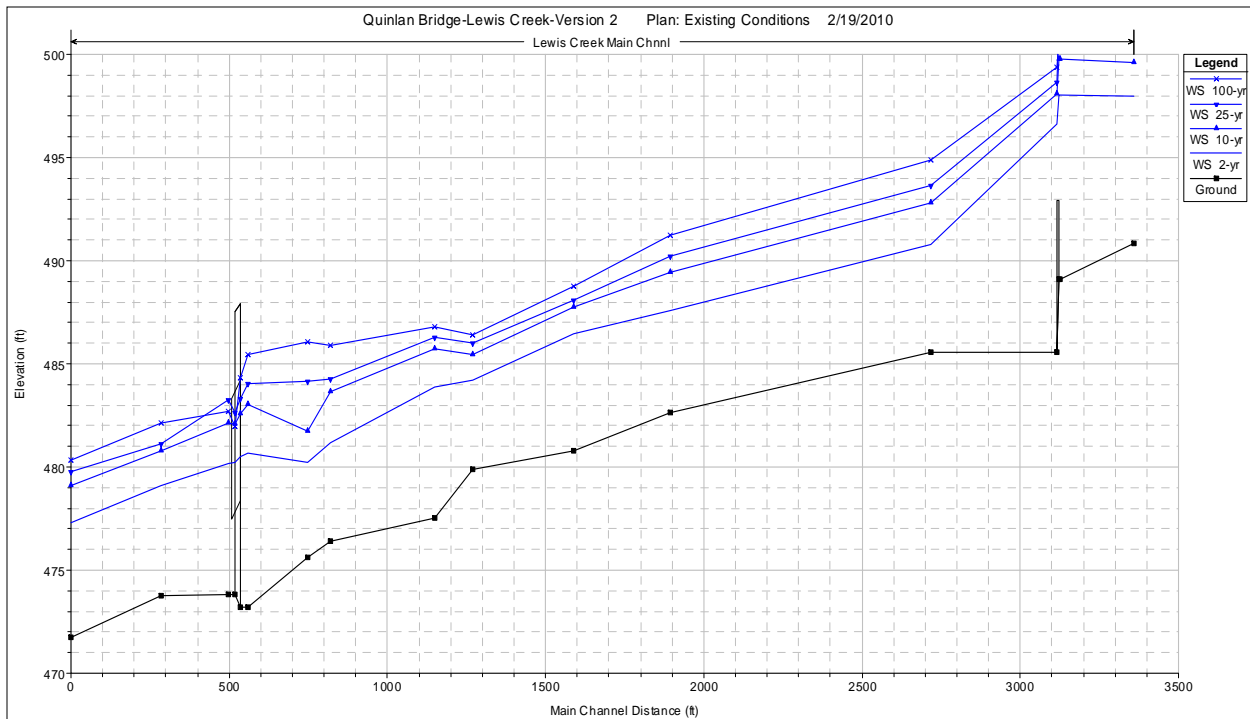
Figure 5: HEC-RAS existing conditions river profile showing the peak flood water surface elevations for the 2-, 10-, 25-, and 100-year storms.

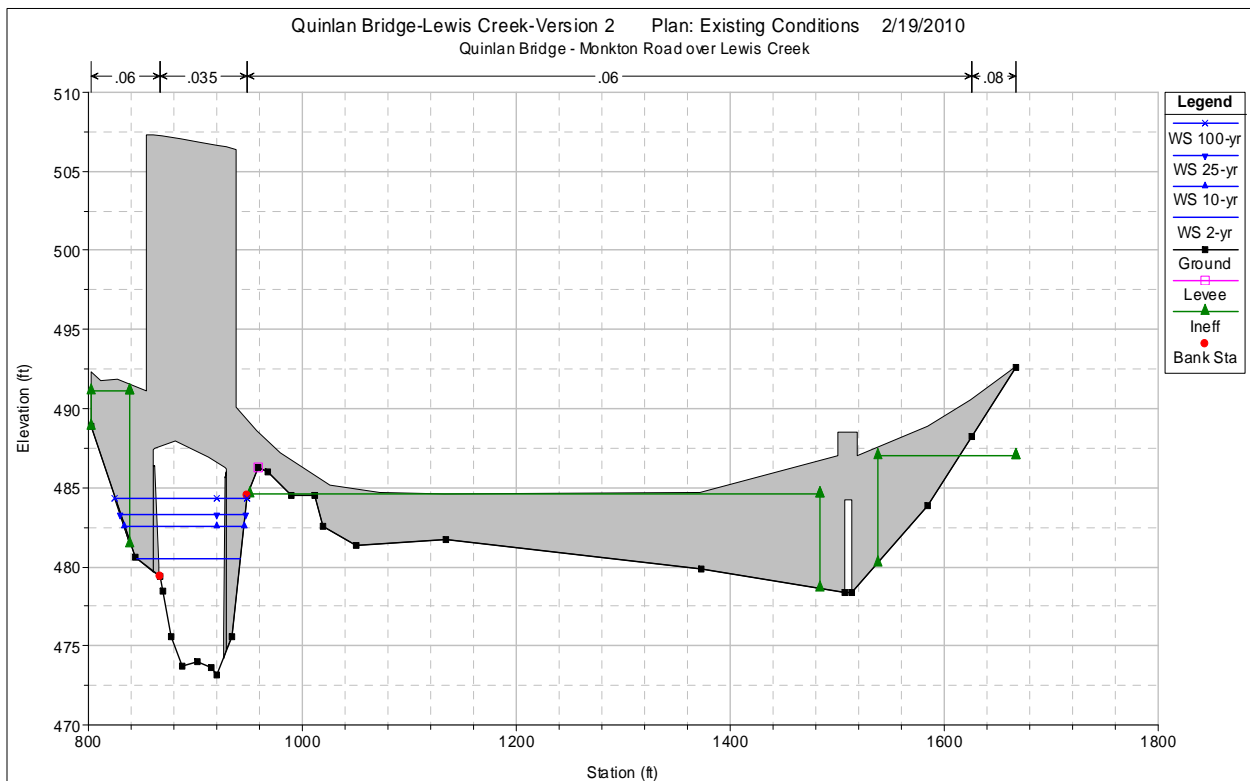
Figure 6: HEC-RAS existing conditions cross section of the upstream face of Quinlan Bridge showing water surface elevations for the 2-, 10-, 25-, and 100-year storms.

The Quinlan Bridge is relatively high above the channel, and thus has considerable flood capacity and clearance. Nevertheless, the structure does cause a rise in water surface elevation upstream of the bridge opening (i.e., backwatering) for storms larger than the 2-year flood (Figure 5). As with most crossing structures that are undersized relative to natural channel width, the downstream movement of flood water, sediment, ice, and debris is slowed at Quinlan Bridge. At the same time, contracted flows accelerate under the bridge leading to increased scour that impacts the abutments. The bridge opening width (at the 2-year flood level) is approximately 62 feet (Figure 6) while the upstream channel bankfull width is approximately 74 feet. The sloping bridge abutments lead to a low-flow channel width of approximately 50 feet that further reduces the capacity of the opening.

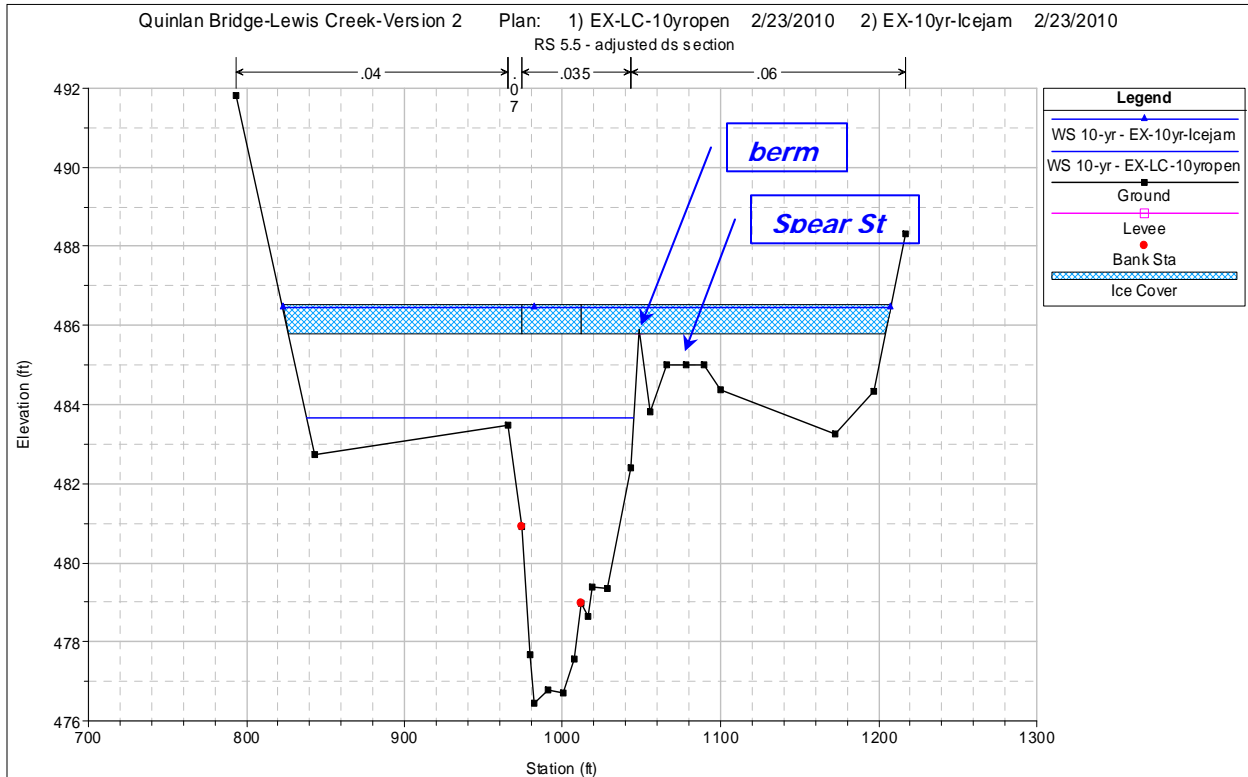
Figure 9: HEC-RAS existing conditions cross section upstream of Quinlan Bridge showing water surface elevations for the 10-year non-ice and ice jam floods. Note the small berm and Spear Street embankment on the right bank isolating the floodplain except during large floods.

Channel cross sections upstream of Quinlan Bridge where ice jamming typically occurs contains a small berm and the Spear Street embankment that blocks flood water from accessing the lower floodplain on the opposite side of Spear Street (Figure 9). When compared to other upstream cross sections, there is less flood flow area available in this cross section due to the encroachments.

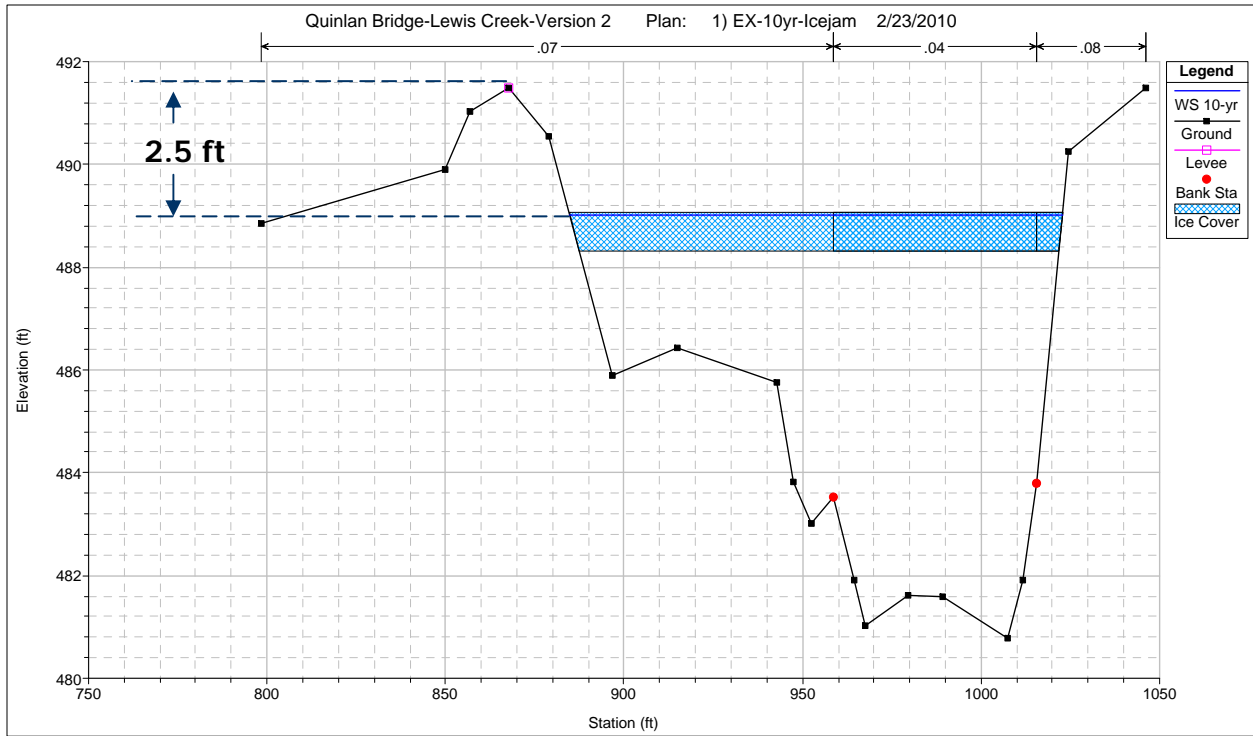
Figure 11: HEC-RAS existing conditions cross section upstream of Quinlan Bridge confirming a 2.5-foot rise from the 25 January 2010 ice jam flood to the top of Lewis Creek Road.

Once these changes were made, additional observations upstream were used to validate the model. High water marks indicate that water and ice crested within 2.5 feet of Lewis Creek Road approximately 1,300 feet upstream of Quinlan Bridge (at river station 9.0). This flood elevation is confirmed in the model (Figure 11) indicating that the model is accurately representing existing conditions upstream of the bridge. The model also matches another field observation 1,050 feet upstream from Quinlan Bridge where the both the field observation and model show a peak flood level 4 feet below Lewis Creek Road (Figure 12).

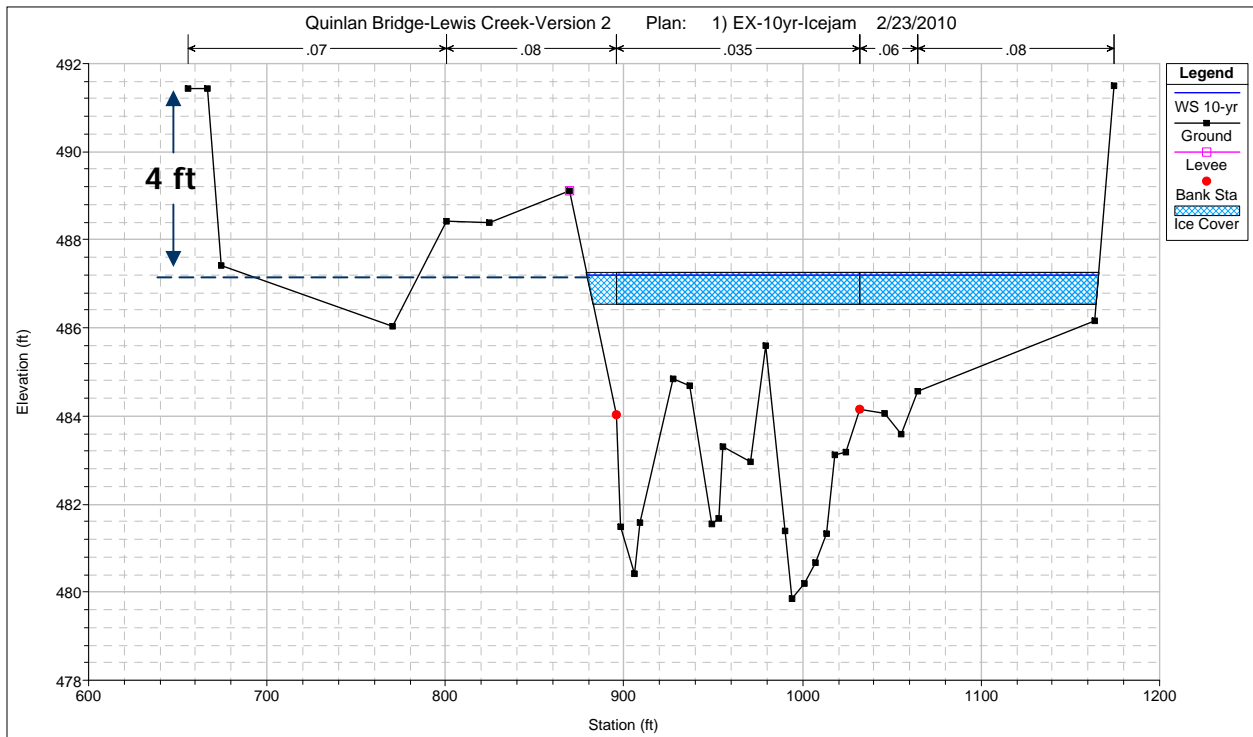
Figure 12: HEC-RAS existing conditions cross section upstream of Quinlan Bridge confirming a 4-foot rise from the 25 January 2010 ice jam flood to the top of Lewis Creek Road.

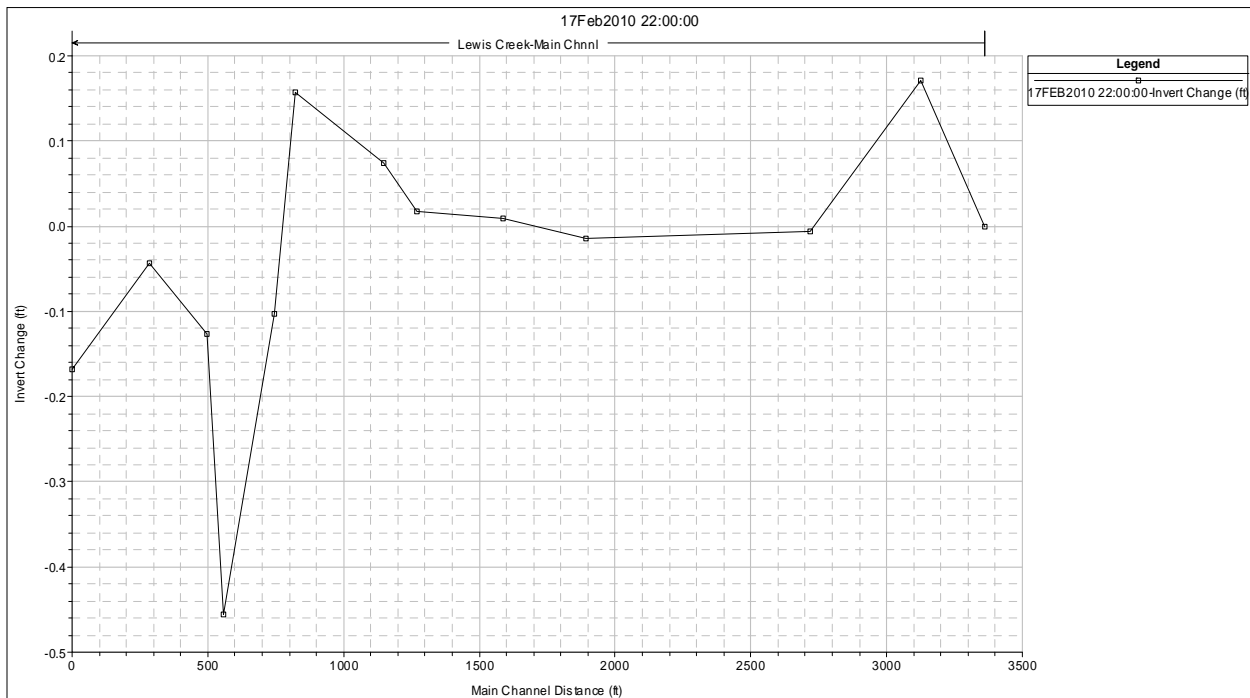
Figure 13: HEC-RAS existing conditions river profile showing the change in channel bed elevation following a modeled bankfull flood.

Sediment transport modeling indicates that sediment aggradation is taking place upstream of the Quinlan Bridge at modest rates, with the highest amount of deposition located on the meander bend where ice jamming is most common (river distance = 822 feet) (Figure 13). The accumulated sediments may be increasing the ice build up and jamming in this location. At the bridge (river distance = 534 feet), modest down-cutting (i.e., incision) is taking place. This is evident at the bridge due to the undermining of the right abutment. As is often the case, the disruption of natural sediment transport is increasing flood and erosion risks in the vicinity of Quinlan Bridge. Channel confinement is the typical cause of the pattern of upstream deposition and local scour at bridges and culverts. The sediment deposition spike located at the upstream end of the model near Scott Pond Dam (river distance = 3,116 feet) is likely an artifact of not having sediment data in the impoundment and thus is an artificial feature due to boundary conditions.

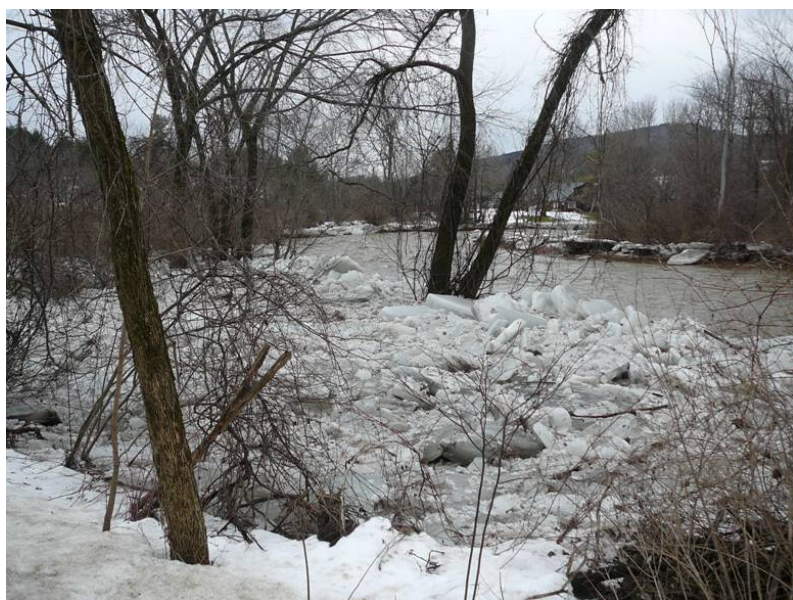
Figure 16. Despite a degree of channel incision, the left-bank wetland along Lewis Creek Road was accessed by flood waters and ice during the 25 January 2010 ice jam event; view downstream.

The 25 January 2010 ice jam flood event illustrated that the river presently does access the subject wetland during higher flows, and ice accumulates in the wetland following ice jam flooding (Figure 16).

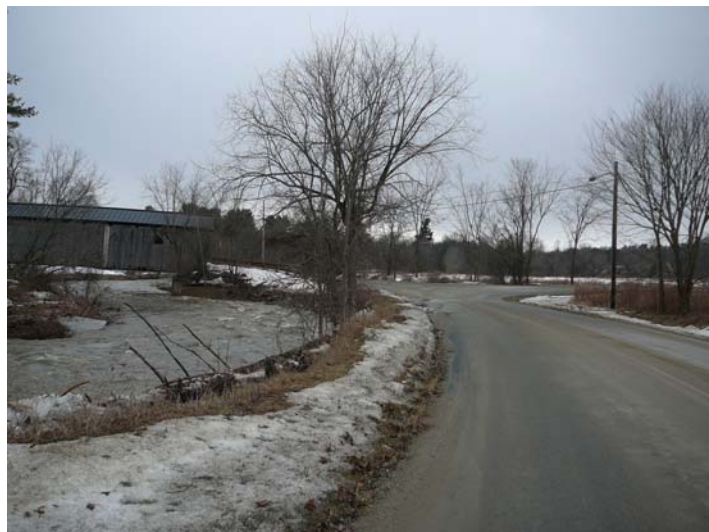
Figure 18. Berm along Spear Street upstream of Quinlan Bridge.

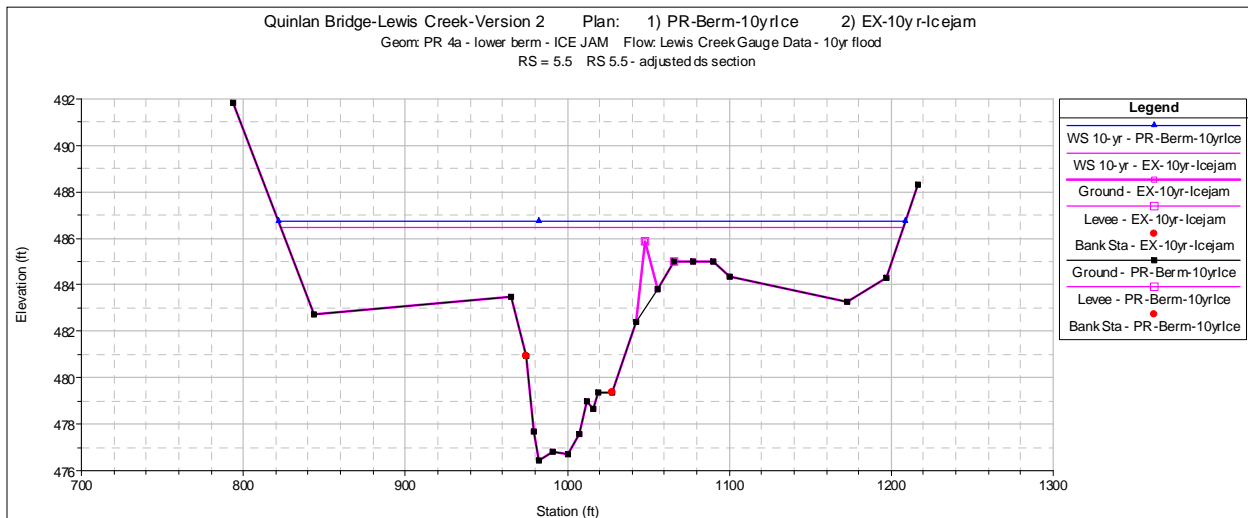
Figure 21: HEC-RAS cross section showing the existing and proposed 10-year ice jam flood for the berm lowering alternative. Note that ice cover is not shown to simplify viewing.

The cross section view of this alternative illustrates the lowered berm and small increase to flood levels on Spear Street during ice jam flooding (Figure 21).

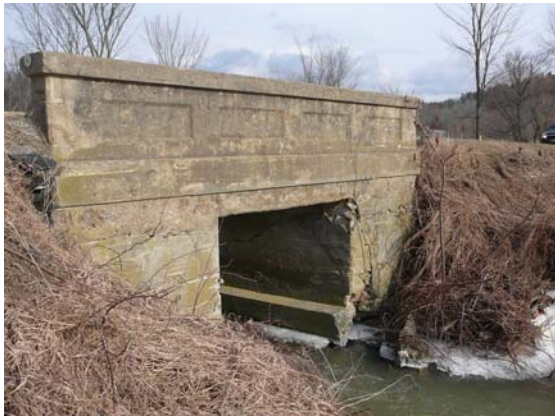
Figure 22. Concrete three-sided bridge, Spear Street crossing of unnamed tributary approximately 600 feet west of Quinlan Bridge; view of culvert outlet.

A small unnamed tributary with upstream drainage area just over 1 square mile joins the Lewis Creek along the right bank 500 feet downstream of Quinlan Bridge. This unnamed tributary passes under Spear Street to the west of Quinlan Bridge through a three-sided concrete bridge (Figure 22). Wetlands to the north and west of Spear Street discharge to this unnamed tributary upstream of the Spear Street crossing. During flooding when Lewis Creek overtops Spear Street and accesses the floodplain to the north and west, a portion of the floodwaters drain to this unnamed tributary. Replacing this structure with a wider and taller structure would improve drainage from the floodplain lowering flood elevation and velocity in vicinity of the Quinlan Bridge. This structure is deteriorated with cracked concrete and a sagging ceiling. The bridge will need to be replaced for structural reasons.

The preliminary cost opinion to replace the three-sided bridge is \$80,000 including engineering, permitting, materials, and construction labor. This high-cost alternative is not justified based solely on project objectives, given the minimal benefits. However, the bridge needs replacement as it approaches the end of its engineering life span. Federal and state grants exist to improve structures for fish passage, and initial conversations by Lewis Creek Association about this alternative have interested agency personnel to explore restoration potential. The possibility of a structure replacement to increase safety and improve fish passage exists.

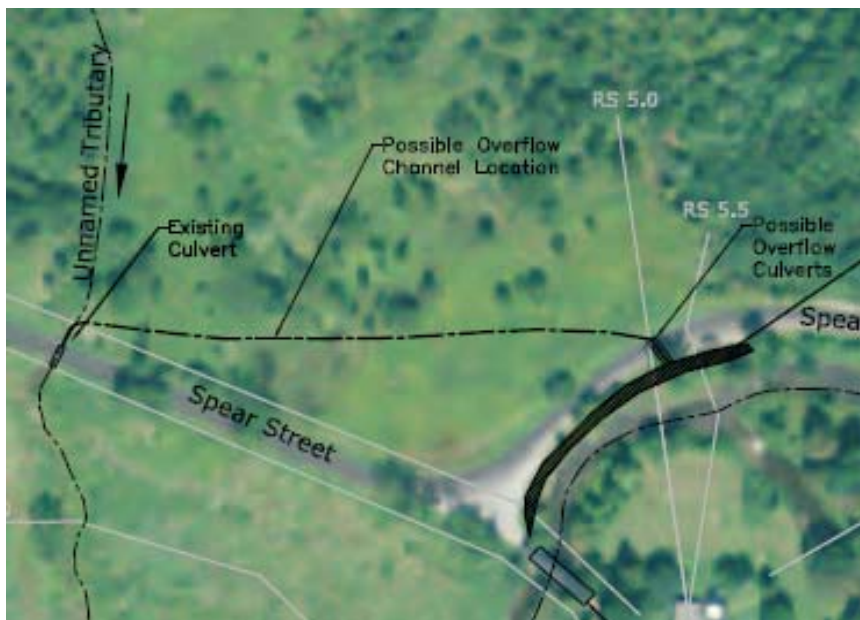
Figure 23. *Alternative schematic of cross culverts under Spear Street.*

The use of culverts to convey flood water from Lewis Creek under Spear Street to the historic floodplain to the northwest was evaluated (Figure 23). Culverts would transfer flood water, now contained in Lewis Creek, onto the floodplain reducing the volume passing through the bridge. This alternative would not improve shedding of ice that is the primary mechanism of flooding because culvert size is limited by the small elevation change between the Spear Street road surface and the adjoining floodplain. To maintain the necessary 1.5 to 2 feet of cover over the culverts and enough structure height to carry large volumes of flood waters, deep ditches would have to be dug on the floodplain edge (Figure 24). A portion of the wetland would have to be excavated to get the water from the culverts to the three-sided bridge for conveyance downstream. The depth of required depth of excavation would limit natural floodplain functions such as storing water and slowing velocity. Concentrating flood flows in a constructed ditch may transfer erosion now occurring on Lewis Creek banks to the ditch edge and reconnected floodplain. This alternative would have a high environmental risk and be difficult to permit. Cross culverts have a very limited cross sectional flow area relative to a reconnected floodplain and would thus have limited function during large floods. Ice would likely clog the culverts during high flow events.

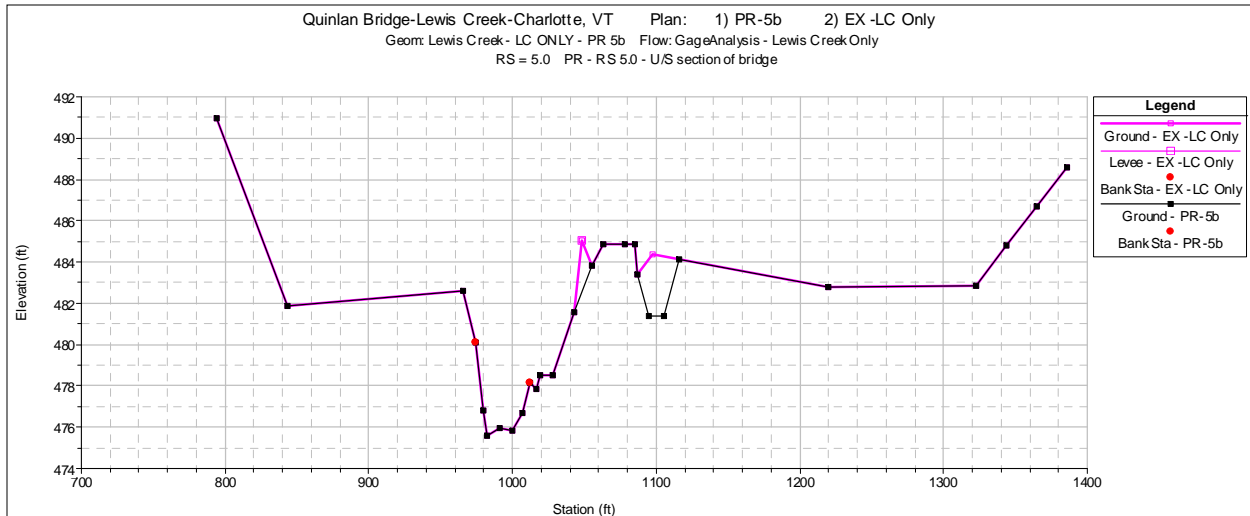
Figure 24. HEC-RAS cross section showing required ditching (pink) to get flood waters from Lewis Creek to the historic floodplain under Spear Street.

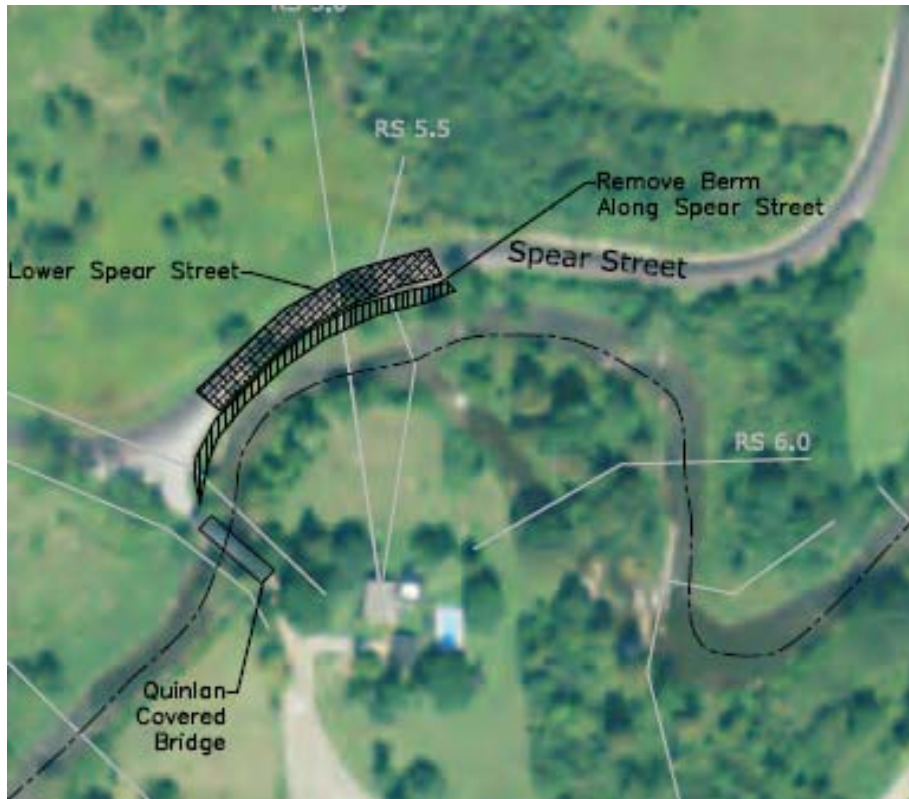
Figure 25. Alternative schematic of lowering berm and Spear Street to the north of Quinlan Bridge.

Lowering Spear Street to the north of Quinlan Bridge, including the existing berm (Figure 25), lowers flood levels upstream of Quinlan Bridge (Figure 26) and reduces flood velocities at the bridge.

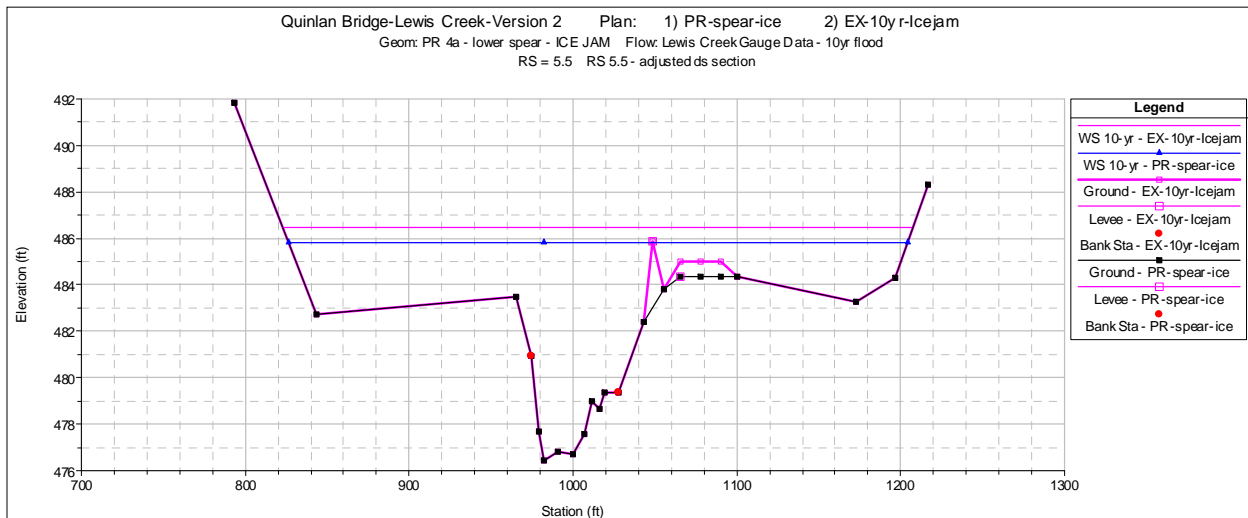
Figure 27. HEC-RAS cross section showing removed berm and lowered road embankment (pink) to get flood waters from Lewis Creek to the historic floodplain under Spear Street.

Lowering the road embankment increases the flood and ice flows out of the banks of the river (Figure 27) reducing the hydraulic force on the river and bridge.

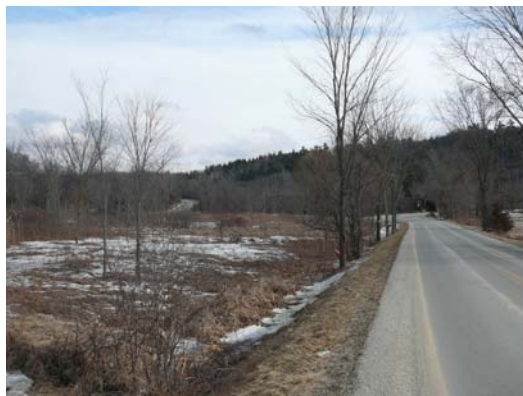
Figure 28. Spear Street west of Quinlan Bridge; view to the east toward the bridge site.

The Spear Street segment to the west of Quinlan Bridge is also elevated above the floodplain due to the buildup of asphalt during road resurfacing without milling (Figure 28). Lowering this road segment by 1.5 feet is also a potential mitigation action to be implemented in combination with or after lowering of the north Spear Street segment (Figure 29). Flood flows could access the wetland and then drain back to Lewis Creek more rapidly across the west portion of Spear Street.

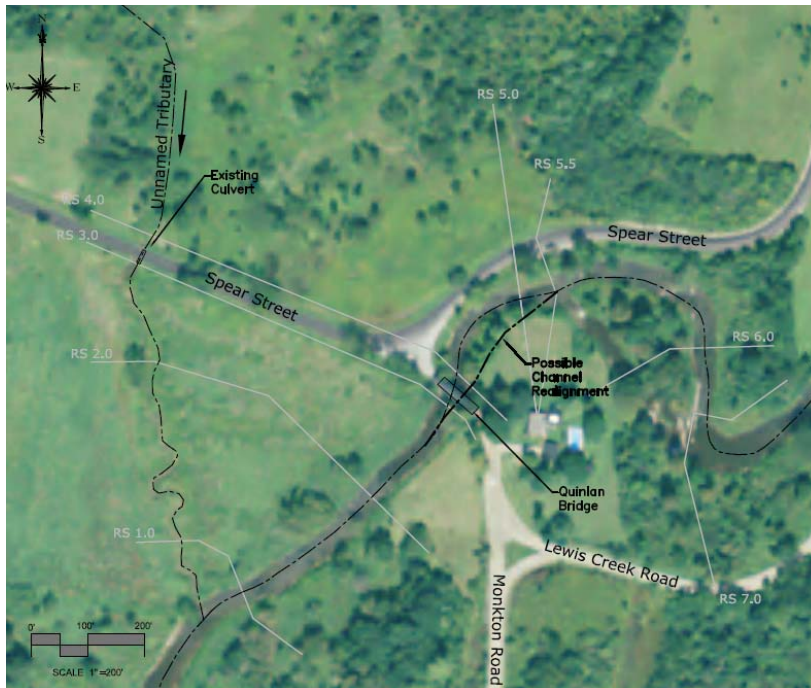
Figure 31: Alternative schematic of channel realignment upstream of Quinlan Bridge.

This type of channel modification introduces additional risk of erosion hazards by moving the river farther from its equilibrium path. During flood events the river would likely re-meander to attempt to achieve its equilibrium slope and reconnect to historic floodplains.

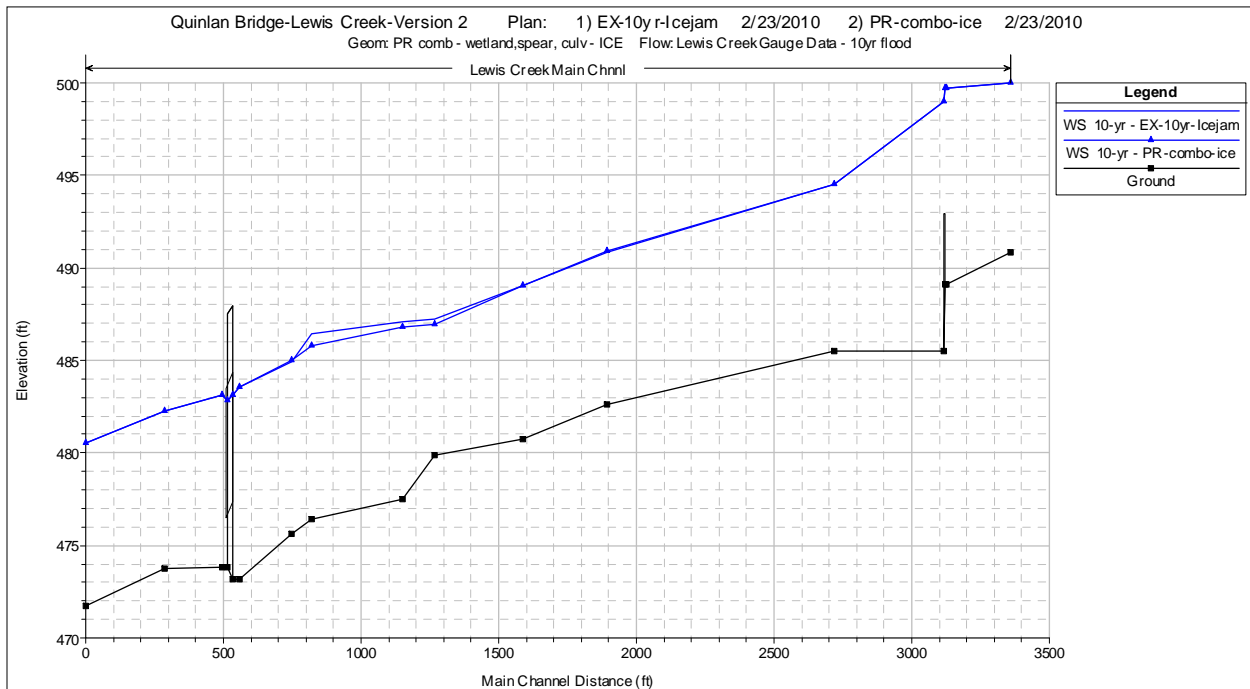
Figure 33: HEC-RAS river profile showing the existing and proposed 10-year ice jam flood for the four preferred alternatives combined. Note that ice cover is not shown to simplify viewing.
