Enhancing Flood Resiliency of Vermont State Lands

30 June 2015 FINAL DRAFT

Vermont Forests, Parks & Recreation
Montpelier, Vermont

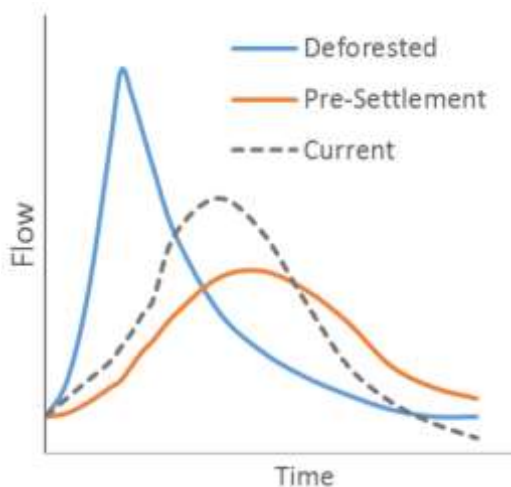
Figure 1. Conceptual diagram of the effects of legacy impacts on watershed hydrology.

Deforestation and upland development changed the water and sediment routing on previously-forested lands, making these lands more connected to receiving stream channels. Removal of vegetation reduced the amount of water intercepted, evaporated and transpired by plants. Infiltrative capacity of the soils was reduced through compaction of the soils during harvesting. Where road networks intersected the stream network, road-side ditches (and the roads themselves) have effectively served as an extension of the stream network (Wemple *et al.*, 1996; King & Tennyson, 1984). The increased density of flowing channels on the land surface led to increased peak flows and velocities, and substantial turbidity in receiving waters. Thus, more water was available for runoff, leading to a shift from gentler pre-settlement flows to flashier, more intense runoff events (“deforested” line in Figure 1).

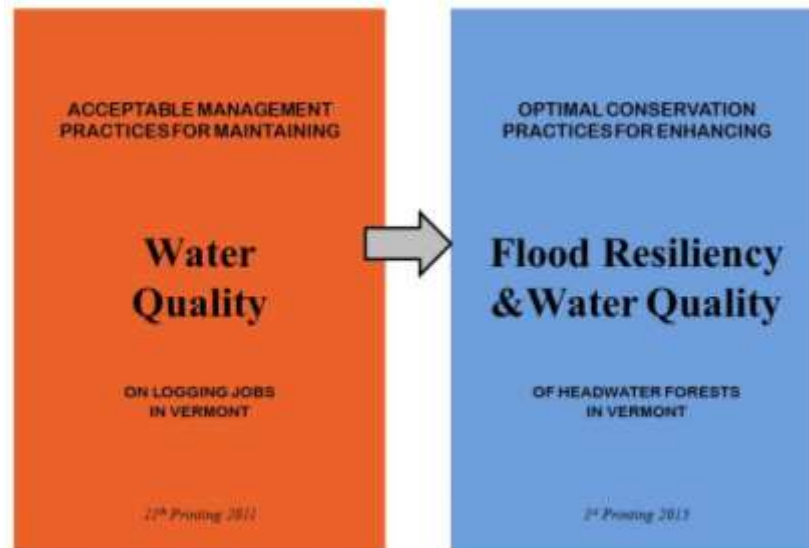
Figure 11. Recommended Optimal Conservation Practices

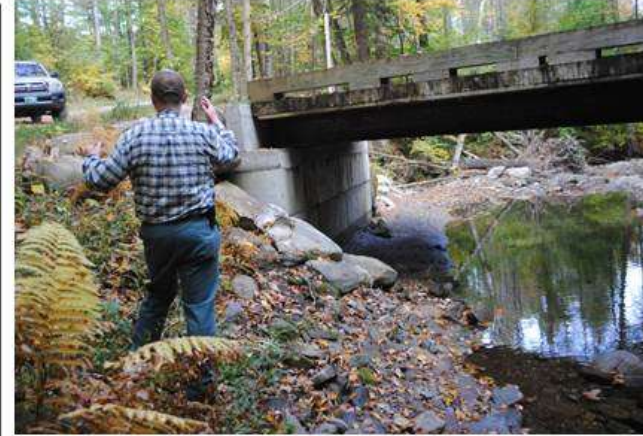
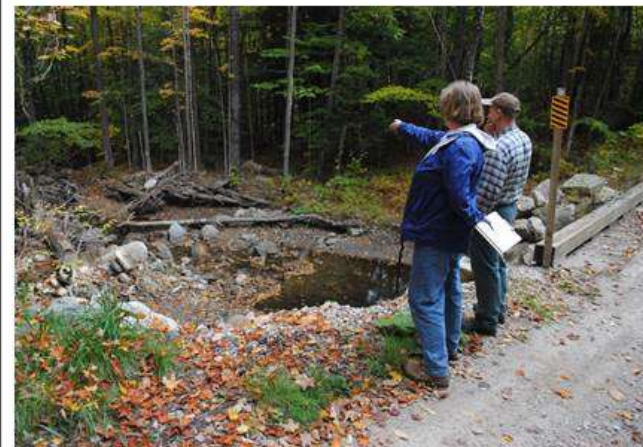
Abutment replaced after TS Irene

Opportunity to Disconnect Road Ditch

Figure 17. Example of Opportunity to Disconnect Road Ditch Runoff from Curtis Hollow Brook, Calvin Coolidge SF – East, Woodstock. Ditch network receives stormwater from ditches along Curtis Hollow Road. Opportunity for town collaboration and possible Better Backroads grant – a possible demonstration and training site.

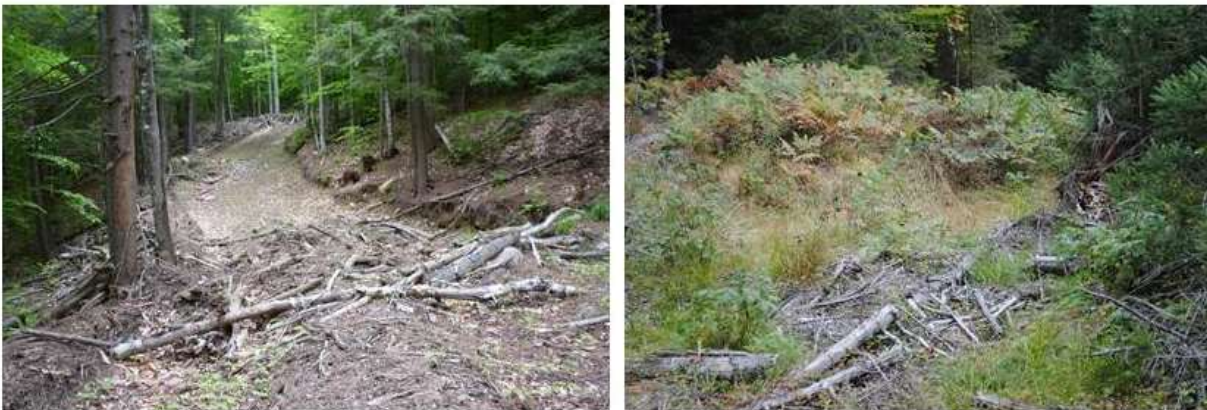
Skid Path, Camp Plymouth State Park

Forwarding Path, Coolidge East

Forwarders should be used and incentivized where possible on State Lands. In general, they result in less soil compaction and less disturbance than skidders (Figure 20). As a consequence, forwarders are useful in a greater variety of weather conditions and require narrower and fewer access roads.

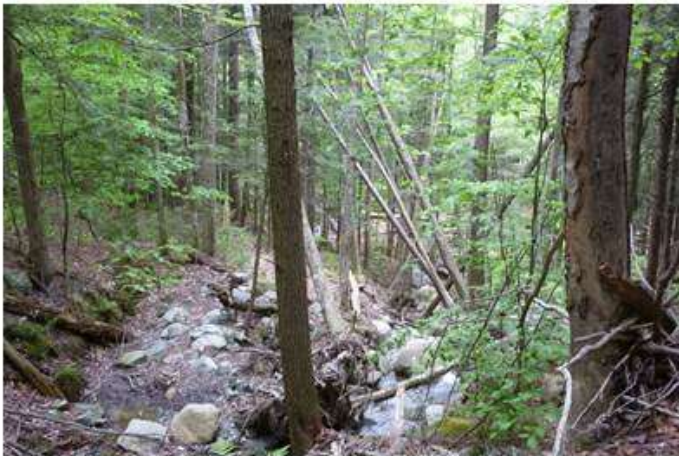
7. Incision and widening of stream channel observed downslope from C2 forest road crossing.

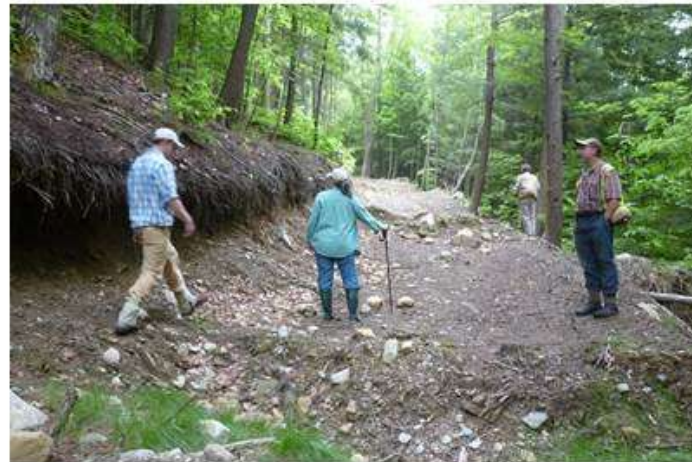
8. Forest road installed across >35% slopes, to access patch cuts. Steepness of hillsides and use of skidders necessitated wide road cuts. Steepness of road grade (>10%) required frequent water bars.

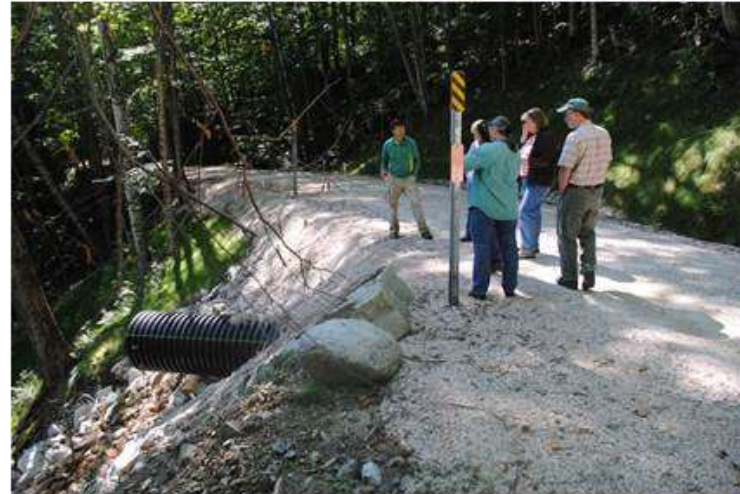
2. View downhill, same culvert site as photo 1.

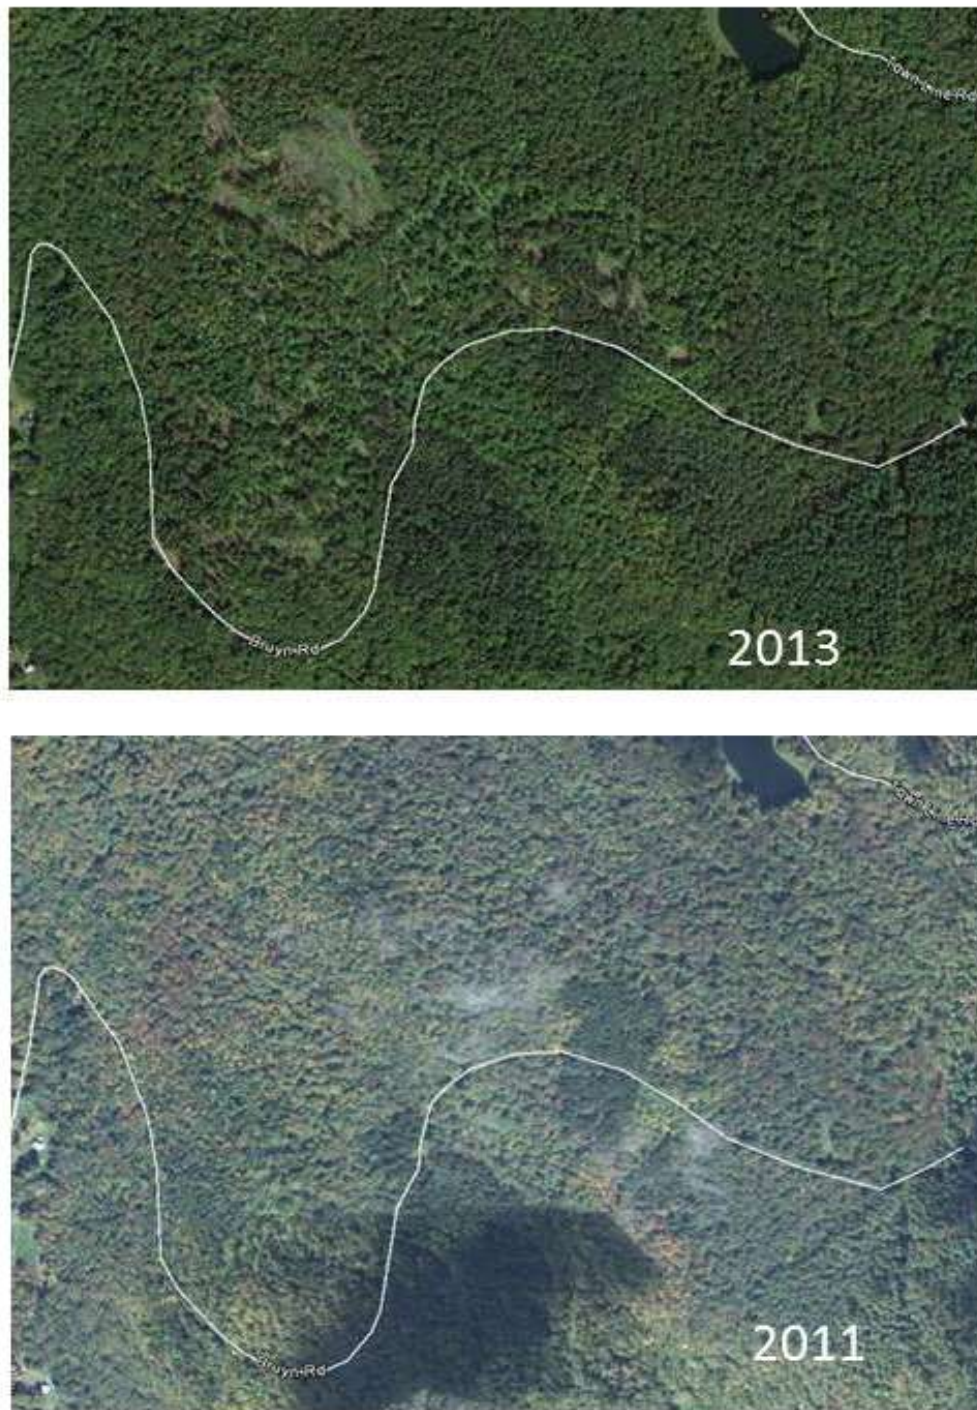
Figure 8. Patch cuts implemented using forwarders in 2011 – 2012 at Quarry Road site.
