Saving our Watershed

Hi, I am Kate Kelly from Lewis Creek Association and LCA's South Chittenden River Watch volunteer water quality monitoring program. I want to talk to you about how we can take better charge of our lake's future by using a watershed approach. We have been learning about our water quality over the years, and want to share this information with you, and invite you to network with us as we work to better achieve an ALL IN approach. We invite you to join LCA, where we can best coordinate and decide how to encourage more action and engagement at all levels of our communities.

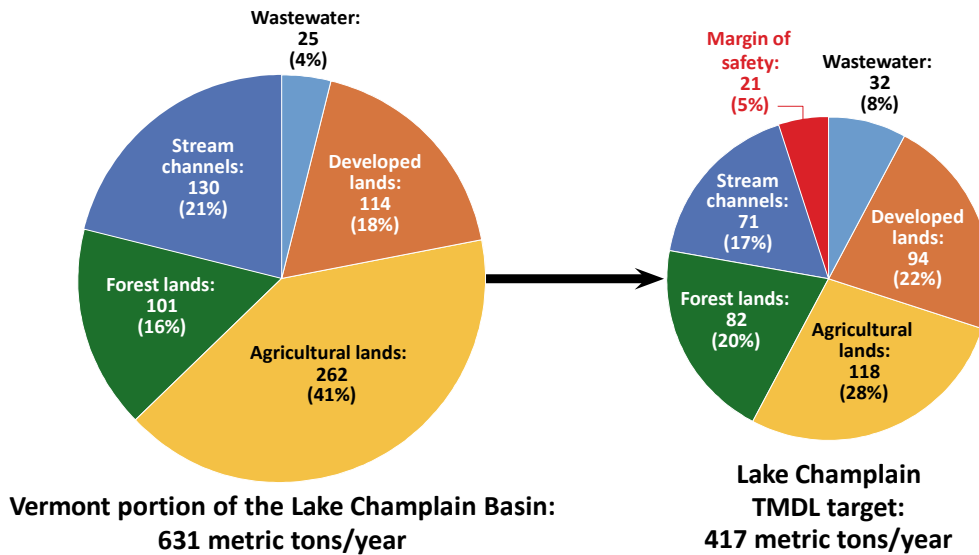
Where the phosphorus comes from

Vermont contributes 631 metric tons of phosphorus to the lake per year. Agriculture and development contribute the most to phosphorus loading. Developed land contributes 18% of the phosphorus load, and agriculture contributes 41% of the phosphorus load. In order to meet our phosphorus reduction targets to improve lake water quality, we need to reduce phosphorus by about 30%, with the largest and most cost effective reductions coming from agriculture.

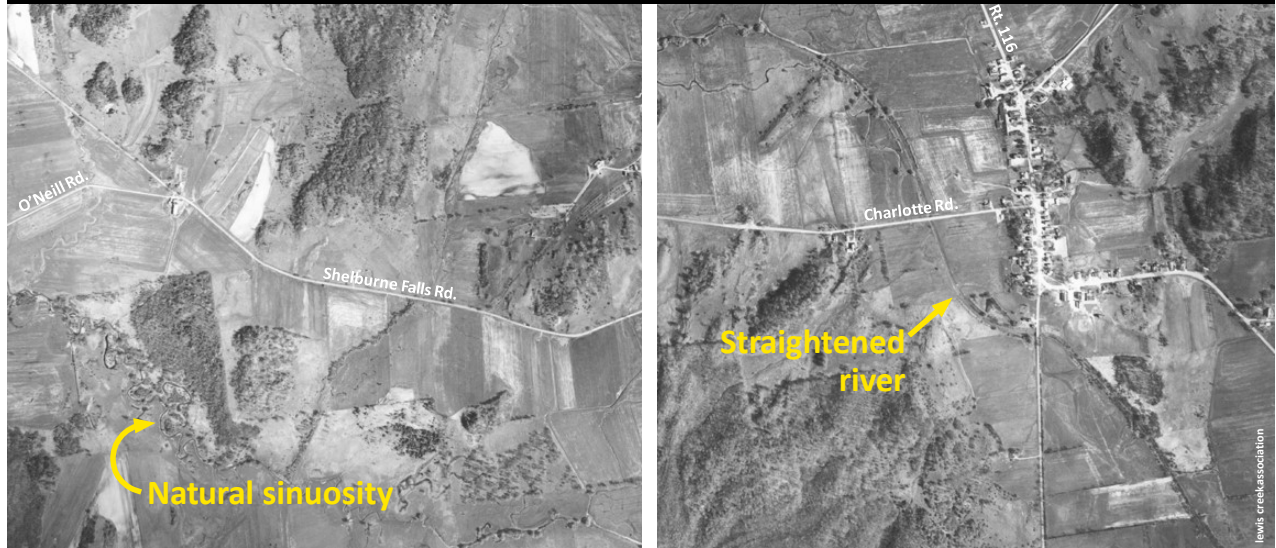
Past management of streams contributes to erosion and flooding today

Straightening rivers and armoring banks was done mistakenly to “save” farm fields and back yards. It caused water to flow faster, which led to more flooding downstream, more carrying of sediments, and more damage to property because of the force of flood waters. In this slide, on the left you can see a naturally sinuous stretch of the LaPlatte River in Hinesburg, near O’Neil Road and Shelburne Falls Road. On the right, you see a straightened stretch of the LaPlatte, near Silver St. and Charlotte Rd. in Hinesburg. Of the reaches that have been assessed in the LaPlatte watershed (66 miles), 14 miles were mapped as straightened (~21% of assessed sites).

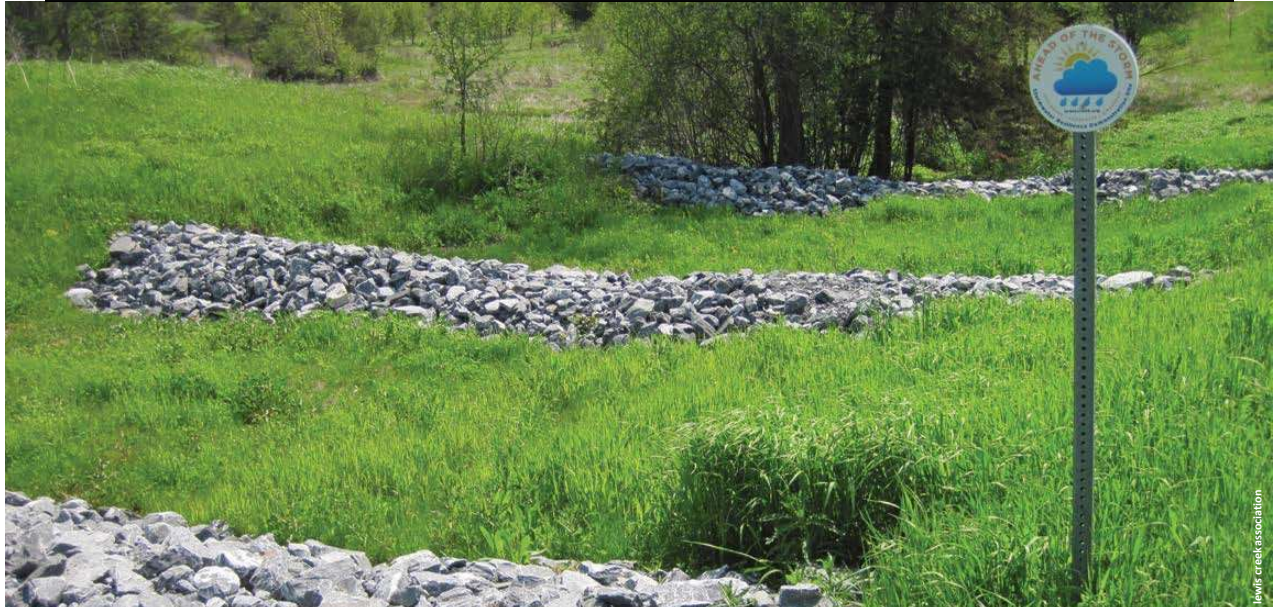
Slow it

This site, E. Thompson's Point Road in Charlotte, is a roadside swale designed with these rock check dams to slow water down before it drains into Thorp Brook.

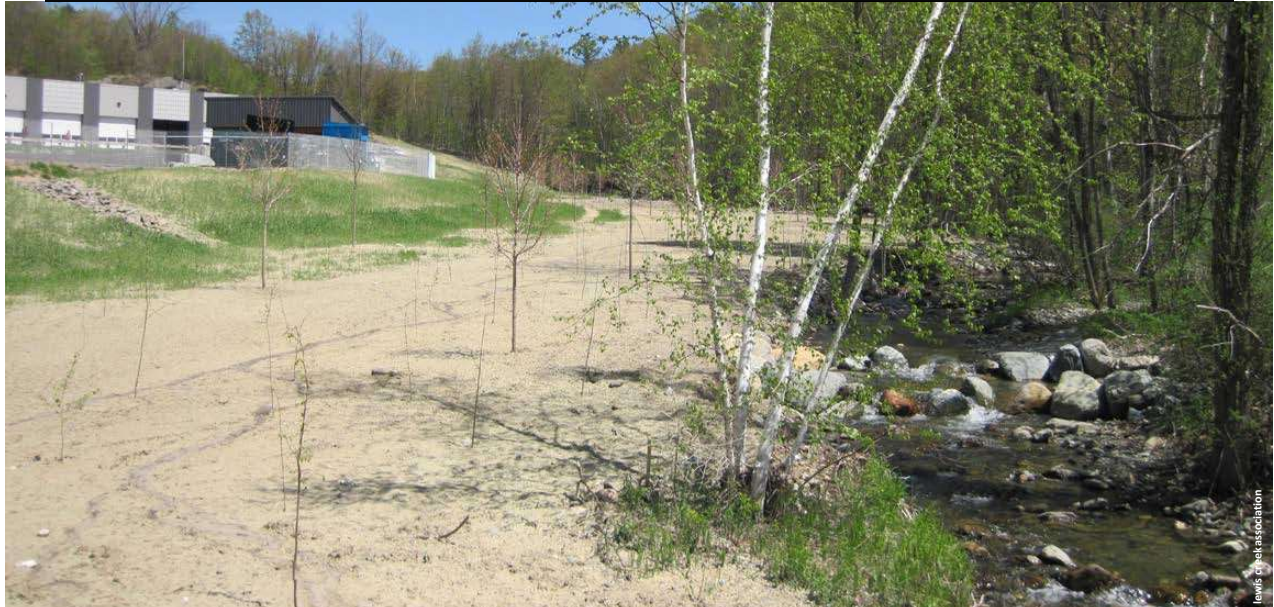
Spread it

At this site, the Hinesburg Town Garage, buildings and a berm next to Beecher Brook were removed, to make space for the stream to spread out onto what was originally its natural floodplain, but had been filled in over time. In addition, rocks and logs were added to the brook to raise its level, to allow it to spread out onto its new floodplain, thereby dropping sediment held in the water before it gets washed down the brook to the LaPlatte River and Lake Champlain.

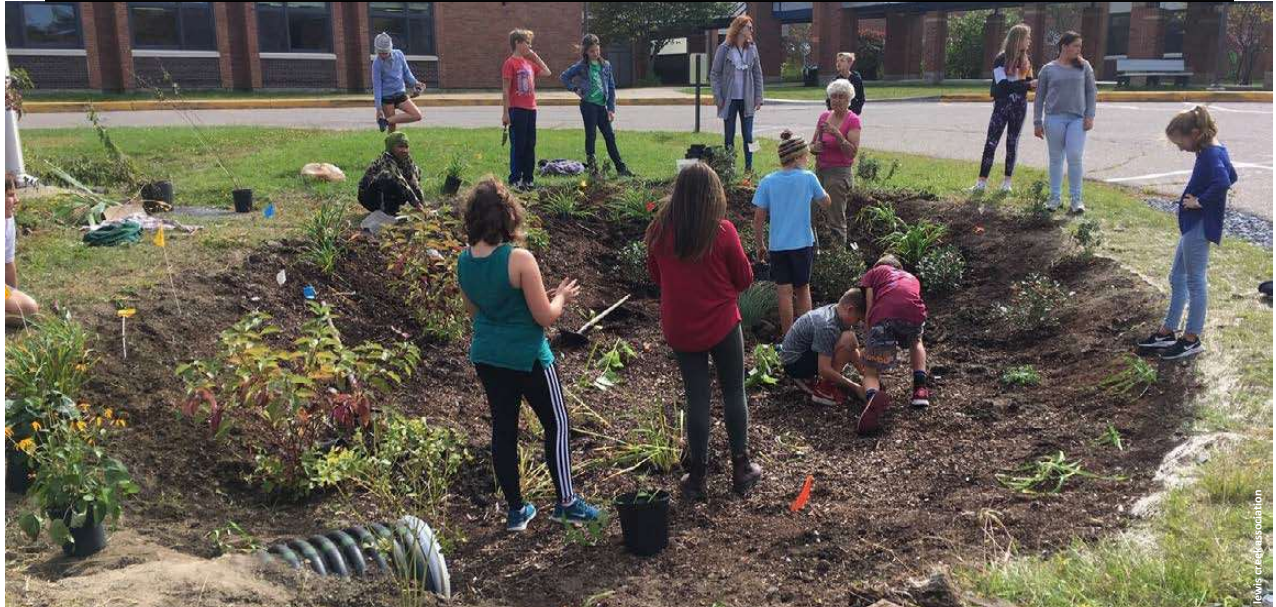
Sink it

At Shelburne Community School, this project transformed the area in the middle of the school bus circle from a grassy lawn with storm grates (where water went directly from the parking lot into McCabe's Brook) into a rain garden, which allows the water to sink into the ground, getting cleaned up by the plants in the rain garden before being sent on to the brook and lake.

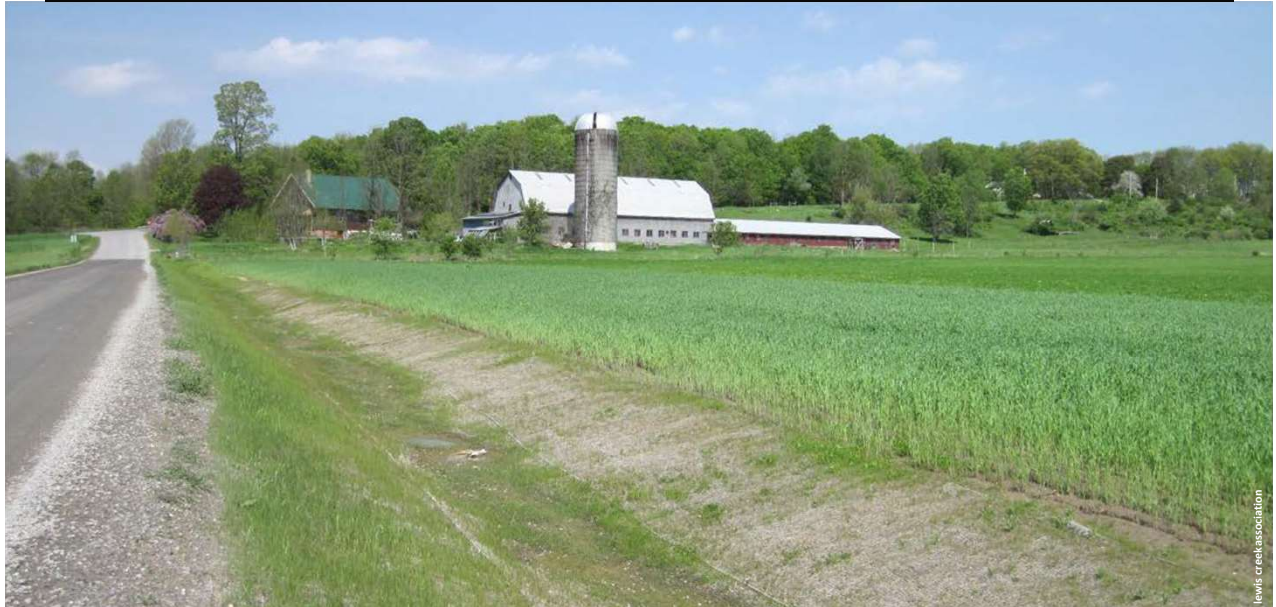
Upgrade roads for larger storms

With larger predicted storms due to climate change, we need to go above and beyond the Municipal Roads General Permit. This roadside swale in Charlotte (East Thompson's Point Rd.) was designed to carry water from a 100-year storm in the swale.

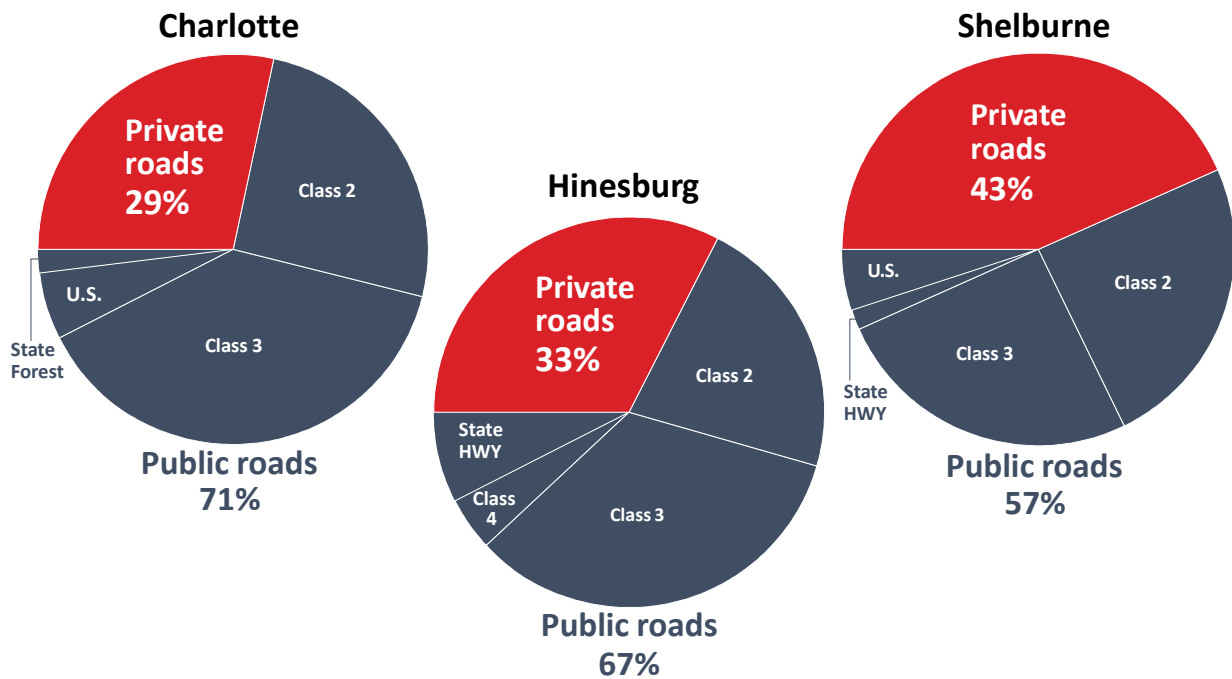
Apply
Municipal Roads General Permit
design principles to driveways
and private roads

The Municipal Roads General Permit applies only to public roads. But we have many private roads and driveways in our towns. We need to apply Municipal Roads General Permit design principles to driveways and private roads, and enhance them to prepare for larger storms. Examples of this include crowning the road to prevent gully erosion, grass-lining ditches on the sides, including broad-based dips or waterbars on steeper roads, and installing check dams and rock lining on steeper road ditches to slow the flow.
