**Stream Corridor Plan
LaPlatte River and Tributaries
Town of Hinesburg, Vermont**

Prepared by the LaPlatte Watershed Partnership
June 2007

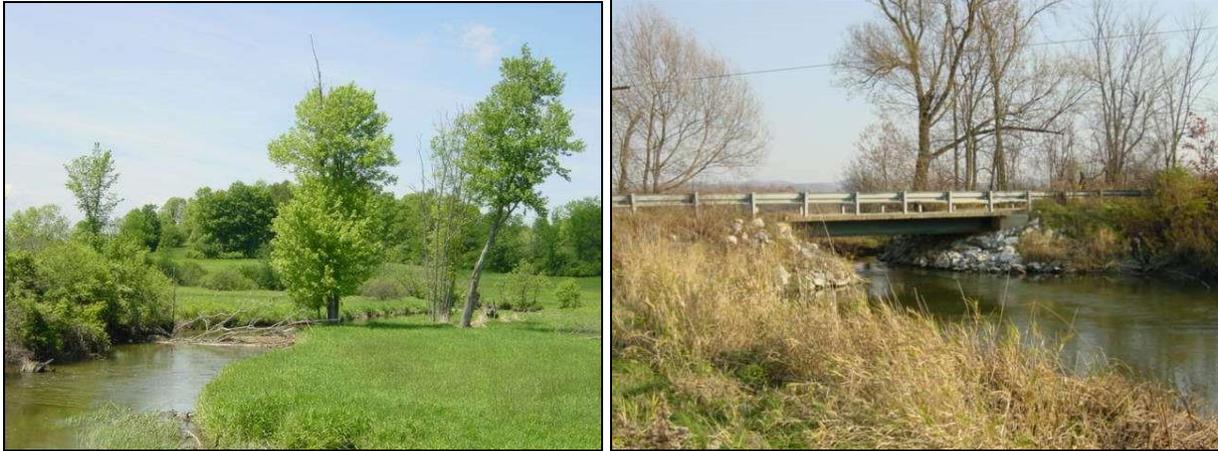
The river corridor was largely undeveloped and the channel appeared in regime, so protecting the corridor along the reach is recommended and a high priority to alleviate pressures from upstream. Also, perennial vegetation was lacking in some parts of the buffer, so planting the stream buffer with native woody vegetation is recommended. This can also act to stabilize the stream banks. Additional bank stabilization not recommended because bank erosion is minor and not endangering buildings.

An undersized bridge is in the reach at Leavensworth Rd. Flooding problems have been identified here by the landowner, who has noticed increased flooding of fields. The bridge and road were apparently designed to have flood flows run over the road, so even though the bridge constricts the bankfull width, pressure is low because of the opportunity for flood flows to access the floodplain and flow over the road. Development past the river on Leavensworth Road now makes road closure due to flooding inconvenient. A series of culverts under the road and adjacent to the bridge to pass flood flows has been proposed. If the culverts are put in and the road therefore raised, more pressure would likely be placed on the bridge (which brings problems there) because the floodplain would be constricted as well.

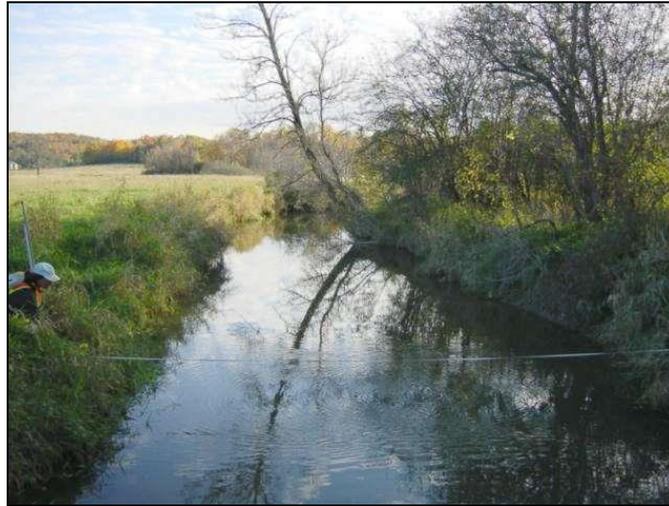
The river corridor was largely undeveloped and channel in regime, so protecting the corridor for the reach is recommended and a high priority to alleviate pressures from upstream. Perennial riparian vegetation was lacking in areas, especially on the left bank. Planting the stream buffer with native woody vegetation is recommended, some planting was observed at the time of assessment.

Bank erosion was observed with moderate changes in channel planform. Planting buffer vegetation can also act to stabilize the stream banks. Additional bank stabilization is not recommended because bank erosion is minor and not endangering buildings.

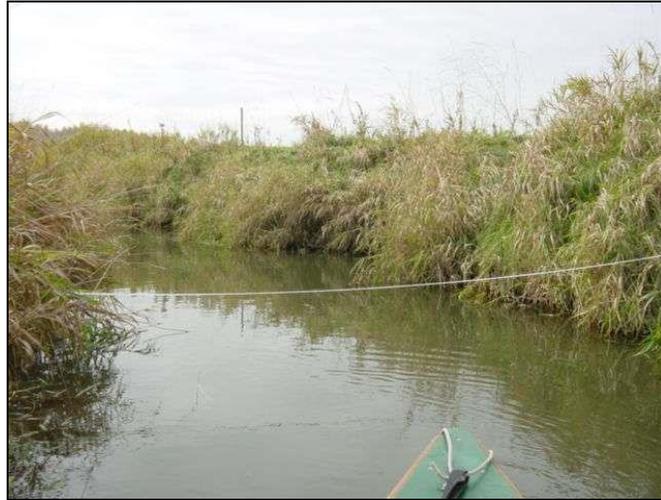
Reach: M14

The river corridor is undeveloped at this time. The channel appeared to be in stage III of the F-stage evolution process, with minor planform and aggradation observed and an incision ratio of 1.3. If the channel were not actively managed in the near term, it may adjust to equilibrium conditions, depending on ongoing channel management and adjustments upstream. So protecting the corridor along the reach is recommended to provide for passive geomorphic restoration of floodplain and meanders, although continued adjustment and/or changes in watershed stressors may require ongoing monitoring of conditions and adjustment here.

Perennial woody riparian vegetation was lacking, so planting the stream buffer with native woody vegetation is recommended, although planting away from actively migrating or unstable banks and toward the outer edges of the corridor is advised. This can also act to stabilize the stream banks. Additional bank stabilization not recommended because bank erosion is minor and not endangering buildings.

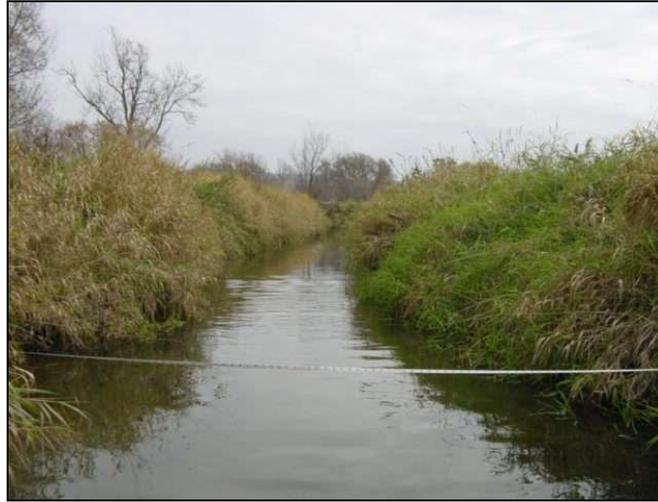
The channel appeared incised (incision ratio of 1.7), likely due to historical channel management activities and possibly some historical watershed deforestation (although the lesser of the stressors), resulting in greater stream power and sediment transport capacity (active bed degradation not observed). No recently abandoned channels were observed to capture as a restoration tool. No permanent constraints exist within the corridor of this segment, although the Hinesburg Sewage Treatment Plant is within the corridor of the upstream segment, M15B. Current corridor land use was pasture, although the landowner was working to fence the pasture and plant a small buffer (35 feet) In terms of flow and sediment load alterations, upstream reaches have been significantly straightened, so stream power would be higher, but no alterations appeared to inhibit active geomorphic restoration of floodplain or meanders here.

The stream is not likely to quickly equilibrate as significant clay in the bed and banks has limited channel movement. Therefore, if adjacent landowners are willing, an active restoration of floodplain with respect to the current channel bed elevation is recommended. Protect the river corridor and plant perennial native vegetation as part of the overall restoration plan to ensure long-term viability.

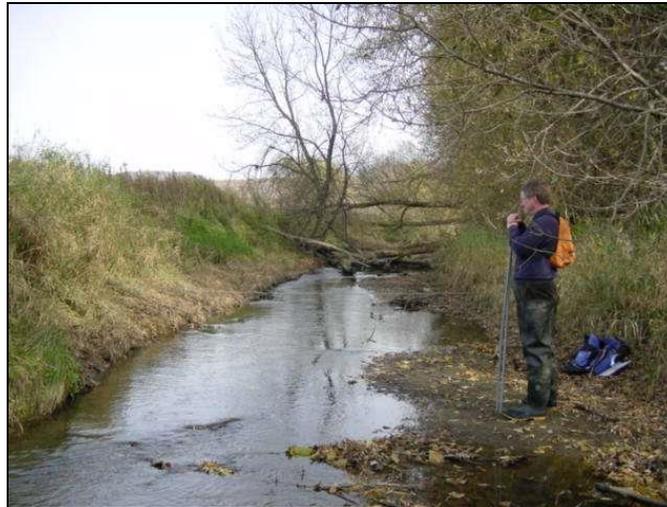
The river corridor is undeveloped except for the Hinesburg Sewage Treatment Plant (STP) on the left bank. If the channel were not actively managed, it may adjust to equilibrium conditions, although the 20-30 year “near-term” time line may not be realistic due to the clay present in the bed and banks, which has limited movement. Therefore, protecting the river corridor and planting stream buffers should be part of an overall restoration plan. Current beaver activity could help by trapping sediment.

The channel was straightened and incised, resulting in greater stream power and increased sediment transport capacity. No recently abandoned channels were observed to capture as a restoration tool. The Hinesburg Sewage Treatment Plant is a permanent constraint within the corridor on the left bank. The LWP has been working with the Town of Hinesburg to plan future Plant expansions out of the stream corridor. Other than that, adjacent land use appeared to be fallow field and flow and sediment load alterations do not appear to be significant enough to inhibit the active geomorphic restoration of floodplain and meanders.

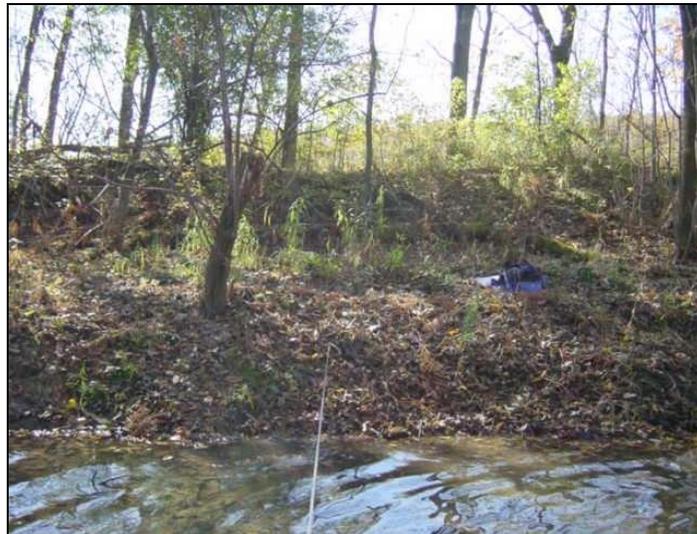
The river corridor is largely undeveloped, however the channel is not likely to adjust to equilibrium conditions in the near term due to the presence of berms and clay soils. Buffer width was 25-50 feet with some areas of about 5 feet or less. Bank erosion and lateral movement were observed. Since the channel was not at or near equilibrium conditions, it is recommended to protect the river corridor and plant perennial native vegetation as part of the overall restoration plan to ensure long-term viability.

Replace structures with appropriately sized structures as they come up for replacement. The culvert at Charlotte Road did not appear to have problems, but does back up water during high flows. The bridge at Silver Street constricted floodprone width, but not bankfull width. Reach is straightened (incision 1.17) resulting in an increase in stream power. No recently abandoned channels were observed to capture as a restoration tool. Very little development (300 feet) exists within the corridor. Current corridor land use was pasture and hay with some crop, although the area adjacent to the stream appears wet much of the year and might be of limited use for agriculture. The parking lot for the Hinesburg Community School, lagoons at the cheese factory, and one house encroached into the corridor. Berms were present in areas along both banks, limiting floodplain access.

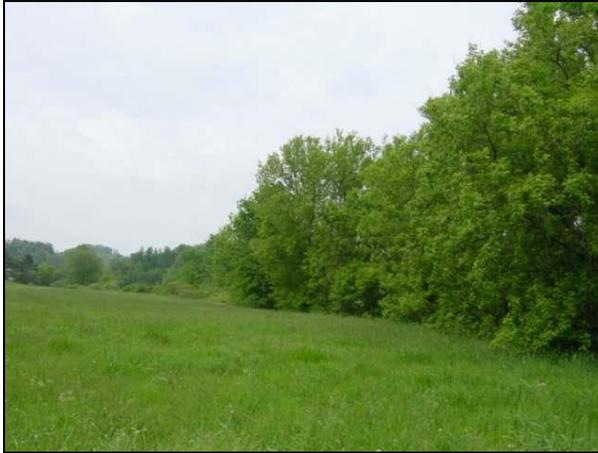
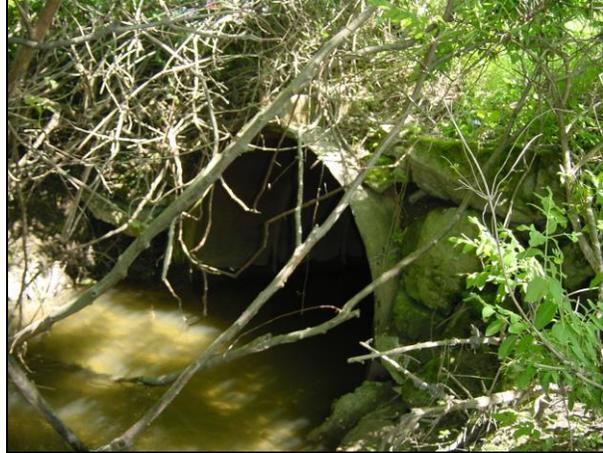
Reach M17 experienced a stream type departure (C to B) and currently appeared to be widening and aggrading, attempting to gain some floodplain and sinuosity in its incised and entrenched position.

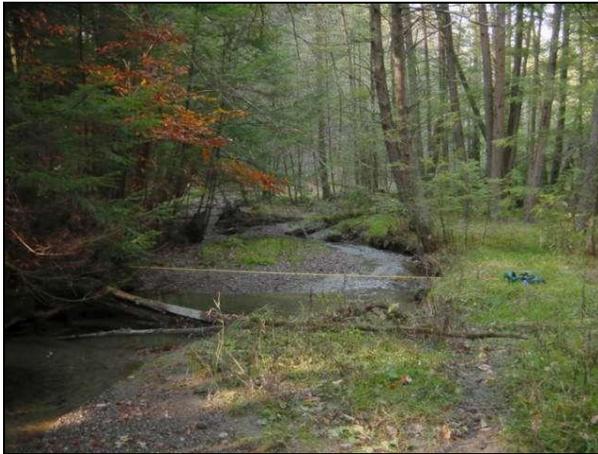
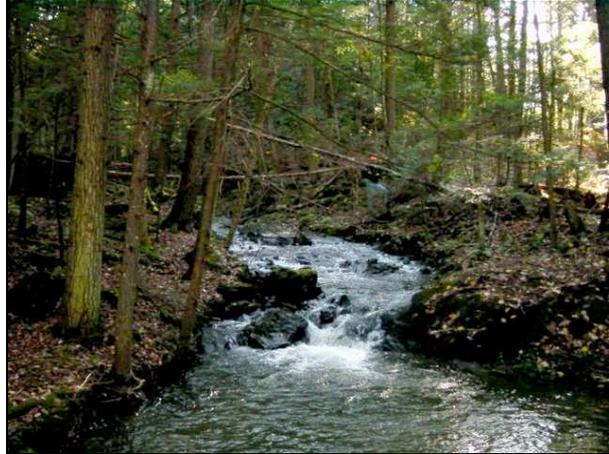
Reach: M18A

Ledge grade control toward downstream end

The river corridor is undeveloped and the channel is likely to adjust to equilibrium conditions in time. So protecting the river corridor is recommended. The segment appeared to be aggrading, but not due to significantly increased sediment supply or decreased peak flows. The stream has access to floodplain, but sediment is being generated in the upstream reach. Protecting the river corridor and addressing upstream issues is recommended.

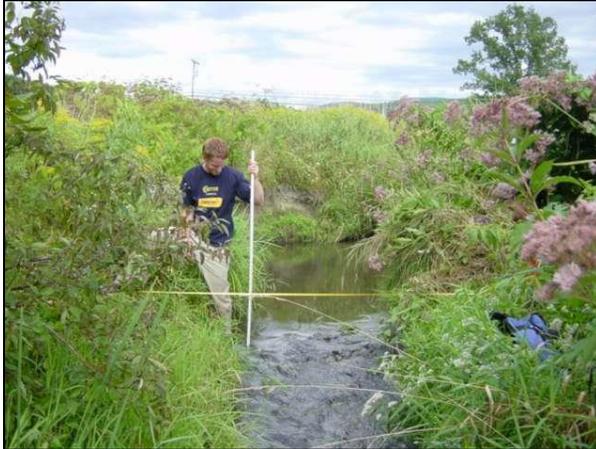
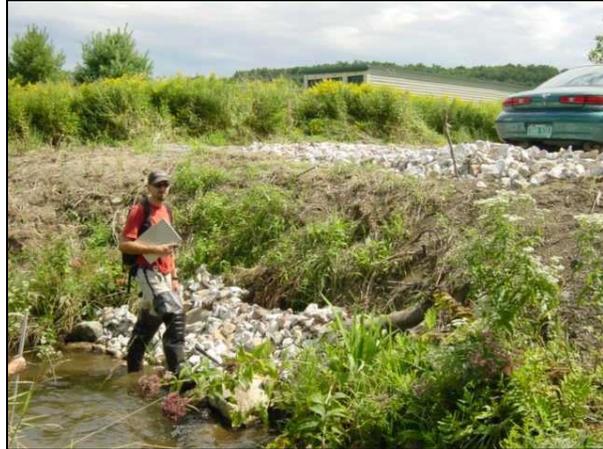
The river corridor is largely undeveloped except for the left bank along Commerce Park. Diversion of water from this reach into “The Canal” has altered flow historically. In recent years, a failing dam behind Nestech has allowed more water to return to this reach. It is likely that this reach would adjust to equilibrium conditions in the near term if conditions were constant. However with uncertainty in the stream flow and in how “The Canal” will be managed in the future, it is recommended that the stream corridor be protected to prevent further investments from encroaching on the area the stream needs to regain equilibrium. Additionally, restoring flow to this reach and finding alternative ways to fill “The Canal” (such as stormwater) are recommended further actions as Potential Restoration/Protection Projects (to also include planting a stream buffer).

A culvert constricts the channel at Route 116, with scour at the downstream end. No upstream sediment deposition was observed. Replacing the structure with one of appropriate size is recommended, especially if flow is restored to this reach from the Canal diversion.

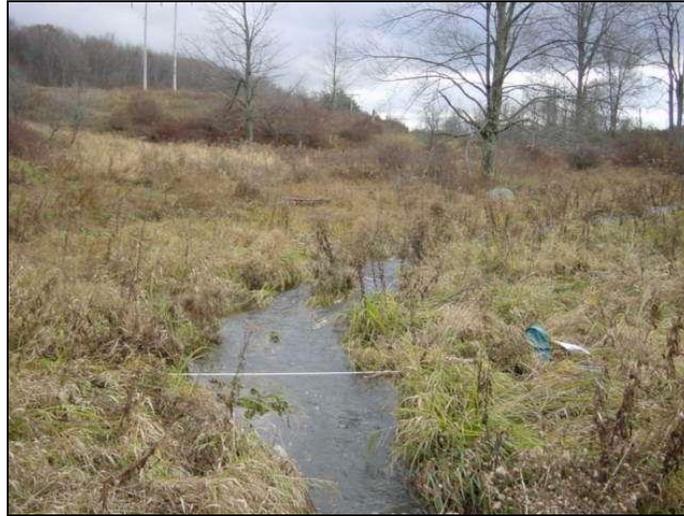
The river corridor is undeveloped and used for pasture. A large beaver dam and pond were located at the upstream end of the reach and beaver activity was observed in the reach. Bank vegetation consisted of herbaceous species with some shrub-saplings. Banks were moderately stable and assessed in “good” condition. Riparian buffer widths were 50-100 feet on each bank with some areas of 5-25 feet. Buffer vegetation was herbaceous with shrubs-saplings. Riparian corridor land use was pasture. Many wetland areas and seeps were noted along the reach. Historical straightening was noted along the reach. The channel is likely to adjust to equilibrium conditions if the corridor is protected and livestock fenced out of the channel. Plant stream buffers in areas where grazing and trampling have disturbed buffer, or allow vegetation to regenerate through corridor protection.

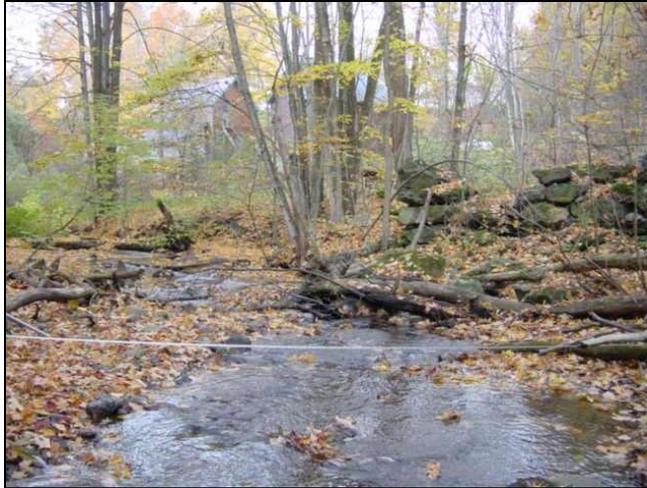
Reach view with old abutment.

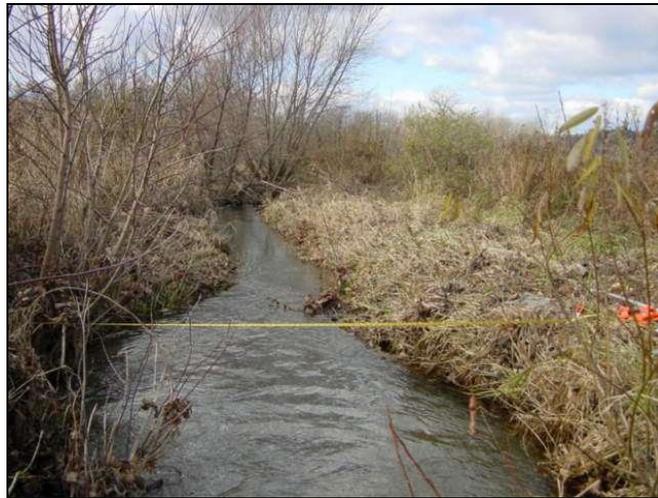
The river corridor is undeveloped, except for a house on the right bank near Route 116. Sediment supply is high and the channel is likely to adjust to equilibrium conditions, although it has been moved over to increase field area. Protecting the river corridor is recommended. The channel has been windrowed downstream of Route 116, with slight sediment buildup along the tops of the banks. This could be removed, or opened up in areas to allow more frequent floodplain access. Planting buffer vegetation away from where the channel is likely to actively migrate can help with long-term bank stability and habitat value.

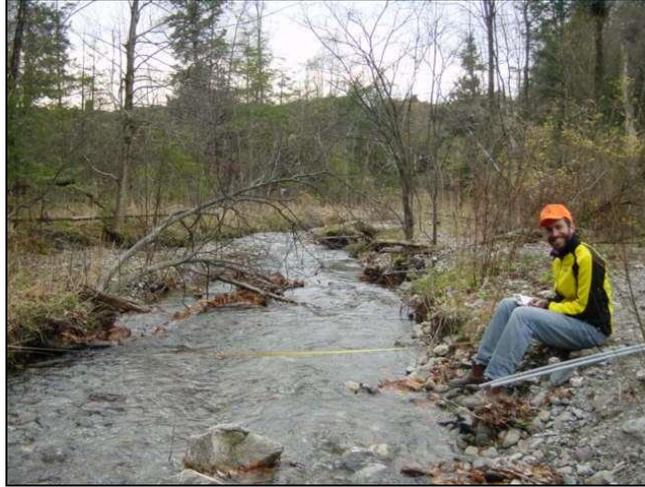
Attenuation area with floodplain connectivity.

The corridor is undeveloped and the channel is likely to adjust to equilibrium on its own, so protecting the stream corridor is recommended. This is also a valuable attenuation zone to buffer against upstream impacts. Planting stream buffer away from actively migrating banks is recommended.

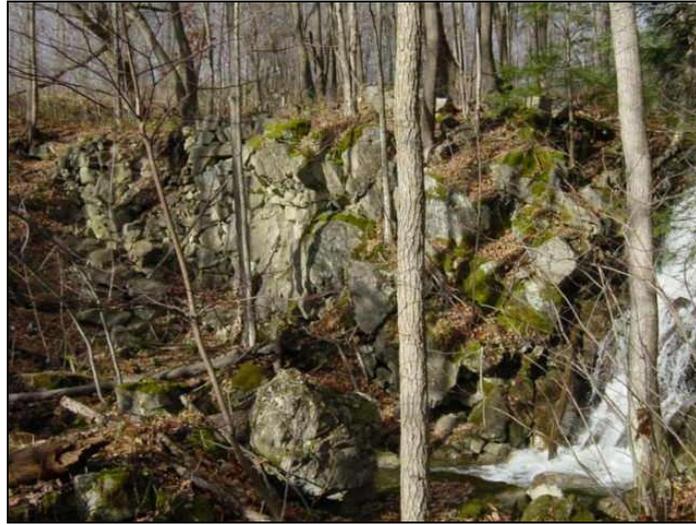
Reach: T5.01C

Milldam to left, falls to right.

This area had multiple ledges and a waterfall and a wooded corridor. Protect the corridor to avoid future encroachment.
